**DEPARTMENT OF TRANSPORTATION**

Contract #: 04-0120F4Cty: SF/ALA Rte: 80 PM: 13.2/13.9File #: 69.25B**QUALITY ASSURANCE -- NON-CONFORMANCE REPORT****Location:** Changxing Island, Shanghai, PRC**Report No:** NCR-000399**Prime Contractor:** American Bridge/Fluor Enterprises, a JV**Date:** 04-Sep-2009**Submitting Contractor:** Zhenhua Port Machinery Company, Ltd (ZPMC), Changxing Island**NCR #:** ZPMC-0373**Type of problem:****Welding****Concrete****Other****Welding****Curing****Procedural****Bridge No:** 34-0006**Joint fit-up****Coating****Other****Component:** East Tower**Procedural****Procedural****Description:** Missed MT indications on East Tower, Lift 2**Reference Description:** Missed MT indications on East Tower, Lift 2 discovered during additional NDT review**Description of Non-Conformance:**

## QUALITY ASSURANCE -- NON-CONFORMANCE REPORT

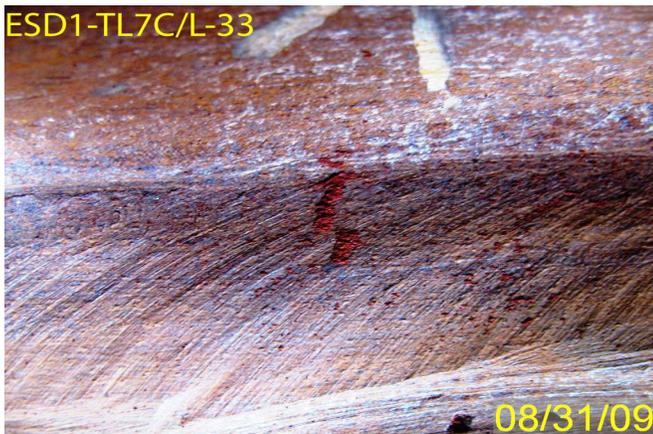
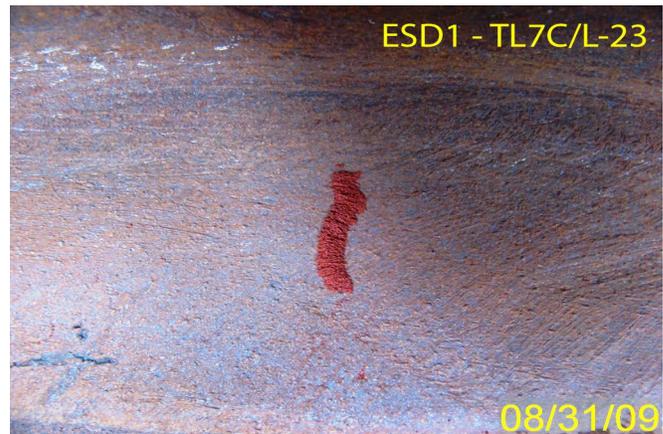
During additional (weld over-check) Magnetic Particle Testing (MT) of accessible welds at the 53 meter diaphragm elevation of East Tower, Lift 2, QA discovered transverse and longitudinal linear indications at the following welds. These welds were previously tested and accepted by ZPMC Quality Control personnel.

**Weld ID - Number of Indications - Type**

ESD1-TL7C/L-23 - 1 - Transverse linear indication  
ESD1-TL7C/L-33 - 1 - Transverse linear indication  
ESD1-TL7C/L-121 - 2 - Transverse linear indication  
ESD1-TL7C/L-132 - 1 - Transverse linear indication  
ESD1-TL7C/L-208 - 1 - Transverse linear indication  
ESD1-SA300D/F-17A/B - 1 - Transverse linear indication  
ESD1-TL7C/L-136 - 1 - Longitudinal linear indication  
ESD1-TL7C/L-141 - 1 - Longitudinal linear indication
