QUALITY ASSURANCE -- NON-CONFORMANCE REPORT

Report No: NCR-000401

NCR #: ZPMC-0375

Welding	Concrete	Other	
Welding	Curing	Procedural	Bridge No: 34-0006
Joint fit-up	Coating	Other	Component: South Tower
Procedural	Procedural	Description: South Tower, Lift 3, Skin A Padeyes

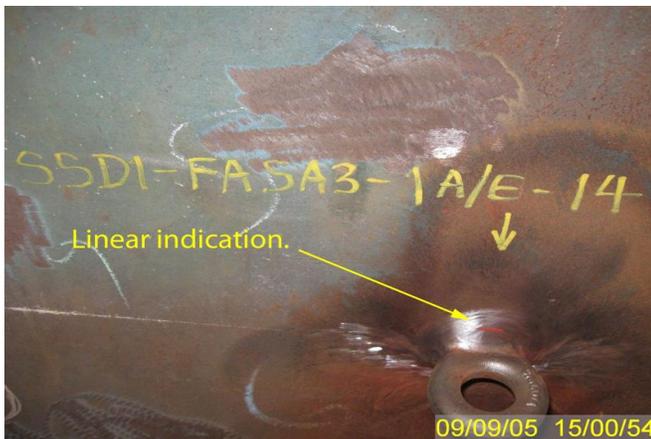
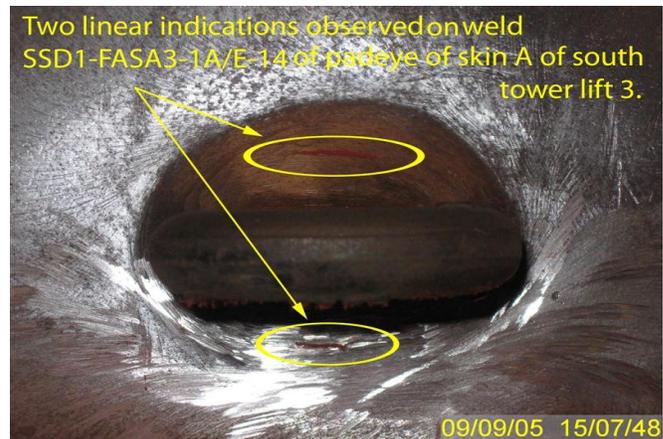
During Magnetic Particle Testing (MT) of South Tower, Lift 3, Padeye weld SSD1-FASA3-1A/E-14, QA discovered two linear indications approximately 15 and 12mm in length. This weld was previously tested and accepted by ZPMC NDT personnel.

AWS D1.5-2002 Section 6.26.2 – “Welds that are subject to MT in addition to visual inspection shall have no cracks.

Propose a resolution for this systematic non-conformance that addresses the failure of Quality Control to identify the linear indications during magnetic particle testing of the welds. Provide documentation of the steps/actions taken by the Quality Control Manager to prevent future occurrences.

In addition to the Quality Control non-conformance, address the material/workmanship for the identified non-conformance including documentation that the deficiencies have been brought into compliance with the contract requirements. Additionally address the probable causes for the indications and the actions that will be taken to limit future occurrences.

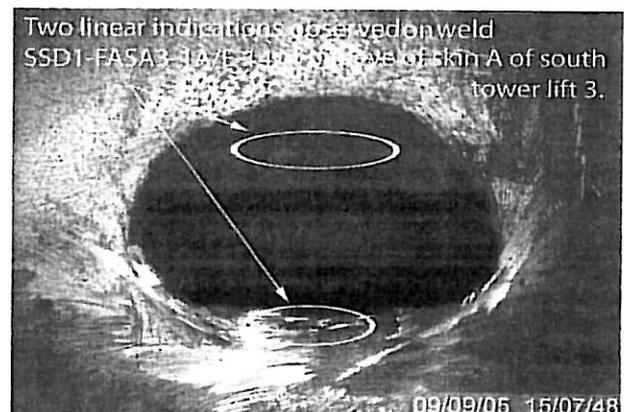
During Magnetic Particle Testing (MT) of South Tower, Lift 3, Padeye weld SSD1-FASA3-1A/E-14, QA discovered two linear indications approximately 15 and 12mm in length. This weld was previously tested and accepted by ZPMC NDT personnel.

AWS D1.5-2002 Section 6.26.2 – “Welds that are subject to MT in addition to visual inspection shall have no cracks.

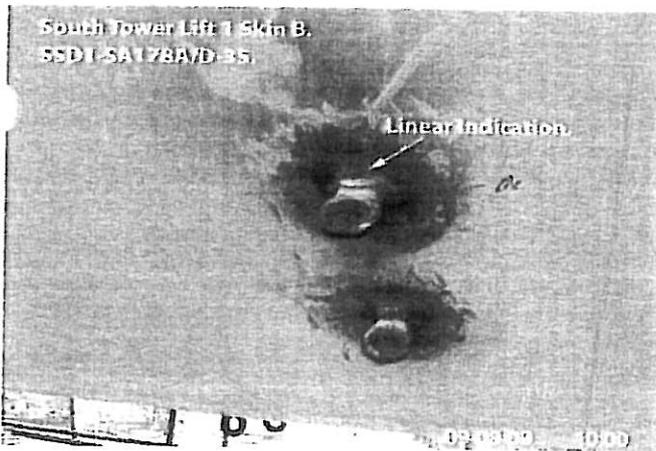
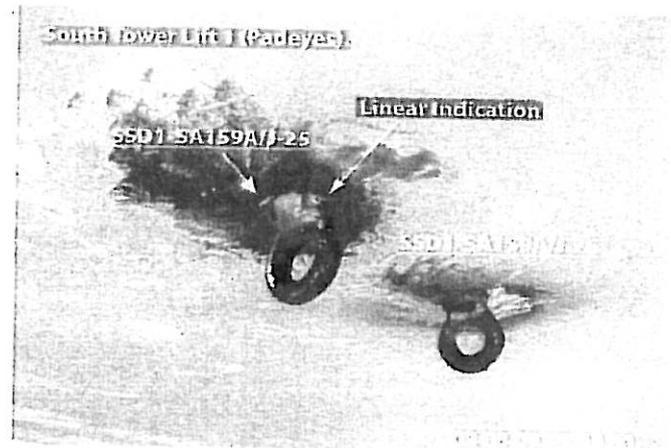
During Magnetic Particle Testing (MT) of South Tower, Lift 1, Skin A pad eyes, QA observed linear indications at weld joints SSD1-SA159A/J-25 & SSD1-SA159A/J-28. ZPMC MT Technicians had previously tested and accepted 10% of the pad eye welds. After QA found the linear indications, ZPMC QC personnel Zhang Jiadi asked to cancel the request for QA inspection in order to perform 100% MT of remaining pad eyes.

Following ZPMC's testing and acceptance of 100% of the pad eye welds, QA performed MT and discovered linear indications at weld joints SSD1-SA159A/J-24 & SSD1-SA178A/D-35.

AWS D1.5-2002 Section 6.26.2 – “Welds that are subject to MT in addition to visual inspection shall have no cracks.

Repair affected welds.

Weld have been repaired and Non-Destructive Testing (NDT) documentation indicating a sound weld has been submitted. To resolve the recurring failure for QC to detect MT indications, ABF has held verbal interviews with ZPMC QC and MT technicians on several occasions. ABF has requested ZPMC to provide an analysis of missed indications to determine if they can be traced to a personnel trend, such as an inspector, welder, or weld location. ABF has informed ZPMC to ensure adequate lighting is provided during inspections. Tests have also been administered to ZPMC MT technicians to demonstrate their ability to detect MT indications.

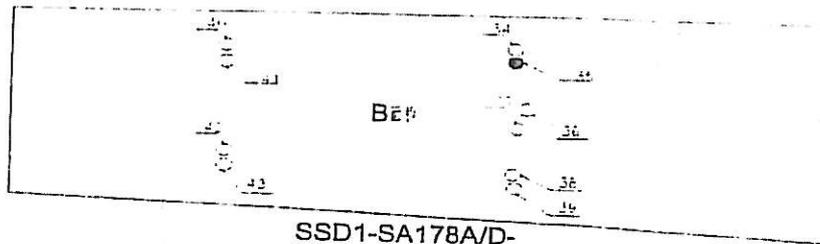
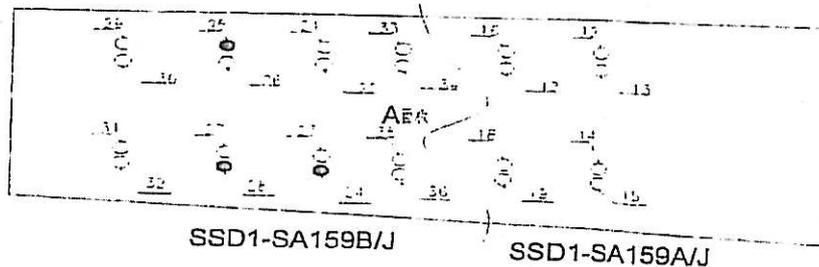
注: 阴影部位为返修区域。Remark: repair area in shadow.

Tower(S) first lifting, the cracks were found on three lifting ring on Skin A and one lifting on Skin B, weld ID : Skin A:SSD1-SA159B/J-24, 25, 28, Skin B SSD1-SA178A/D-35.

1. 火焰加热时, 水汽没有完全的去除或者这个区域预热不够;
1. Moisture wasn't completely removed during drying operation (preheating) or the area wasn't preheated sufficiently.

3. QC shall monitor and direct the welder and the grinder doing the repair operation.
 4. Preheat before gouging; the temperature shall be at least 65°C.

5. Gouge the weld to remove identified defects.
 6. Joint details shall refer to the approved WPS repair.
 7. Grind the gouged areas to a smooth and shiny surface.

8. Verify with VT and MT to ensure no defects remain in the weld joint prior to welding.
 9. QC shall monitor all welding passes being deposited.
 10. QC shall ensure all slag has been removed prior the deposition of next pass.

11. Preheat and maintain interpass temperature control in accordance with the WPS.
 12. Blend the weld repaired areas into the adjacent weld or base metal by grinding.

13. Perform VT, MT inspection to the repaired areas.
- 1、在返修过程中, QC 应该监控和指导焊工和打磨工;
 - 2、碳刨之前必须先进行预热, 温度不低于 65° C;
 - 3、碳刨去除缺陷;
 - 4、缺陷被完全消除后, 必须准备一个正确的接头型式, 具体接头型式请参见对应的修补焊接工艺规程(WPS);
