QUALITY ASSURANCE -- NON-CONFORMANCE REPORT

Report No: NCR-000402

Welding	Concrete	Other	
Welding	Curing	Procedural	Bridge No: 34-0006
Joint fit-up	Coating	Other	Component: Tower Struts
Procedural	Procedural	Description: Tower Type 2 Struts

Reference Description: Missed MT indications on Tower Type 2 Struts

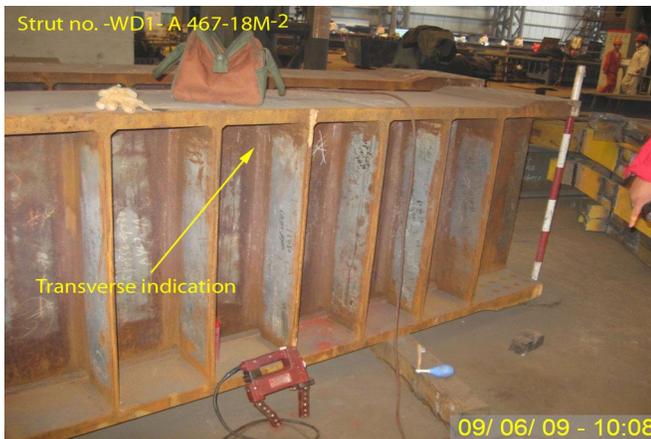
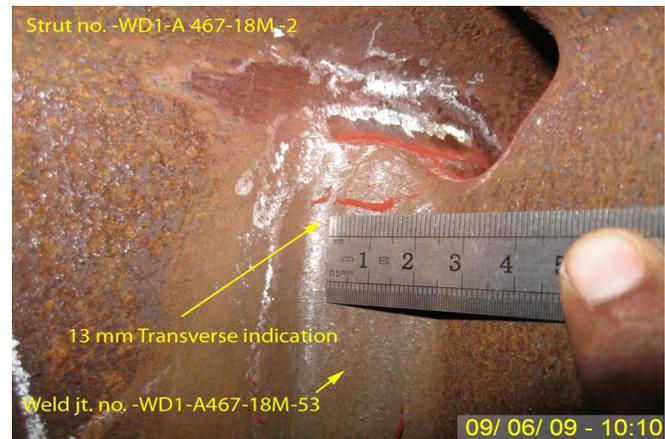
During Magnetic Particle Testing (MT) of strut welds WD1-A467-18M-2-53 and WD1-A467-38M-1-88, QA discovered transverse linear indications measuring approximately 13mm and 5mm in length. These welds were previously accepted by ZPMC QC personnel.

AWS D1.5-2002 Section 6.26.2 – “Welds that are subject to MT in addition to visual inspection shall have no cracks.

ZPMC acknowledged this problem, and arranged ZPMC's worker to deal with that. After smoothly grinding, the indication has been taken out. Finally performed re-inspection by MT, and also such weld was re-inspected and accepted by CT inspector. In order to avoid such problem occurs again ZPMC will perform NDT work according to related procedures strictly, and enhance QC be more responsible. Here attached the MT reports to prove the weld was perfect .

The affected welds have been repaired and a NDT report indicating sound welds has been submitted. The welds have since been verified by QA and green tagged.

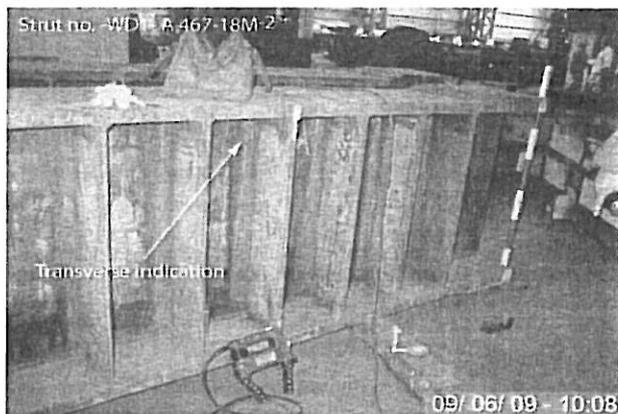
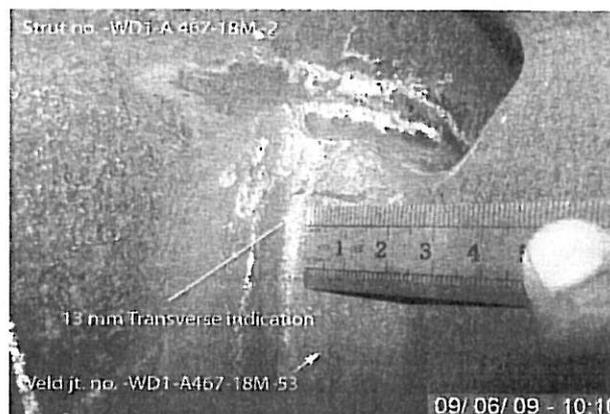
During Magnetic Particle Testing (MT) of strut welds WD1-A467-18M-2-53 and WD1-A467-38M-1-88, QA discovered transverse linear indications measuring approximately 13mm and 5mm in length. These welds were previously accepted by ZPMC QC personnel.

AWS D1.5-2002 Section 6.26.2 – “Welds that are subject to MT in addition to visual inspection shall have no cracks.
