Contract #: 04-0120F4  
 Cty: SF/ALA Rte: 80 PM: 13.2/13.9  
 File #: 69.25B

**QUALITY ASSURANCE -- NON-CONFORMANCE REPORT**

**Location:** Changxing Island, Shanghai, PRC **Report No:** NCR-000403  
**Prime Contractor:** American Bridge/Fluor Enterprises, a JV **Date:** 10-Sep-2009  
**Submitting Contractor:** Zhenhua Port Machinery Company, Ltd (ZPMC), Changxing Island **NCR #:** ZPMC-0377

**Reference Description:** Missed MT indications on South Tower, Lift 1, Skin A & B Pad Eyes

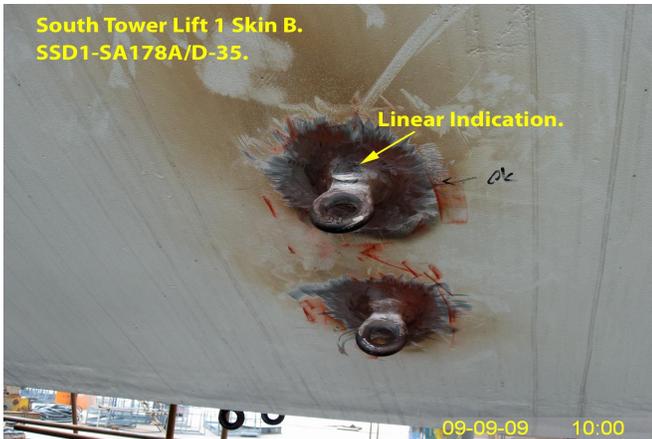
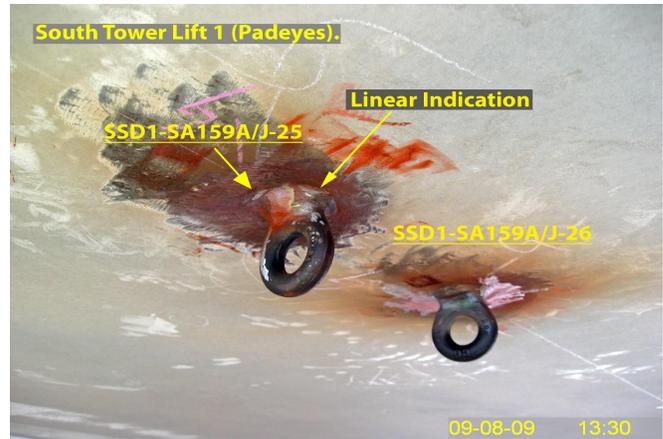
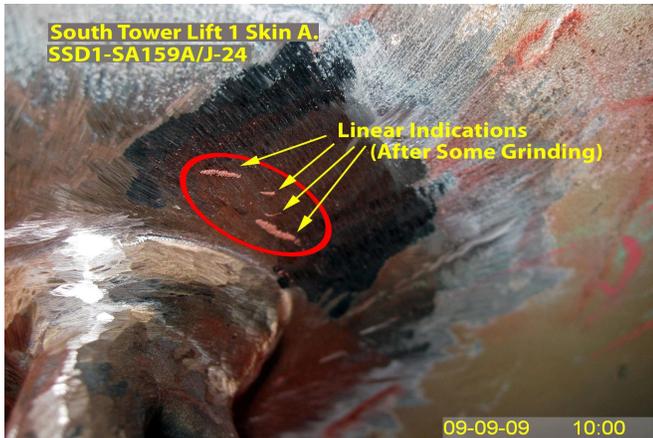
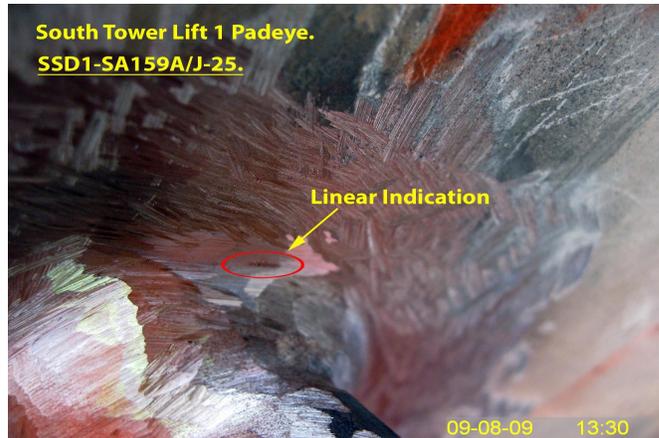
During Magnetic Particle Testing (MT) of South Tower, Lift 1, Skin A pad eyes, QA observed linear indications at weld joints SSD1-SA159A/J-25 & SSD1-SA159A/J-28. ZPMC MT Technicians had previously tested and accepted 10% of the pad eye welds. After QA found the linear indications, ZPMC QC personnel Zhang Jiadi asked to cancel the request for QA inspection in order to perform 100% MT of remaining pad eyes.

Following ZPMC's testing and acceptance of 100% of the pad eye welds, QA performed MT and discovered linear indications at weld joints SSD1-SA159A/J-24 & SSD1-SA178A/D-35.

AWS D1.5-2002 Section 6.26.2 – “Welds that are subject to MT in addition to visual inspection shall have no cracks.

Propose a resolution for this systematic non-conformance that addresses the failure of Quality Control to identify the linear indications during magnetic particle testing of the welds. Address whether this failure represents a breakdown in the QC system / NDT procedures or is specific to individual NDT personnel. Specifically considering that ZPMC requested to cancel the initial QA inspection after indications were identified and then performed 100% NDT prior to the second QA inspection. Provide documentation of the steps/actions taken by the Quality Control Manager to prevent future occurrences.

In addition to the Quality Control non-conformance, address the material/workmanship for the identified non-conformance including documentation that the deficiencies have been brought into compliance with the contract requirements. Additionally address the probable causes for the indications and the actions that will be taken to limit future occurrences.

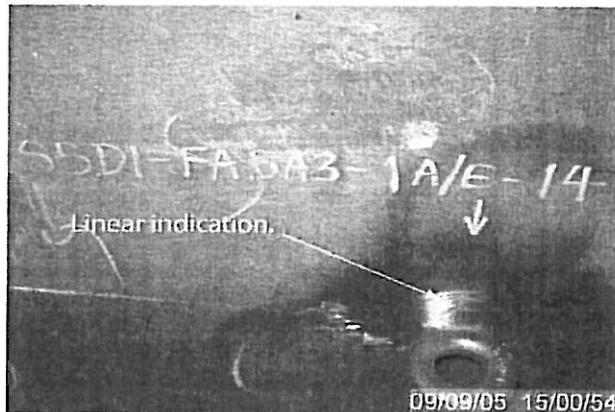
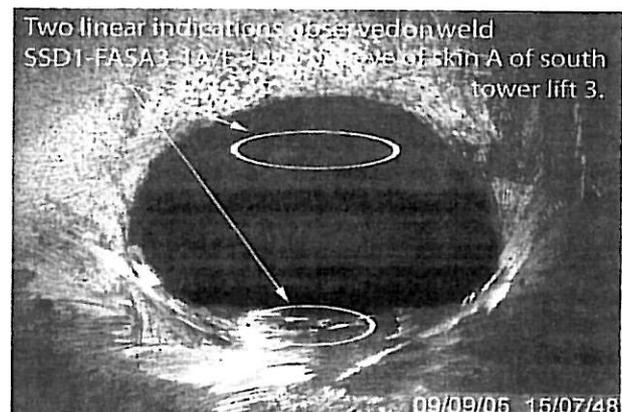
During Magnetic Particle Testing (MT) of South Tower, Lift 3, Padeye weld SSD1-FASA3-1A/E-14, QA discovered two linear indications approximately 15 and 12mm in length. This weld was previously tested and accepted by ZPMC NDT personnel.

AWS D1.5-2002 Section 6.26.2 – “Welds that are subject to MT in addition to visual inspection shall have no cracks.

Propose a resolution for this systematic non-conformance that addresses the failure of Quality Control to identify the linear indications during magnetic particle testing of the welds. Provide documentation of the steps/actions taken by the Quality Control Manager to prevent future occurrences.

In addition to the Quality Control non-conformance, address the material/workmanship for the identified non-conformance including documentation that the deficiencies have been brought into compliance with the contract requirements. Additionally address the probable causes for the indications and the actions that will be taken to limit future occurrences.

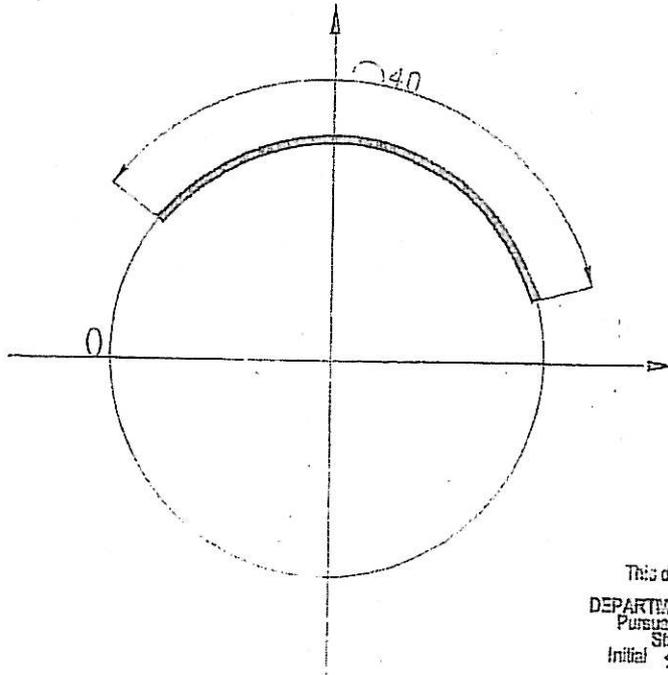
WELD NUMBER:SSD1-FASA3-1A/E-14

One line indication was found by use of MT on SSD1-FASA3-1A/E-14.

1. 火焰加热时, 水汽没有完全的去掉或者这个区域预热不够;
1. Moisture wasn't completely removed during drying operation (preheating) or the area wasn't preheated sufficiently.

1. QC shall monitor and direct the welder and the grinder doing the repair operation.
  2. Preheat before gouging; the temperature shall be at least 65°C.

3. Gouge the weld to remove identified defects.
  4. Joint details shall refer to the approved WPS repair.
  5. Grind the gouged areas to a smooth and shiny surface.

6. Verify with VT and MT to ensure no defects remain in the weld joint prior to welding.
  7. QC shall monitor all welding passes being deposited.
  8. QC shall ensure all slag has been removed prior the deposition of next pass.

9. Preheat and maintain interpass temperature control in accordance with the WPS.
  10. Blend the weld repaired areas into the adjacent weld or base metal by grinding.

11. Perform VT, MT and UT NDT inspection to the repaired areas.
1. 在返修过程中, QC 应该监控和指导焊工和打磨工;
  2. 碳刨之前必须先进行预热, 温度不低于 65°C;
  3. 碳刨去除缺陷;
  4. 缺陷被完全消除后, 必须准备一个正确的接头型式, 具体接头型式请参见对应的修补焊接工艺规程(WPS);

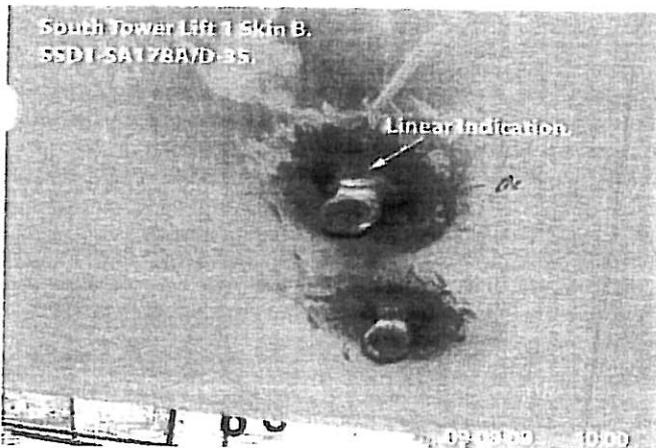
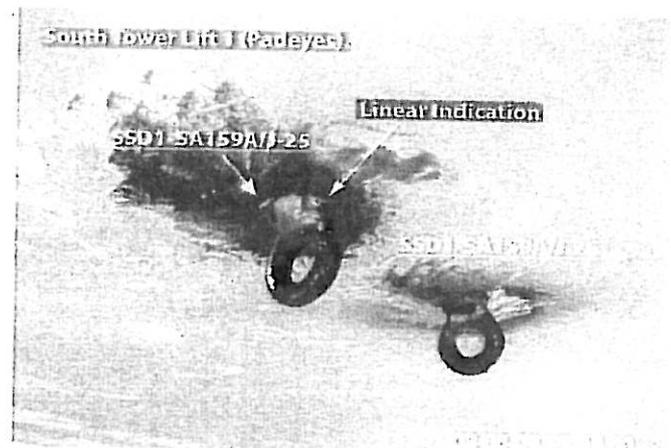
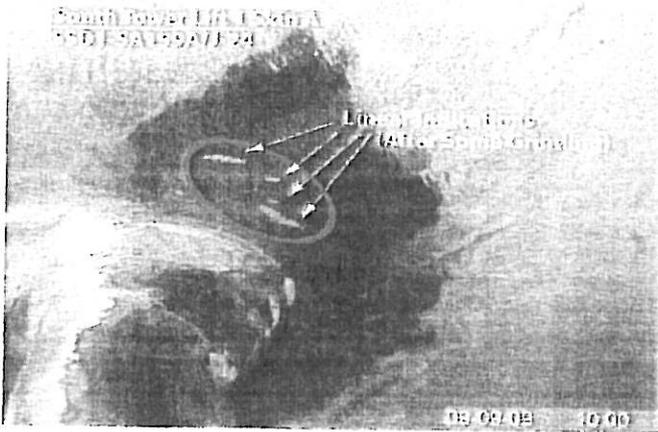
During Magnetic Particle Testing (MT) of South Tower, Lift 1, Skin A pad eyes, QA observed linear indications at weld joints SSD1-SA159A/J-25 & SSD1-SA159A/J-28. ZPMC MT Technicians had previously tested and accepted 10% of the pad eye welds. After QA found the linear indications, ZPMC QC personnel Zhang Jiadi asked to cancel the request for QA inspection in order to perform 100% MT of remaining pad eyes.

Following ZPMC's testing and acceptance of 100% of the pad eye welds, QA performed MT and discovered linear indications at weld joints SSD1-SA159A/J-24 & SSD1-SA178A/D-35.

AWS D1.5-2002 Section 6.26.2 – “Welds that are subject to MT in addition to visual inspection shall have no cracks.

Repair affected welds.

Welds have been repaired, verified by QA, and subsequently green tagged.

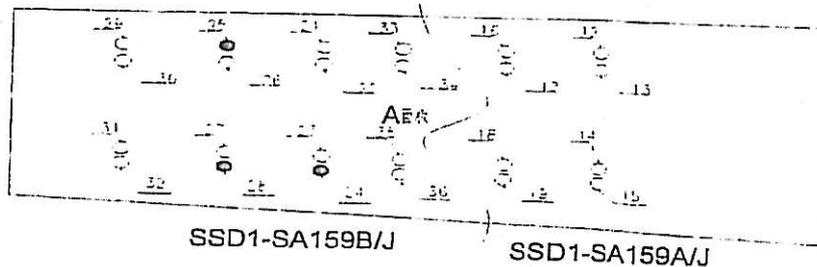
注: 阴影部位为返修区域。Remark: repair area in shadow.

Tower(S) first lifting, the cracks were found on three lifting ring on Skin A and one lifting on Skin B, weld ID : Skin A:SSD1-SA159B/J-24, 25, 28, Skin B SSD1-SA178A/D-35.

1. 火焰加热时, 水汽没有完全的去除或者这个区域预热不够;
1. Moisture wasn't completely removed during drying operation (preheating) or the area wasn't preheated sufficiently.

3. QC shall monitor and direct the welder and the grinder doing the repair operation.
  4. Preheat before gouging; the temperature shall be at least 65°C.

5. Gouge the weld to remove identified defects.
  6. Joint details shall refer to the approved WPS repair.
  7. Grind the gouged areas to a smooth and shiny surface.

8. Verify with VT and MT to ensure no defects remain in the weld joint prior to welding.
  9. QC shall monitor all welding passes being deposited.
  10. QC shall ensure all slag has been removed prior the deposition of next pass.

11. Preheat and maintain interpass temperature control in accordance with the WPS.
  12. Blend the weld repaired areas into the adjacent weld or base metal by grinding.

13. Perform VT, MT inspection to the repaired areas.
1. 在返修过程中, QC 应该监控和指导焊工和打磨工;
  2. 碳刨之前必须先进行预热, 温度不低于 65° C;
  3. 碳刨去除缺陷;
  4. 缺陷被完全消除后, 必须准备一个正确的接头型式, 具体接头型式请参见对应的修补焊接工艺规程(WPS);
