Contract #: 04-0120F4Cty: SF/ALA Rte: 80 PM: 13.2/13.9File #: 69.25B**QUALITY ASSURANCE -- NON-CONFORMANCE REPORT****Location:** Changxing Island, Shanghai, P.R. China**Report No:** NCR-000406**Prime Contractor:** American Bridge/Fluor Enterprises, a JV**Date:** 27-Aug-2009**Submitting Contractor:** Zhenhua Port Machinery Company, Ltd (ZPMC), Changxing Island**NCR #:** ZPMC-0380**Type of problem:**

**Bridge No:** 34-0006**Component:** T-Stiffener Splice in OBG Segment 10CE**Reference Description:** Improper backing bar fit-up and unidentifiable material**Description of Non-Conformance:**

**Job Name:** SAS Superstructure

**Subject:** NCR No. ZPMC-0380

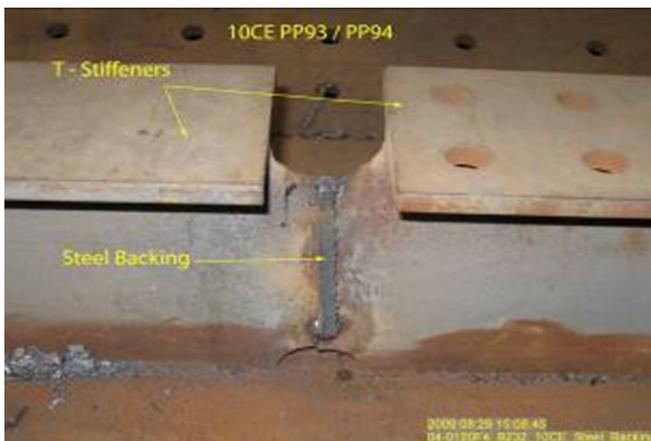
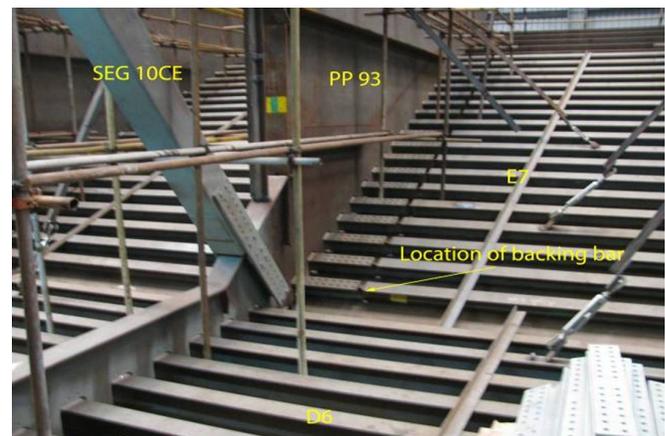
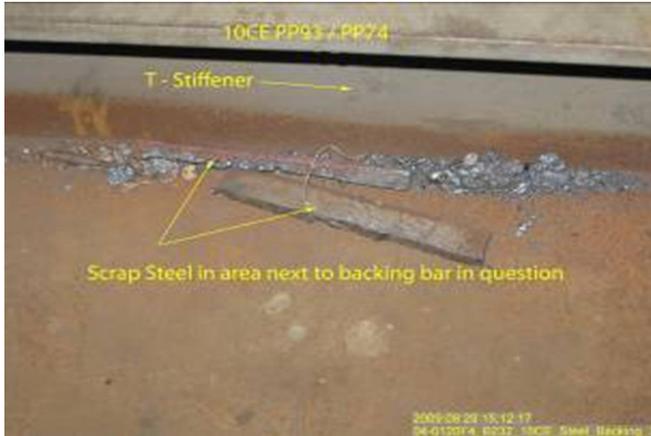
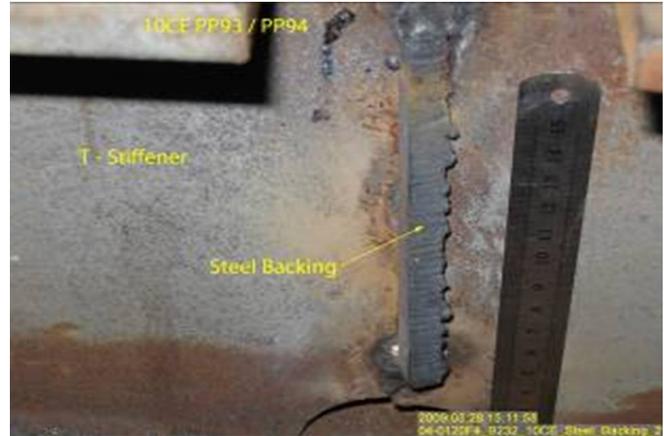
This Quality Assurance Inspector (QA) observed that the contractor has performed T-stiffeners splice weld between panel point 93 and 94 in Segment 10CE. The contractor used a steel backing on a T-Stiffener that does not conform to the code requirements. This steel backing bar is from an unknown material source and is not in intimate contact with the base metal. The location of this joint is on SP633A closest to the bottom panel.

1. AWS D1.5 Section 3.13.1 Backing: Steel backing shall conform to the following requirements: (1) When welding any approved steel described in 1.2.2, backing may be of any of the steels described in 1.2.2 except that Grade 690 (100) or 690W (100W) backing shall not be used on lower strength steels.

2. AWS D1.5 Section 3.13.5: Steel backing shall be placed and held in intimate contact with the base metal. The maximum gap between steel backing and the base metal at the weld root shall be 2 mm [1/16 in.], as shown in Figure 3.2(A).

Submit a repair plan to the engineer that includes use of the proper steel and correct fit up.

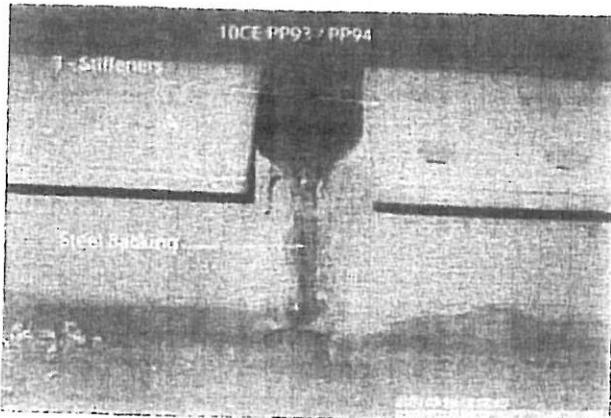
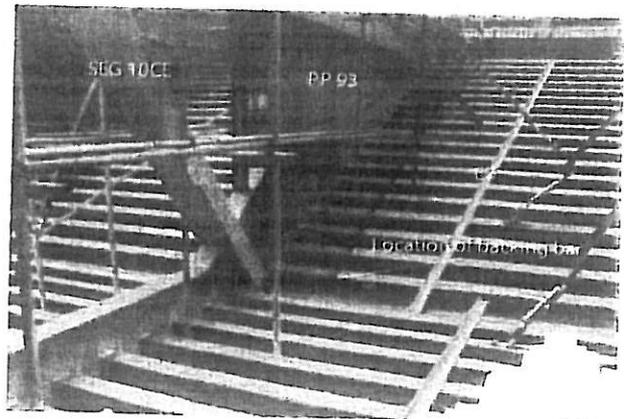
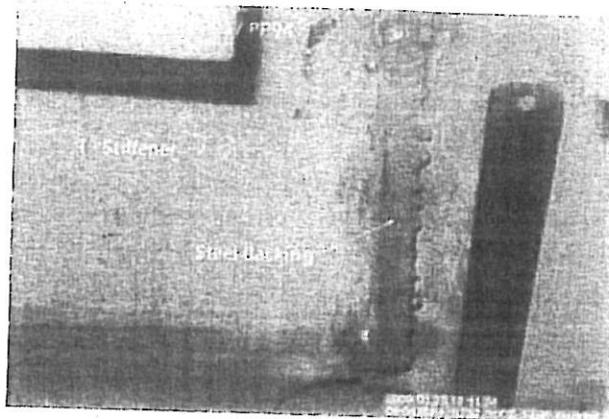
This Quality Assurance Inspector (QA) observed that the contractor has performed T-stiffeners splice weld between panel point 93 and 94 in Segment 10CE. The contractor used a steel backing on a T-Stiffener that does not conform to the code requirements. This steel backing bar is from an unknown material source and is not in intimate contact with the base metal. The location of this joint is on SP633A closest to the bottom panel.

1. AWS D1.5 Section 3.13.1 Backing: Steel backing shall conform to the following requirements: (1) When welding any approved steel described in 1.2.2, backing may be of any of the steels described in 1.2.2 except that Grade 690 (100) or 690W (100W) backing shall not be used on lower strength steels.

Submit a repair plan to the engineer that includes use of the proper steel and correct fit up.
