Contract #: 04-0120F4Cty: SF/ALA Rte: 80 PM: 13.2/13.9File #: 69.25B**QUALITY ASSURANCE -- NON-CONFORMANCE REPORT****Location:** Changxing Island, Shanghai, PRC**Report No:** NCR-000409**Prime Contractor:** American Bridge/Fluor Enterprises, a JV**Date:** 15-Sep-2009**Submitting Contractor:** Zhenhua Port Machinery Company, Ltd (ZPMC), Changxing Island**NCR #:** ZPMC-0383**Type of problem:**

Welding	Concrete	Other	
Welding	Curing	Procedural	Bridge No: 34-0006
Joint fit-up	Coating	Other	Component: East Tower
Procedural	Procedural	Description: East Tower, Lift 1

Reference Description: Missed MT indications on East Tower, Lift 1**Description of Non-Conformance:**

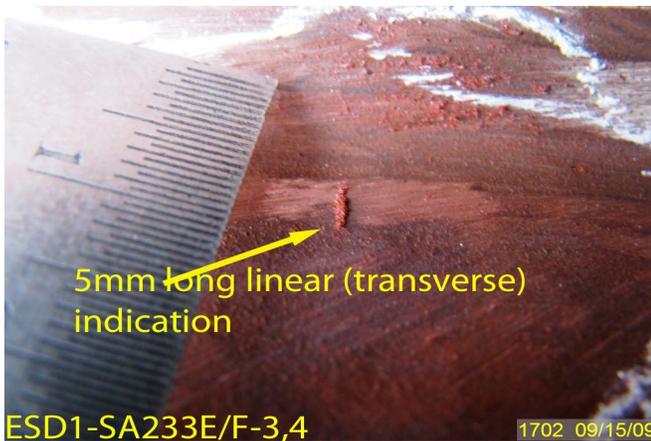
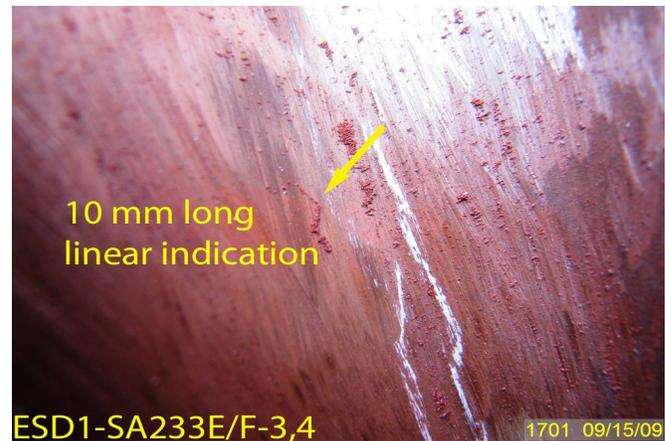
During Magnetic Particle Testing (MT) of East Shaft, Lift 1, welds ESD1-SA233E/F-3,4, QA observed one transverse and one longitudinal linear indications. These welds have been previously tested and accepted by ZPMC MT Technicians.

AWS D1.5-2002, Section 6.26.2 – “Welds that are subject to MT in addition to visual inspection shall have no cracks.

ABF JV QCM has implemented training with ZPMC to improve the quality of inspections. ABF JV will provide documentation showing attendance by ZPMC QC inspectors and the subject of training. Topics to be covered during the instruction are: inspection of equipment prior to use, proper conditions for inspection, proper technique for MT, and UT. In addition, ABF JV has committed to perform overchecks in both the Tower and OBG. This will serve two purposes, first to monitor if the training is effective at reducing the number of missed indications and second to ensure missed indications are prevented.

Documentation of repairs and subsequent NDT specific to this report will be transmitted through Daily Welding Reports and will be available in the documentation data base. Based on this course of action, ZPMC is requesting that this proposed resolution be approved with action pending. Once training records are available to be transmitted, ZPMC will request closure of this NCR.

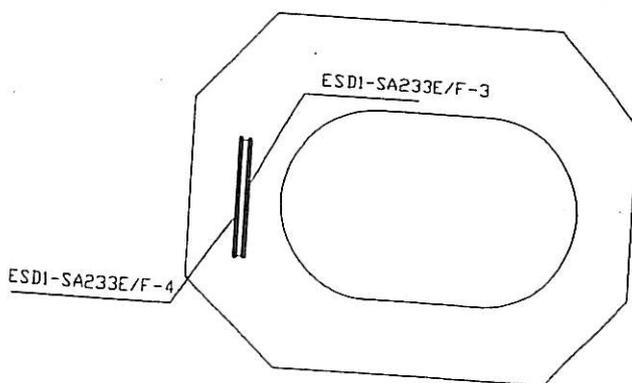
Draft of welding discontinuity:

东塔第一吊装段报验时，发现B面板踏步板2条裂纹，长度分别为10MM，5MM.具体如图：
During inspection first lifting east tower, two cracks were found at Skin B, 10mm and 5mm in length, the details sees the following draft.

阴影处为需要补焊区域 Repair area in shadow.

1. 火焰加热时, 水汽没有完全的去掉或者这个区域预热不够;
1. Moisture wasn't completely removed during drying operation (preheating) or the area wa sn't preheated sufficiently.

1. QC 须监控碳刨、打磨和焊接过程
 2. 碳刨去除缺陷并打磨光滑
 3. VT 检测以确保缺陷被清除
 4. 焊接须符合 WPS 要求
 5. 在进入下道焊缝前, QC 须确保所有焊渣都已被去除干净
 6. 打磨返修区域使其与临近焊缝或母材齐平
 7. 对返修区域进行 VT, MT 和 UT 检测
-
1. QC shall monitor gouging/grinding/welding
 2. Gouge defects & grind smoothly
 3. Verify that defects have been removed with VT
 4. Welding shall be in accordance with WPS
 5. QC shall ensure all slag is removed prior to deposition of subsequent weld passes
 6. Blend repair area with adjacent base metal
 7. Perform VT, MT, & UT to repaired area

1. QC shall verify sufficient preheat has been applied, to remove moisture, prior to welding.
