Contract #: 04-0120F4
 Cty: SF/ALA Rte: 80 PM: 13.2/13.9
 File #: 69.25B

QUALITY ASSURANCE -- NON-CONFORMANCE REPORT

Report No: NCR-000410

Reference Description: Missed MT indications on East Tower, Lift 2 cowling plate weld

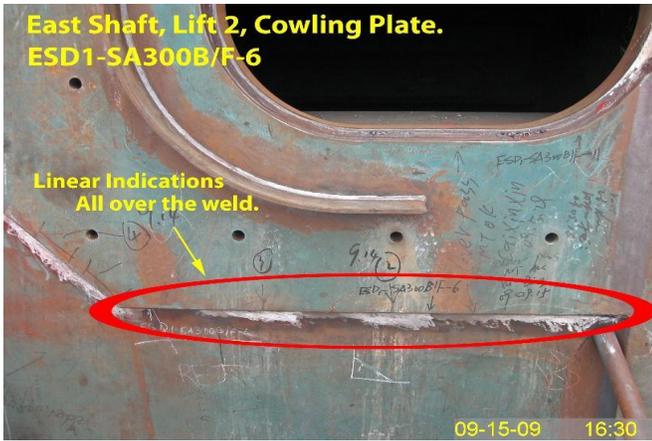
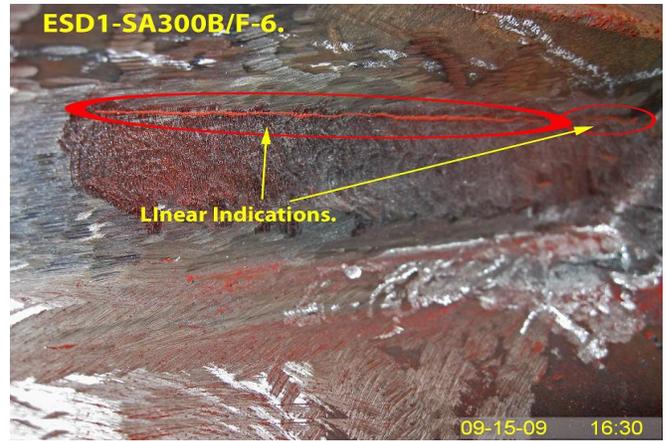
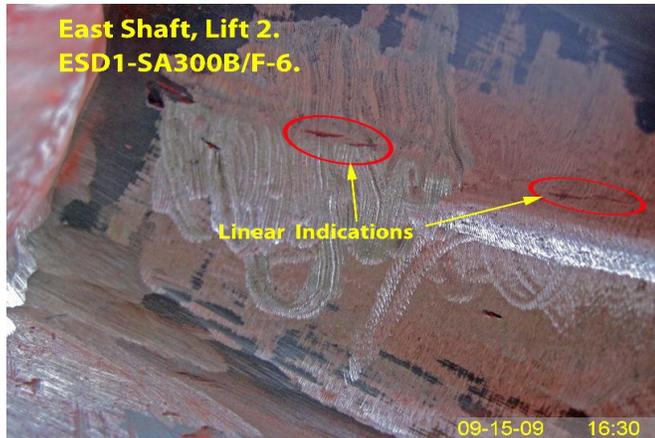
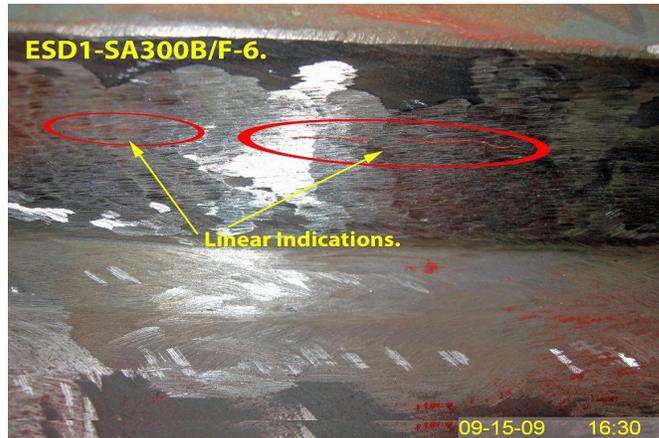
During Magnetic Particle Testing (MT) of East Shaft, Lift 2 cowling plate, QA discovered eight (8) linear indications at weld joint ESD1-SA300B/F-6. This weld was previously tested and accepted by ZPMC MT Technicians.

Special Provisions Section 8.3 – “Quality Control (QC) shall be the responsibility of the Contractor. As a minimum, the Contractor shall perform inspection and testing of each weld joint prior to welding, during welding, and after welding as specified in this section and to ensure that materials and workmanship conform to the requirements of the contract documents.”

AWS D1.5-2002, Section 6.26.2 – “Welds that are subject to MT in addition to visual inspection shall have no cracks.

ABF JV QCM has implemented training with ZPMC to improve the quality of inspections. ABF JV will provide documentation showing attendance by ZPMC QC inspectors and the subject of training. Topics to be covered during the instruction are: inspection of equipment prior to use, proper conditions for inspection, proper technique for MT, and UT. In addition, ABF JV has committed to perform overchecks in both the Tower and OBG. This will serve two purposes, first to monitor if the training is effective at reducing the number of missed indications and second to ensure missed indications are prevented.

Documentation of repairs and subsequent NDT specific to this report will be transmitted through Daily Welding Reports and will be available in the documentation data base. Based on this course of action, ZPMC is requesting that this proposed resolution be approved with action pending. Once training records are available to be transmitted, ZPMC will request closure of this NCR.

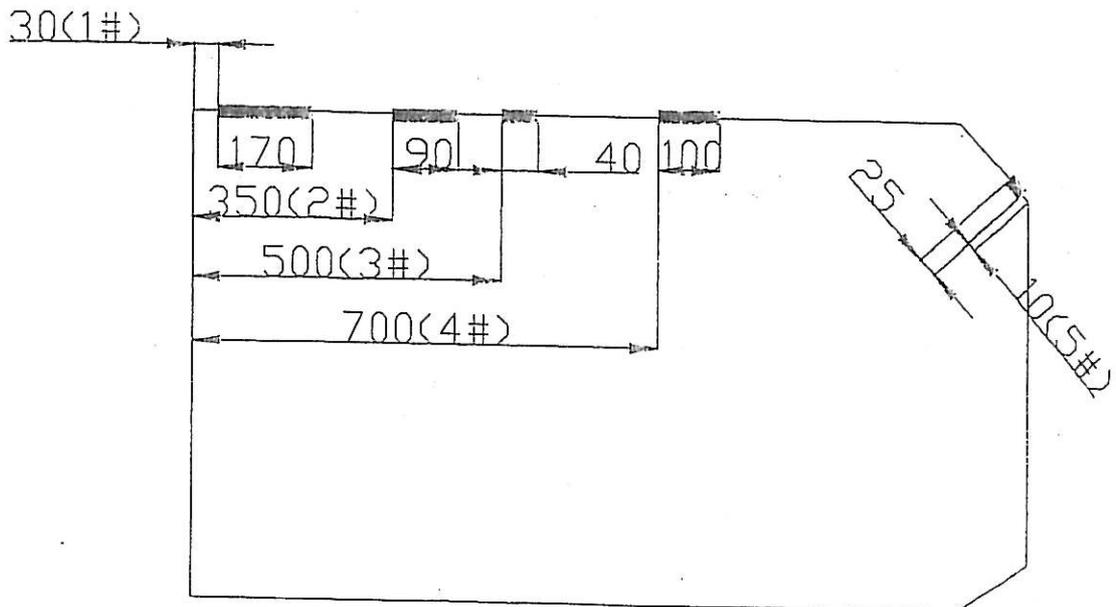
Draft of Welding Discontinuity:

在对ESD1-SA300B/F-6检测时, 发现5处纵向裂纹。L1=170mm L2=90mm L3=40mm L4=100mm L5=25mm

Five longitudinal cracks were found by use of MT on ESD1-SA300B/F-6.

1. Moisture wasn't completely removed during drying operation (preheating) or the area wasn't preheated sufficiently

1. QC shall monitor and direct the welder and the grinder doing the repair operation.
2. Preheat before gouging; the temperature shall be at least 65°C.
3. Gouge the weld to remove identified defects.
4. Joint details shall refer to the approved WPS repair.
5. Grind the gouged areas to a smooth and shiny surface.
6. Verify with VT and MT to ensure no defects remain in the weld joint prior to welding.
7. QC shall monitor all welding passes being deposited.
8. QC shall ensure all slag has been removed prior the deposition of next pass.
9. Preheat and maintain interpass temperature control in accordance with the WPS.
10. Blend the weld repaired areas into the adjacent weld or base metal by grinding.
11. Perform VT, MT and UT NDT inspection to the repaired areas.

1. QC shall verify sufficient preheat has been applied, to remove moisture, prior to welding.
