Contract #: 04-0120F4
 Cty: SF/ALA Rte: 80 PM: 13.2/13.9
 File #: 69.25B

QUALITY ASSURANCE -- NON-CONFORMANCE REPORT

Report No: NCR-000411

Reference Description: Backing bars with intermittent fillet welds in South Tower, Lift 3

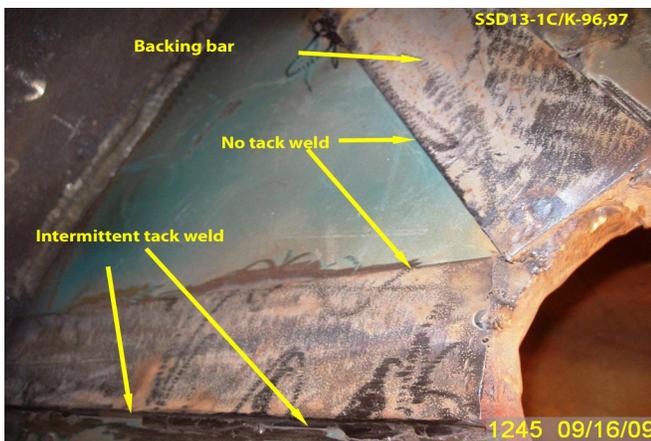
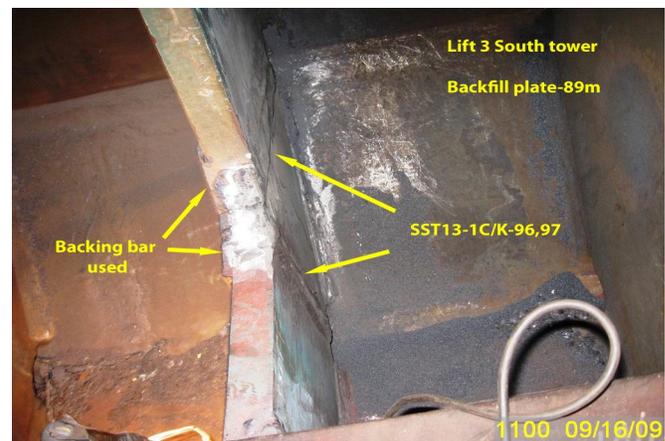
During Ultrasonic Testing (UT) of the South Tower, Lift 3 welds SST13-1C/K-96 & 97, QA discovered that backing bars have been attached with intermittent fillet welds outside of the weld joints. These weld joints were previously tested and accepted by ZPMC Quality Control Personnel.

AWS D1.5-2002, Section 3.3.7.6 - "Tack welds used to attach steel backing and placed external to the weld joint shall be made continuous by fillet welding for the full length of the backing or shall be removed."

Reference Resolution: ZPMC has welded the backing bar to welds SST-1CK-96 and 97 using a continuous weld. Attached are the UT reports that support the work done and acceptability of the welds.

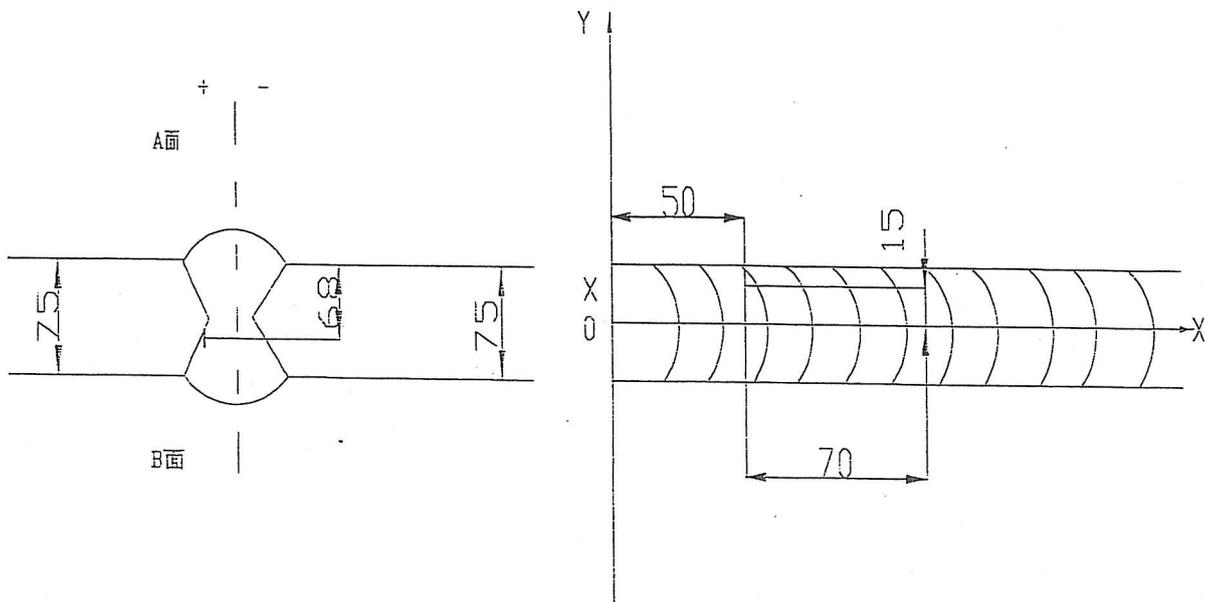
WELD NUMBER: SSD1-A164H/J-194

Rejected indication found by ultrasonic inspection is less than the maximum allowance aggregate length.

- 1、 碳弧气刨, 焊接接头没有有效打磨;
 - 2、 起弧和收弧没有交错布置, 以减少熔渣最少到最少;
 - 3、 焊道间没有有效的清理。
1. The weld joint was not ground sufficiently after arc-gouging.
 2. The arc starts and stops were not staggered to minimize slag entrapment.
 3. Interpass cleaning was not performed properly.

- 1、 Gouge off the defect weld;
- 2、 Grind smoothly the gouged surface;
- 3、 If User's request, check with VT or other NDT method to make sure the defect remove completely;
- 4、 Preheat and the interpass temperature control according to the relative WPS-repair;
- 5、 Check the welding according to the approved shop drawing.

1. 碳钎后的接头位置打磨更滑过渡, 保证每道焊缝的接头可以交错布置;
 2. 认真仔细检查每道焊缝和加强焊道的清理;
 3. 焊缝中所有的焊渣全部去除后, 表面的缺陷全部打磨干净.
1. The joint shall be ground to a smooth transition to ensure that arc starts and stops are in a staggered Arrangement.
 2. QC shall inspect the weld passes more carefully and enforcing interpass cleaning.
 3. All weld slag shall be removed and surface defects ground during interpass cleaning.
