Contract #: 04-0120F4Cty: SF/ALA Rte: 80 PM: 13.2/13.9File #: 69.25B**QUALITY ASSURANCE -- NON-CONFORMANCE REPORT****Location:** Changxing Island, Shanghai, PRC**Report No:** NCR-000412**Prime Contractor:** American Bridge/Fluor Enterprises, a JV**Date:** 21-Sep-2009**Submitting Contractor:** Zhenhua Port Machinery Company, Ltd (ZPMC), Changxing Island**NCR #:** ZPMC-0386**Type of problem:**

Reference Description: Missed base metal MT indication in South Tower, Lift 3**Description of Non-Conformance:**

To:	AMERICAN BRIDGE/FLUOR, A JV 375 BURMA ROAD OAKLAND CA 95607	Date:	21-Sep-2009
Dear:	Mr. Charles Kanapicki	Contract No:	04-0120F4 04-SF-80-13.2 / 13.9
Attention:	Mr. Thomas Nilsson Project/Fabrication Manager	Job Name:	SAS Superstructure
Subject:	NCR No. ZPMC-0386	Document No:	05.03.06-000374

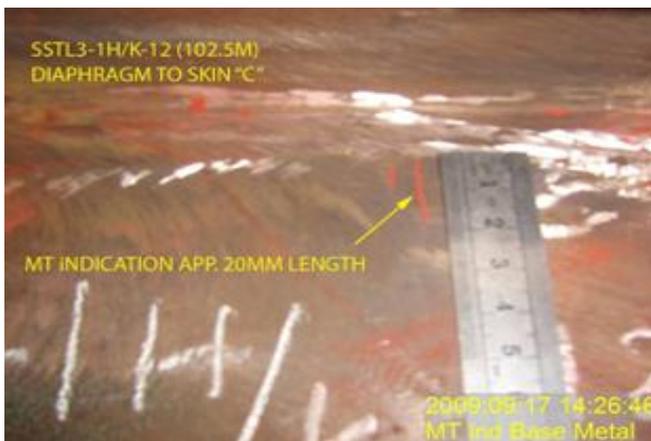
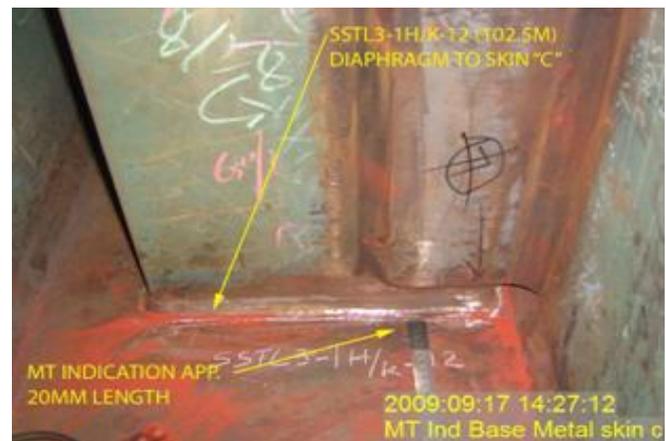
During Magnetic Particle Testing (MT) of South Tower, Lift 3, 102.5 m Diaphragm to Skin C weld SSTL3-1H/K-12, QA discovered a 20mm long transverse linear indication in the base metal which was previously tested and accepted by ZPMC Quality Control personnel. ZPMC proceeded to excavated 3mm to 4mm deep to remove the base metal indication and repaired it without prior Engineer approval.

AWS D1.5-2002, Section 6.26.2 – “Welds that are subject to MT in addition to visual inspection shall have no cracks.

AWS D1.5-2002, Section 3.7.4 – “Prior approval of the engineer shall be obtained for repairs to base metal (other than those required by 3.2)...”

Propose a resolution for this systematic non-conformance that addresses the failure of Quality Control to identify the linear indication during magnetic particle testing of the welds. Provide documentation of the steps/actions taken by the Quality Control Manager to prevent future occurrences.

Address the material/workmanship for the identified non-conformance including documentation that the deficiency has been brought into compliance with the contract requirements. Additionally address the probable causes for the indication and the actions that will be taken to limit future occurrences.

Furthermore address the failure by both Production and Quality Control in proceeding with the repair of the base metal without prior approval from the engineer. Provide documentation of the steps/actions taken by Production and Quality Control to prevent future occurrences.

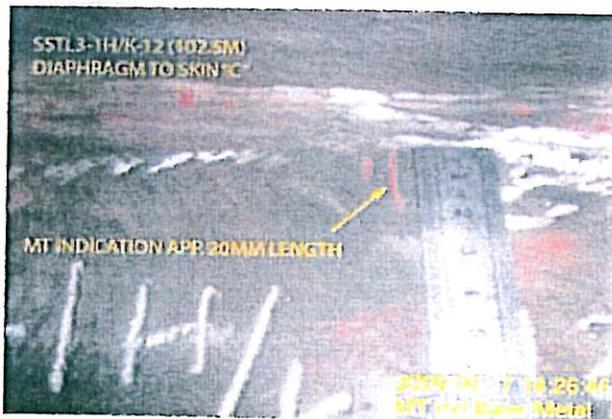
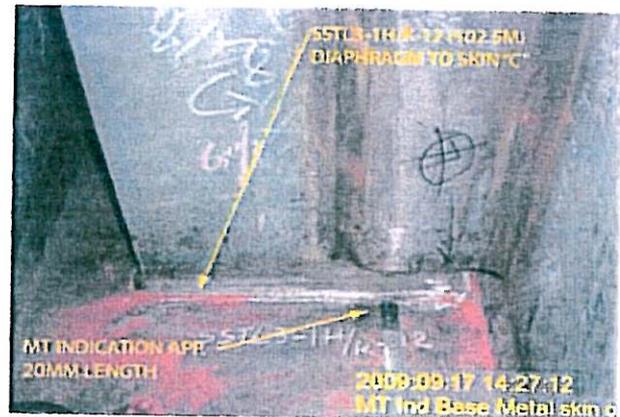
During Magnetic Particle Testing (MT) of South Tower, Lift 3, 102.5 m Diaphragm to Skin C weld SSTL3-1H/K-12, QA discovered a 20mm long transverse linear indication in the base metal which was previously tested and accepted by ZPMC Quality Control personnel. ZPMC proceeded to excavated 3mm to 4mm deep to remove the base metal indication and repaired it without prior Engineer approval.

The base metal has been repaired and NDT reports indicating base metal soundness have been submitted. To resolve the recurring failure for QC to detect MT indications, ABFJV QCM has implemented training with ZPMC to improve quality of inspectors. Topics include: inspection of equipment prior to use, proper conditions for inspection, proper technique for MT & UT. In addition, ABFJV is performing weld over-checks.

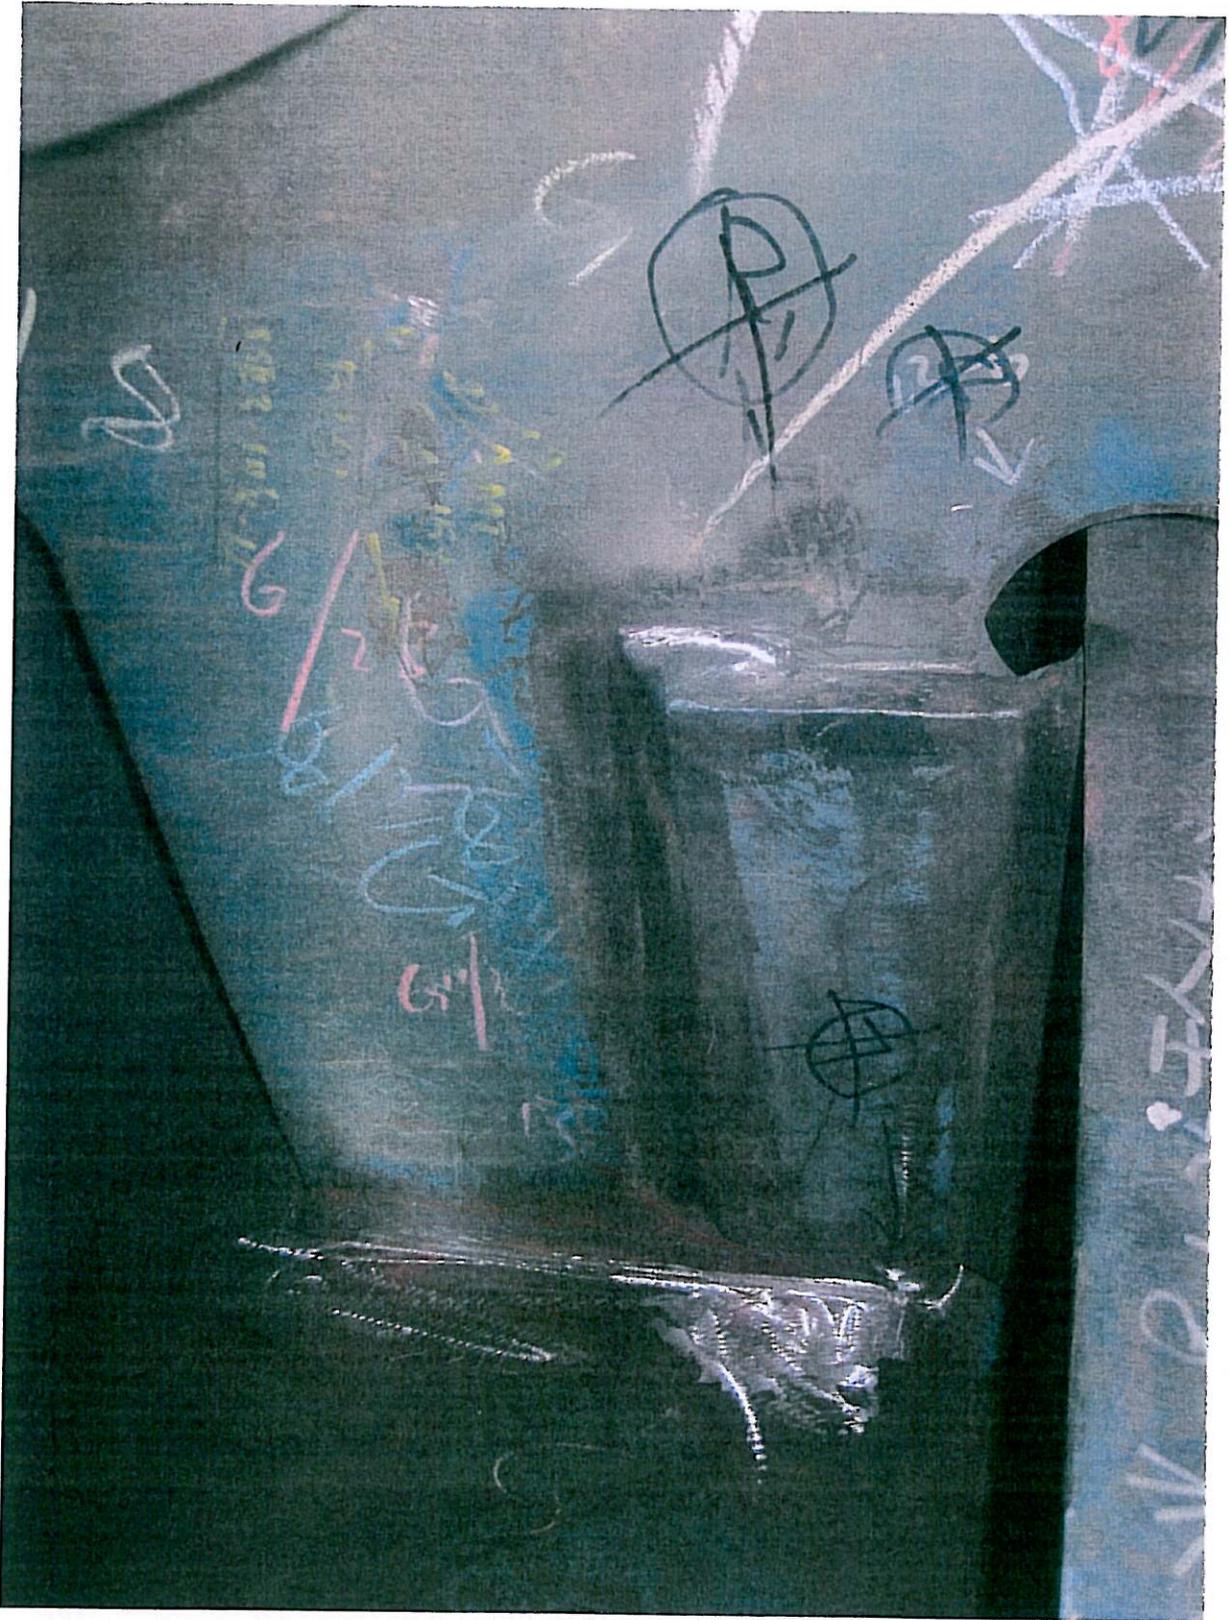
Picture of CT verification

ZPMC acknowledged this. When ZPMC received this information, the grinder was arranged and the indication was removed from the weld surface. ZPMC MT technician and CT inspector retested the weld subsequently.
