QUALITY ASSURANCE -- NON-CONFORMANCE REPORT

Report No: NCR-000413

Reference Description: Missed MT indication on South Tower, Lift 3, Diagonal Stiffener weld

Dear: Mr. Charles Kanapicki
Job Name: SAS Superstructure

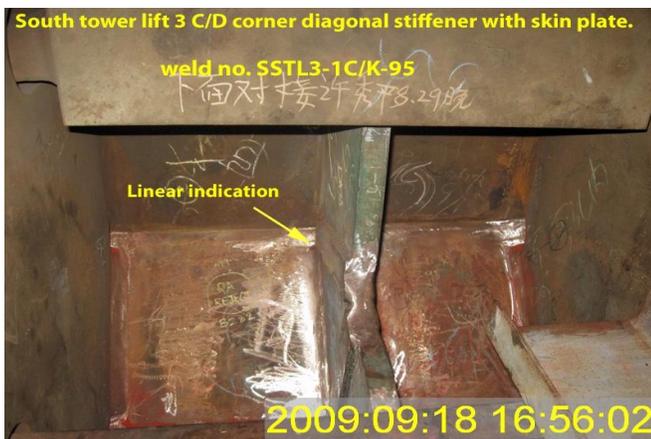
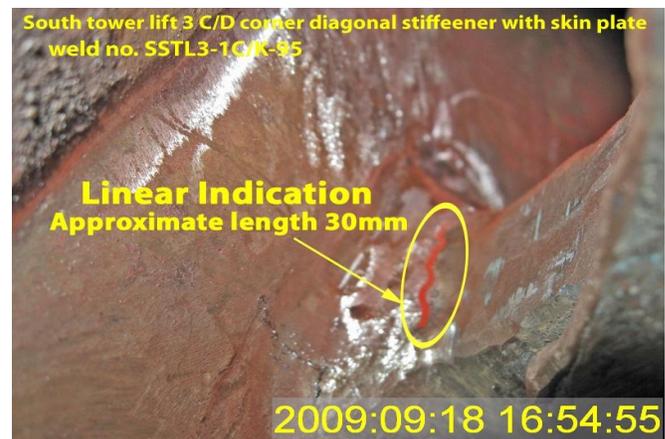
During Magnetic Particle Testing (MT) of South Tower, Lift 3, C/D corner diagonal stiffener to skin plate weld SSTL3-1C/K-95, QA discovered a linear indication of approximately 30 mm in length. This weld had been previously tested and accepted by ZPMC Quality Control personnel.

AWS D1.5-2002, Section 6.26.2 – “Welds that are subject to MT in addition to visual inspection shall have no cracks.

Propose a resolution for this systematic non-conformance that addresses the failure of Quality Control to identify the linear indication during magnetic particle testing of the welds. Provide documentation of the steps/actions taken by the Quality Control Manager to prevent future occurrences.

In addition to the Quality Control non-conformance, address the material/workmanship for the identified non-conformance including documentation that the deficiency has been brought into compliance with the contract requirements. Additionally address the probable causes for the indication and the actions that will be taken to limit future occurrences.

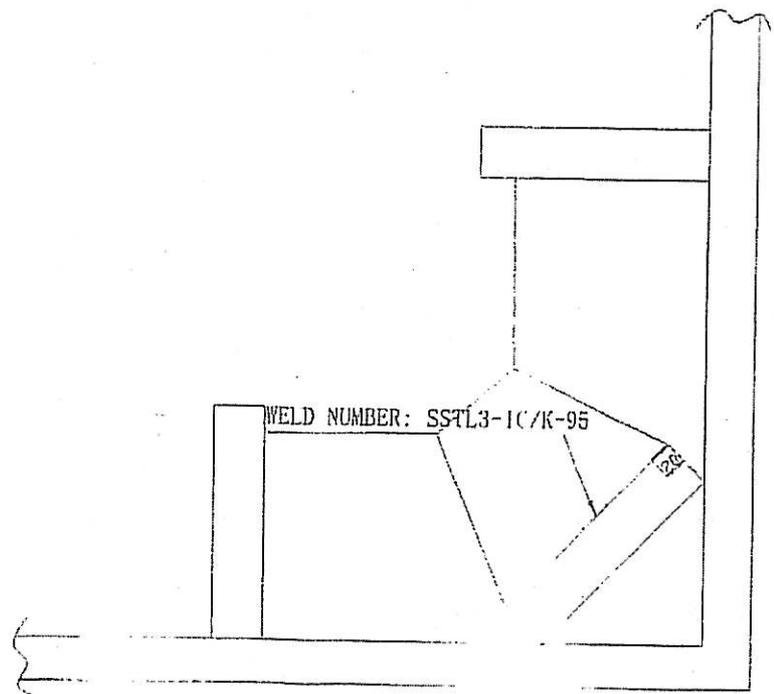
焊缝返修位置示意图:
 Draft of Welding Discontinuity:

One line indication was found by use of MT on SSTL3-1C/K-95.

1. Moisture wasn't completely removed during drying operation (preheating) or the area wasn't preheated sufficiently.

1. QC shall monitor and direct the welder and the grinder doing the repair operation.
2. Preheat before gouging; the temperature shall be at least 65°C.
3. Gouge the weld to remove identified defects.
4. Joint details shall refer to the approved WPS repair.
5. Grind the gouged areas to a smooth and shiny surface.
6. Verify with VT and MT to ensure no defects remain in the weld joint prior to welding.
7. QC shall monitor all welding passes being deposited.
8. QC shall ensure all slag has been removed prior the deposition of next pass.
9. Preheat and maintain interpass temperature control in accordance with the WPS.
10. Blend the weld repaired areas into the adjacent weld or base metal by grinding.
11. Perform VT, MT and UT NDT inspection to the repaired areas.

1. QC shall verify sufficient preheat has been applied, to remove moisture, prior to welding.
