QUALITY ASSURANCE -- NON-CONFORMANCE REPORT

Location: Changxing Island, Shanghai, PRC **Report No:** NCR-000414
Prime Contractor: American Bridge/Fluor Enterprises, a JV **Date:** 21-Sep-2009
Submitting Contractor: Zhenhua Port Machinery Company, Ltd (ZPMC), Changxing Island **NCR #:** ZPMC-0388

Reference Description: Missed MT indications on East Tower, Lift 1, base-end weld build-up

Reference Description: Missed Indications (MT) / East Shaft Lift 1 / Skin C Weld Build-Up / Transverse & Longitudinal Indications

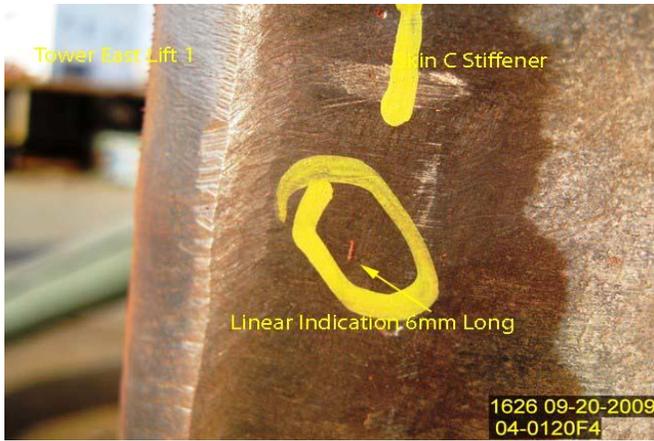
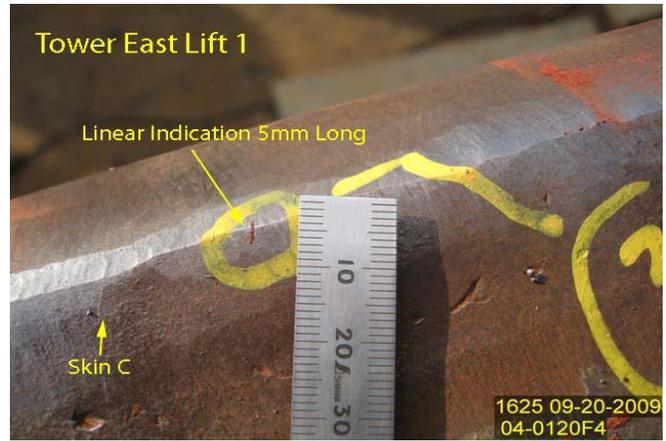
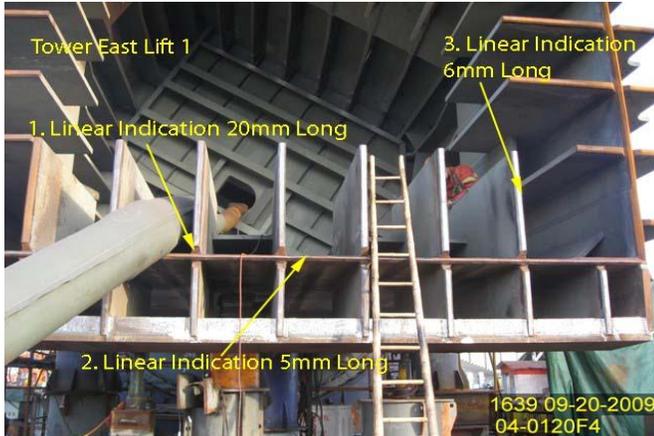
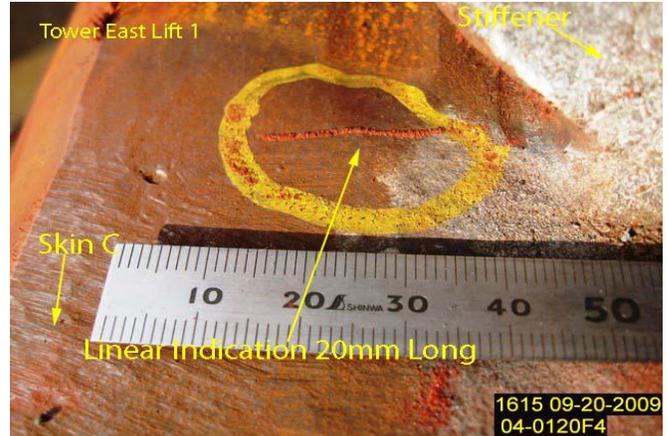
During Magnetic Particle Testing (MT) of East Tower, Lift 1, Skin C base-end weld build-up, QA discovered 20 mm and 5 mm transverse; and 6 mm long longitudinal linear indications. 100% of the weld build-up had been previously tested and accepted by ZPMC Quality Control MT Technicians.

AWS D1.5-2002 Section 6.26.2 – “Welds that are subject to MT in addition to visual inspection shall have no cracks.”

Propose a resolution for this systematic non-conformance that addresses the failure of Quality Control to identify the linear indications during magnetic particle testing of the welds. Provide documentation of the steps/actions taken by the Quality Control Manager to prevent future occurrences.

In addition to the Quality Control non-conformance, address the material/workmanship for the identified non-conformance including documentation that the deficiencies have been brought into compliance with the contract requirements. Additionally address the probable causes for the indications and the actions that will be taken to limit future occurrences.

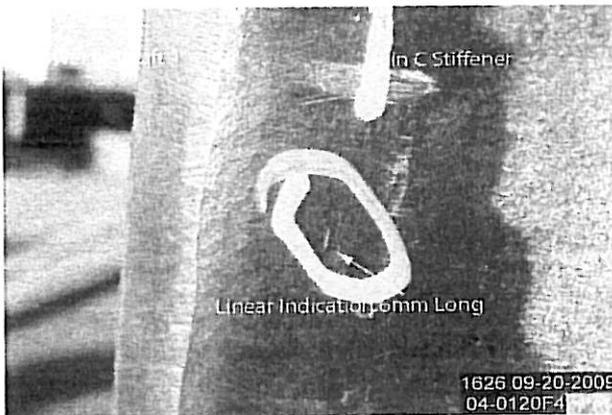
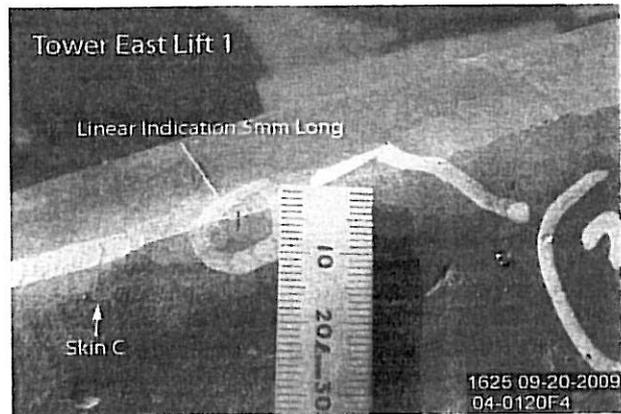
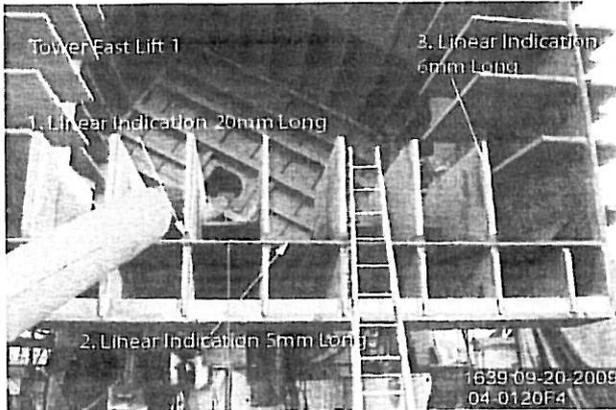
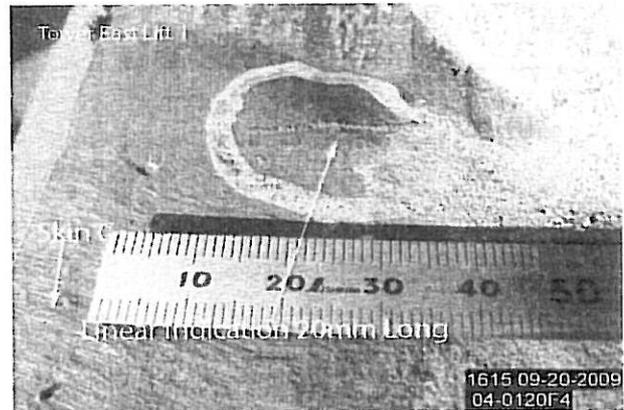
During Magnetic Particle Testing (MT) of East Tower, Lift 1, Skin C base-end weld build-up, QA discovered 20 mm and 5 mm transverse; and 6 mm long longitudinal linear indications. 100% of the weld build-up had been previously tested and accepted by ZPMC Quality Control MT Technicians.

AWS D1.5-2002 Section 6.26.2 – “Welds that are subject to MT in addition to visual inspection shall have no cracks.”

The affected weld build-up has been repaired and the repair was verified by QA.
