Contract #: 04-0120F4Cty: SF/ALA Rte: 80 PM: 13.2/13.9File #: 69.25B**QUALITY ASSURANCE -- NON-CONFORMANCE REPORT****Location:** Changxing Island, Shanghai, PRC**Report No:** NCR-000416**Prime Contractor:** American Bridge/Fluor Enterprises, a JV**Date:** 21-Sep-2009**Submitting Contractor:** Zhenhua Port Machinery Company, Ltd (ZPMC), Changxing Island**NCR #:** ZPMC-0390**Type of problem:**

Reference Description: Missed MT indications at East Tower, Lift 3, Diagonal Stiffener weld**Description of Non-Conformance:**

Subject: NCR No. ZPMC-0390

Reference Description: Missed Indications (MT) & Undercut (VT) / East Shaft Lift 3 / Diagonal Stiffener Weld

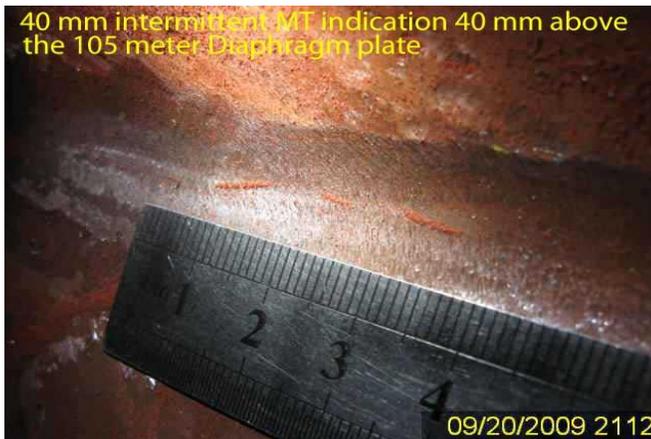
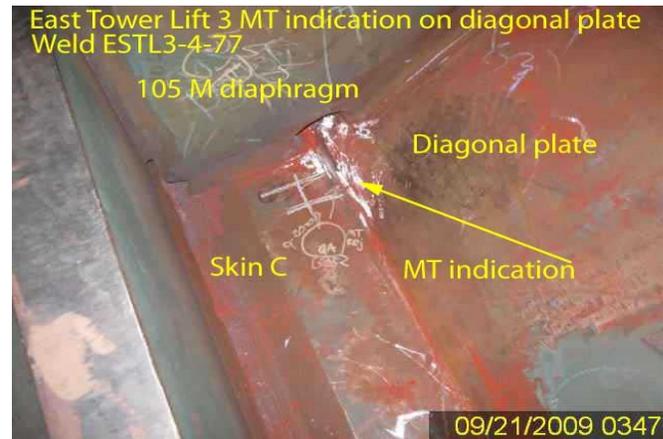
During Magnetic Particle Testing (MT) of East Tower, Lift 3, CD corner diagonal stiffener weld ESTL3-4B/K-77, QA discovered one 10 mm linear indication and one 40 mm intermittent linear indication. Undercut of up to 2.5 mm in depth was also observed at weld ESTL3-4B/K-78 between the 99 m and 102.5 m Diaphragms. These welds have been previously tested and accepted by ZPMC Quality Control Personnel.

AWS D1.5-2002, Section 6.26.2 – “Welds that are subject to MT in addition to visual inspection shall have no cracks.”

AWS D1.5-2002, Section 6.26.1.5 - “In primary members, undercut shall be no more than 0.25mm deep when the weld is transverse to tensile stress under any design loading condition. Undercut shall be no more than

1mm deep for all other cases.”

Propose a resolution for this systematic non-conformance that addresses the failure of Quality Control to identify the linear indications during magnetic particle testing of the welds and the undercut during visual inspection of the welds. Provide documentation of the steps/actions taken by the Quality Control Manager to prevent future occurrences.

In addition to the Quality Control non-conformance, address the material/workmanship for the identified non-conformance including documentation that the deficiencies have been brought into compliance with the contract requirements. Additionally address the probable causes for the indications and the actions that will be taken to limit future occurrences.

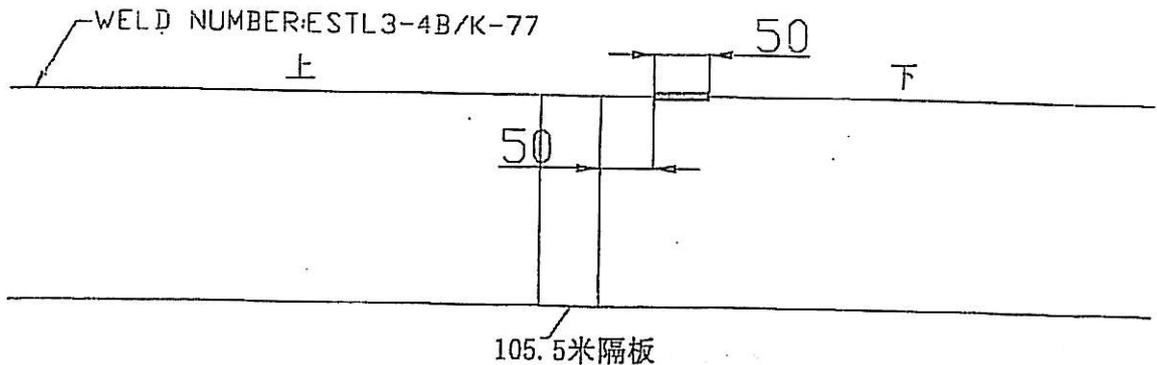
在对ESTL3-4B/K-77检测时, 发现1处纵向裂纹。L=50mm Y=50mm

One longitudinal crack was found by use of MT on ESTL3-4B/K-77.

1. 火焰加热时, 水汽没有完全的去除或者这个区域预热不够;
1. Moisture wasn't completely removed during drying operation (preheating) or the area wasn't preheated sufficiently.

1. QC shall monitor and direct the welder and the grinder doing the repair operation.
 2. Preheat before gouging; the temperature shall be at least 65°C.

3. Gouge the weld to remove identified defects.
 4. Joint details shall refer to the approved WPS repair.
 5. Grind the gouged areas to a smooth and shiny surface.

6. Verify with VT and MT to ensure no defects remain in the weld joint prior to welding.
 7. QC shall monitor all welding passes being deposited.
 8. QC shall ensure all slag has been removed prior the deposition of next pass.

9. Preheat and maintain interpass temperature control in accordance with the WPS.
 10. Blend the weld repaired areas into the adjacent weld or base metal by grinding.

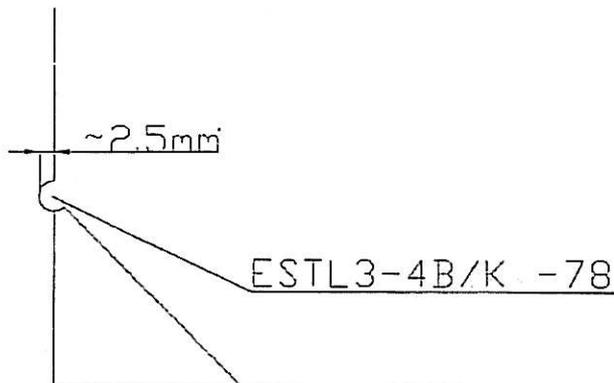
东塔第三吊装段斜筋板与面板焊缝(ESTL3-4B/K-78)发现一处咬边, 深度约为2.5MM, 如图:
The undercut was found at third lifting diagonal stiffener and skin (ESTL3-4B/K-78), 2.5mm in length, see draft.

Welding current too fast caused the undercut.

- 1、Grind the building-up area;
 - 2、Preheat and weld passes temperature according to the approved WPS, it should be 2-3mm than the theory size;
 - 3、Grind the weld area smoothly after repairing;
 - 4、Perform 100%MT and 100%UT to the repair area.
-
- 1、对需堆焊部分进行打磨;
 - 2、按批准后焊接工艺规程 WPS 要求进行预热和控制道间温度, 进行堆焊, 略高于理论值 2~3mm;
 - 3、施焊完毕后将施焊位置打磨平整;
 - 4、对修补区域做 100%MT+100%UT.
