Contract #: 04-0120F4
 Cty: SF/ALA Rte: 80 PM: 13.2/13.9
 File #: 69.25B

QUALITY ASSURANCE -- NON-CONFORMANCE REPORT

Report No: NCR-000419

Reference Description: Excessive interpass temperature during repair of North Tower, Lift 3, AB corner seam weld

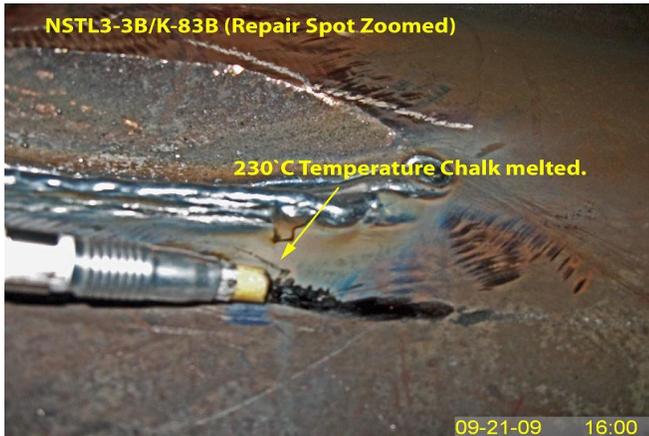
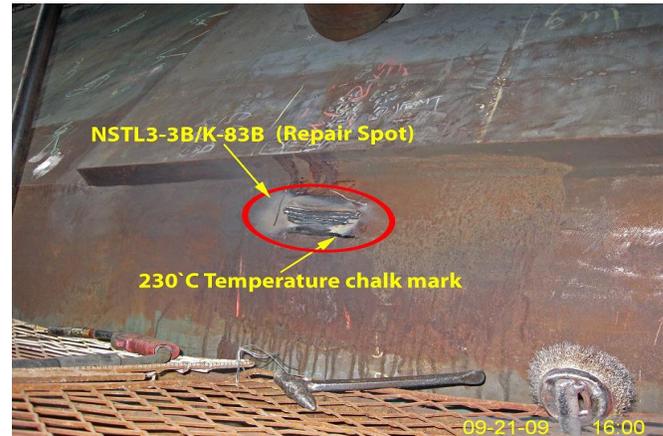
During In-Process Visual Testing (VT) of weld repairs on North Tower, Lift 3, AB corner seam weld NSTL3-3B/K-83, QA observed that the temperature of adjacent base metal was above the maximum allowable interpass temperature (230 C). A 230 degrees Celsius temperature crayon melted when applied to the adjacent base material. The repair was being performed in presence of ZPMC Quality Control Personnel.

Reference Resolution: ZPMC will provide NDT documentation which shows that the repair weld was not adversely affected by the increased interpass temperature. Documentation will be submitted when available.

ZPMC will provide NDT documentation which shows that the repair weld was not adversely affected by the increased interpass temperature. Documentation will be submitted when available. ZPMC requests that this proposed action be approved, with action pending.

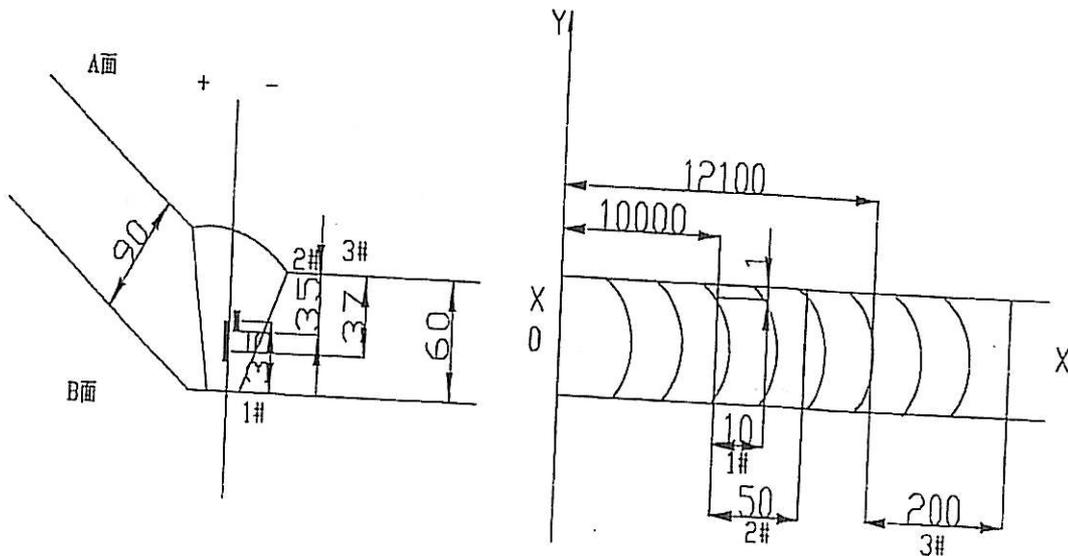
WELD NUMBER: NSTL3-3B/K-83A/B

Rejected indication found by ultrasonic inspection at third time.
(UT探伤返修第三次。) NSTL3-3B/K-83A/B

1. 碳刨打磨后, 要圆滑过度, VT和MT确认所有的缺陷已经去除;
 2. 教导在烧熔透焊缝和焊道清理时, 焊工必须负责任;
 3. 关键焊缝返修时, 主要的QC负责人要在现场;
1. Grind smoothly transition after gouging. Perform VT and MT to ensure all the defects have been removed.
 2. Instruct the welder that it is his responsibility to produce sound welds and perform interpass cleaning.
 3. Greater QC presence during critical welding operations.
