Contract #: 04-0120F4Cty: SF/ALA Rte: 80 PM: 13.2/13.9File #: 69.25B**QUALITY ASSURANCE -- NON-CONFORMANCE REPORT****Location:** Changxing Island, Shanghai, P.R. China**Report No:** NCR-000420**Prime Contractor:** American Bridge/Fluor Enterprises, a JV**Date:** 26-Aug-2009**Submitting Contractor:** Zhenhua Port Machinery Company, Ltd (ZPMC), Changxing Island**NCR #:** ZPMC-0394**Type of problem:**

**Reference Description:** Heat Straightening not according to the Heat Straightening Procedure**Description of Non-Conformance:**

**Job Name:** SAS Superstructure

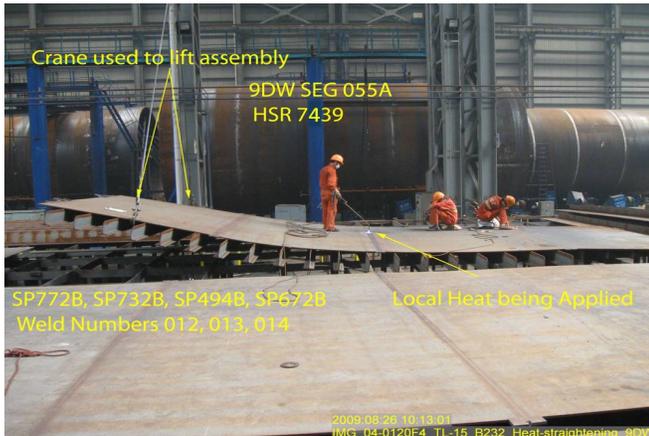
This Quality Assurance Inspector (QA) observed that the contractor is deviating from the AWS D1.5 Code requirements for heat straightening. The contractor used an overhead crane to lift one end of a side panel while local heat was being applied. This method deviated from the ZPMC Heat Straightening Report (HSR1) #7439. The side panel in question is for OBG Segment 9DW (SEG 055A) with Side Panels designation SP772B, SP732B, SP494B, and SP672B. The weld being heated in the photograph below is weld number 013.

Applicable reference: AWS D1.5 Section 3.7.3: "Members distorted by welding shall be straightened by mechanical means or by carefully supervised application of a limited amount of localized heat as approved by the Engineer. The temperature of the heated areas as measured by approved methods shall not exceed 600°C [1100°F] for quenched and tempered steel nor 650°C [1200°F] (a dull, red color) for other steels. The part to be heated for straightening shall be substantially free of stress and from external forces, except those stresses resulting from the mechanical straightening method used in conjunction with the application of heat."

Submit repair procedure to the engineer for approval.

**Reference Resolution:** ZPMC acknowledges the heat straightening observed deviated from the HSR1. ZPMC will submit NDT documentation showing that the welds listed were not adversely affected.

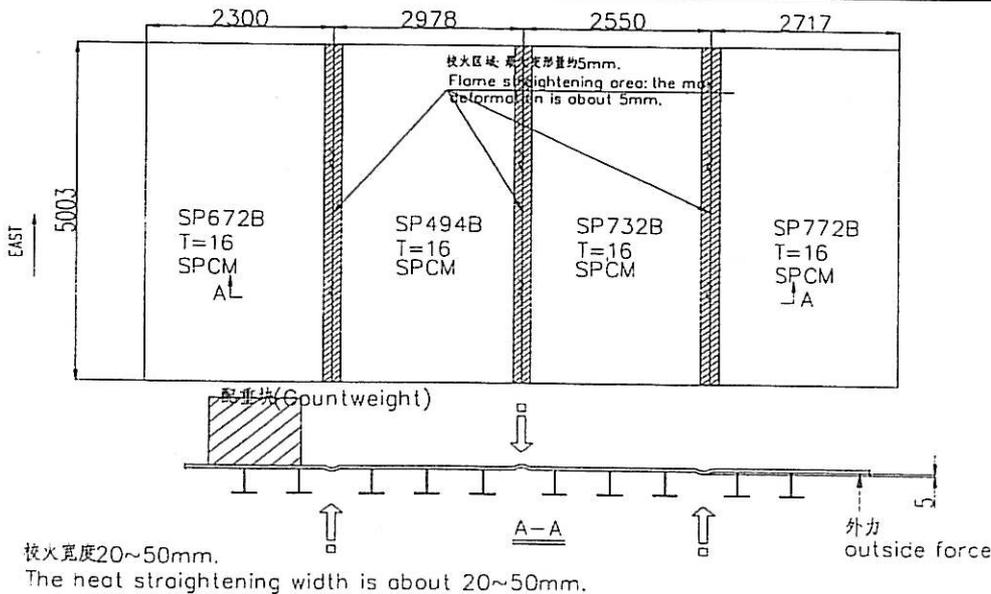
### 简图 Sketch

Cause原因 Welding distortion 焊接变形  
 Type of Defect缺陷类型 Welding distortion 焊接变形  
 Inspection Method检查方法 Visual 目检

缺陷去除方法(Defect Removal Method): Flame Straightening by oxygen acetylene 运用氧乙炔进行校火

后续NDE(Post-Removal NDE): After finishing heat straightening, the weld of the heat area shall perform NDT according to the approved shop drawing 校火后, 根据图纸要求对热影响区域进行NDT检测。

纠正措施(Corrective Action(s)): Control current, voltage and weld speed according to relevant WPS. If necessary anti-deformation or hold down device can be added. 依据相应的WPS的要求控制电流, 电压和焊接速度。如有必要, 可使用反变形设施进行校正。
