Contract #: 04-0120F4Cty: SF/ALA Rte: 80 PM: 13.2/13.9File #: 69.25B**QUALITY ASSURANCE -- NON-CONFORMANCE REPORT****Location:** Changxing Island, Shanghai, P.R. China**Report No:** NCR-000421**Prime Contractor:** American Bridge/Fluor Enterprises, a JV**Date:** 24-Aug-2009**Submitting Contractor:** Zhenhua Port Machinery Company, Ltd (ZPMC), Changxing Island**NCR #:** ZPMC-0395**Type of problem:**

Reference Description: Missed MT Indications by QC on Stiffeners to Side Panel Weld Joints**Description of Non-Conformance:**

Job Name: SAS Superstructure

Subject: NCR No. ZPMC-0395

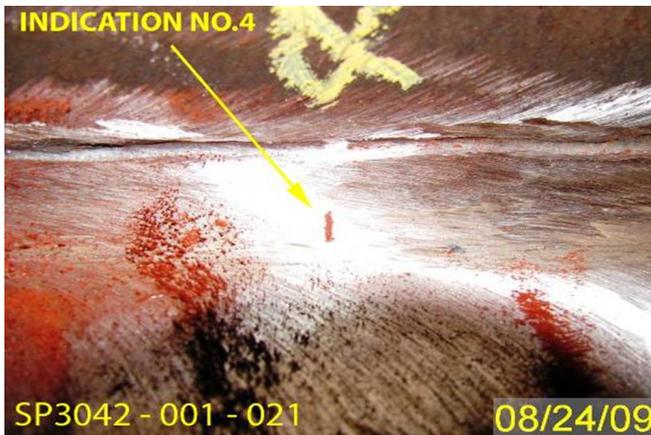
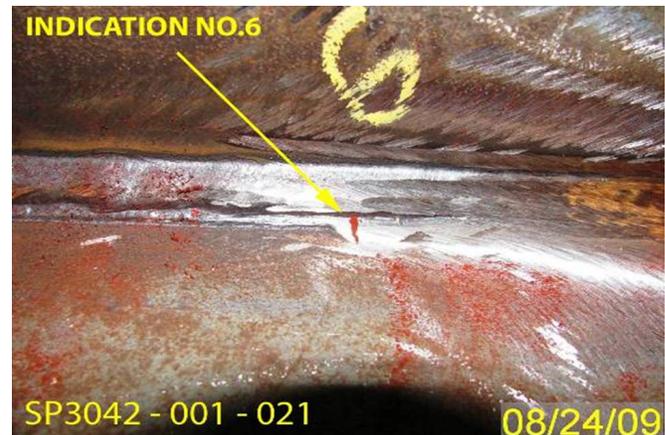
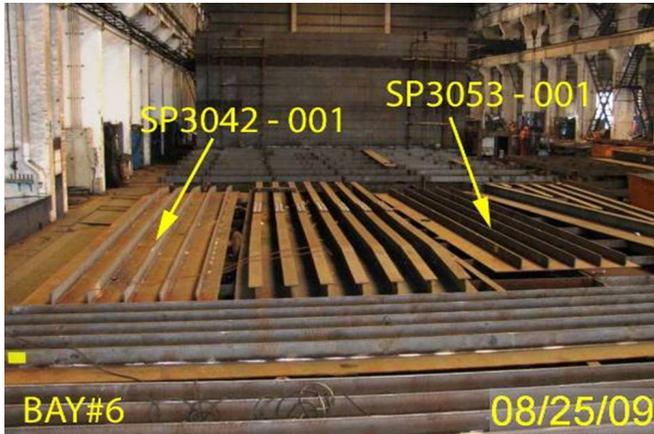
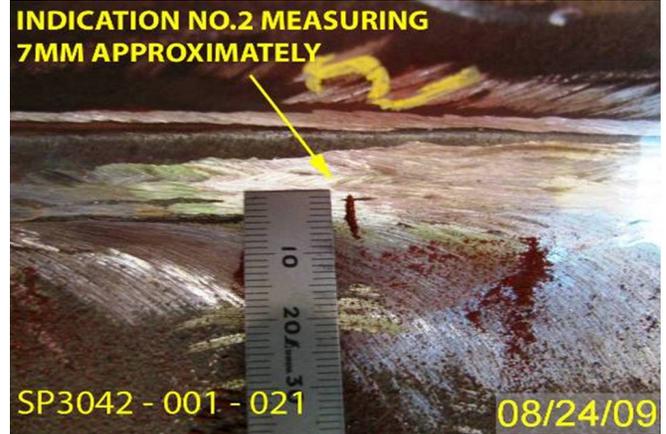
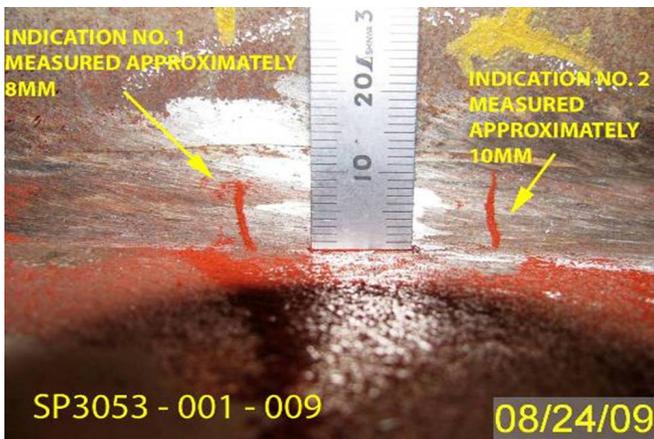
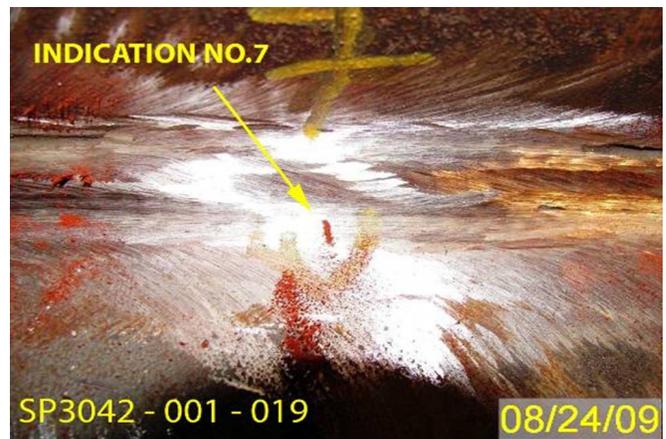
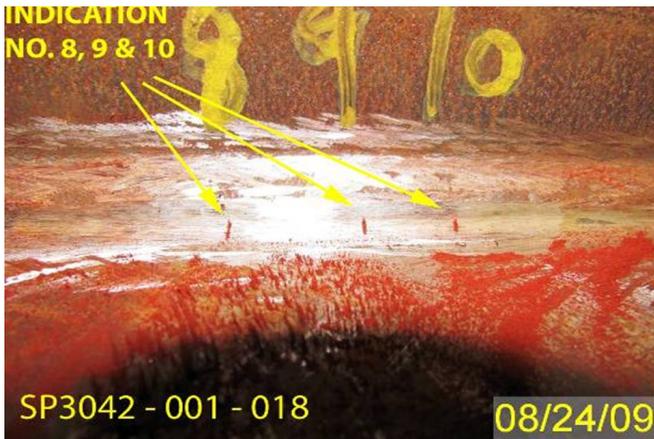
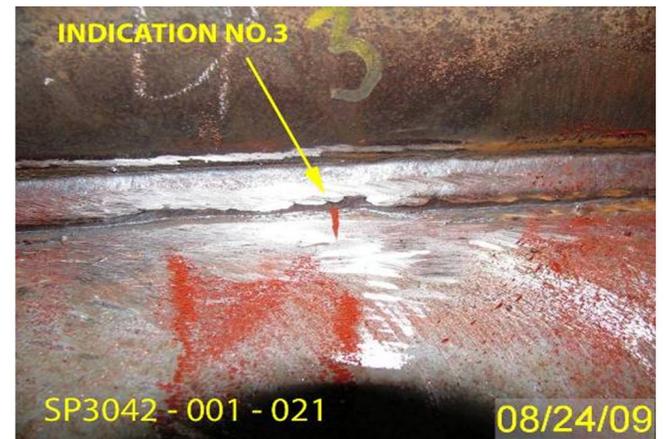
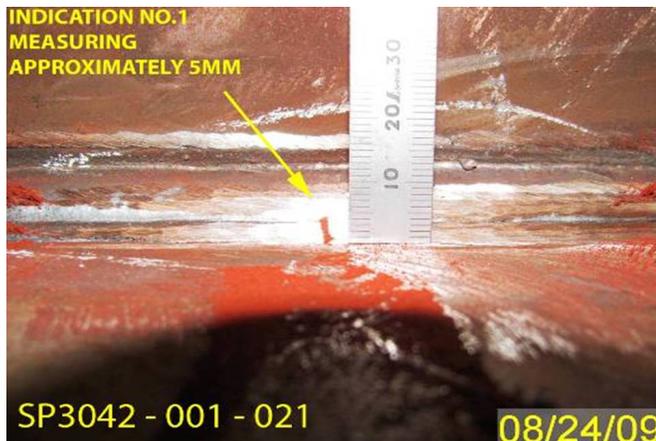
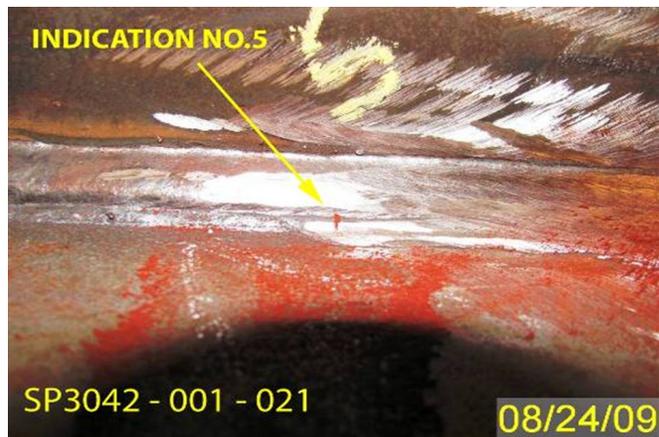
Caltrans Quality Assurance (QA) Inspector was provided an inspection request for Magnetic Particle Testing (MT) of the OBG Side Plates located in Bay #6. This Caltrans Quality Assurance (QA) Inspector observed a total of Twelve (12) transverse linear indications. The indication lengths measured approximately 4mm to 10mm in length. The Side Plates are identified as SP3042-001 (12CW) and SP3053-001 (12BW).

The affected weld designations are as follows:

SP3042-001-021 - Six (6) Transverse linear indications

SP3042-001-019 - One (1) Transverse linear indication

SP3042-001-018 - Three (3) Transverse linear indications

SP3053-001-009 - Two (2) Transverse linear indications

The above mentioned Side Plates had been welded on the gantry with automatic FCAW by electrode Super cored 71H (1.4 diameter) (E71T-1) using WPS-B-T-2132-3. These welds had been previously tested and accepted by ZPMC NDT personnel.

Submit a repair procedure to the engineer for approval.

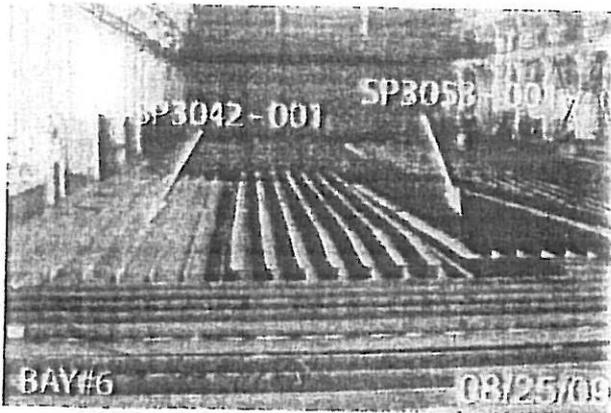
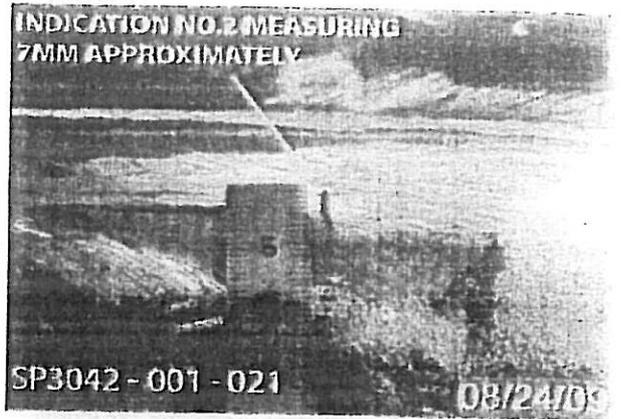
Caltrans Quality Assurance (QA) Inspector was provided an inspection request for Magnetic Particle Testing (MT) of the OBG Side Plates located in Bay #6. This Caltrans Quality Assurance (QA) Inspector observed a total of Twelve (12) transverse linear indications. The indication lengths measured approximately 4mm to 10mm in length. The Side Plates are identified as SP3042-001 (12CW) and SP3053-001 (12BW).

SP3053-001-009 - Two (2) Transverse linear indications

The above mentioned Side Plates had been welded on the gantry with automatic FCAW by electrode Super cored 71H (1.4 diameter) (E71T-1) using WPS-B-T-2132-3. These welds had been previously tested and accepted by ZPMC NDT personnel.

Repair missed indications and perform required NDT.

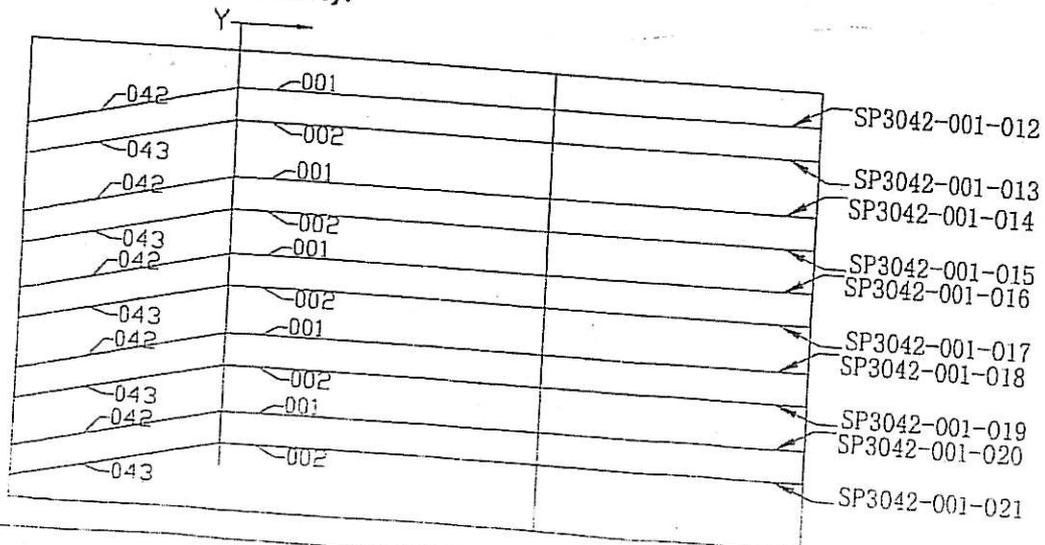
Draft of Welding Discontinuity:

One transverse crack was found by use of MT on SP3042-001-001.
 One transverse crack was found by use of MT on SP3042-001-008.
 Two transverse cracks were found by use of MT on SP3042-001-009.
 Two transverse cracks were found by use of MT on SP3042-001-012.
 One transverse crack was found by use of MT on SP3042-001-013.
 Two transverse cracks were found by use of MT on SP3042-001-015.
 Six transverse cracks were found by use of MT on SP3042-001-017.
 Two transverse cracks were found by use of MT on SP3042-001-018.
 Five transverse cracks were found by use of MT on SP3042-001-019.
 Seven transverse cracks were found by use of MT on SP3042-001-021.

All cracks were extended to material.
 Please see the detail data from MT report!

- 1. 火焰加热时, 水汽没有完全的去掉或者这个区域预热不够;
- 1. Moisture wasn't completely removed during drying operation (preheating) or the area wasn't preheated sufficiently.

- 1. QC and a Lead CWI shall be present, direct and supervise all grinding and welding operations during this repair to ensure the repair is per the disposition requirements

- 2. QC and a Lead CWI shall have an approved copy of the CWR in hand prior to the repair.
- 3. Remove paint ≥ 25 mm in all direction of HAZ prior to MT.

- 4. Clean the excavation area of all loose debris including MT powder. Preheat to 65° C before removing cracks by grinding, repair area shall extend a minimum of 50mm beyond each end of single crack repairs, and 50mm beyond the outermost cracks for multiple crack repairs.

- 5. If base metal is damaged by grinding, the damaged area shall be ground clean prior to performing weld repair. If gap > 5 mm is found during or after grinding, comply with the notification on changing fillet weld to CJP which is submitted for Engineer's review and approval form.

- 6. Prepare excavation in accordance with the New Repair Procedure prior to welding.
- 7. Before this repair, Verify with VT and MT repair areas are defects free, and also MT shall be performed on the base metal along cracks to ensure that no cracks were propagated to the base metal. Separate CWR approval is needed if cracks are found in the base metal and only after this new CWR's approval can continue the repair. *CRACKS EXIST IN B.M., DO NOT ENTIRE EXCAVATION AREA PRIOR TO WELDING.*

- 8. Clean excavation area of all loose debris including MT powder after excavation. Preheat and weld according to repair WPS, the preheat shall between 160° C-230° C.

- 9. Perform post weld heating according to repair WPS, the postheat shall between 230° C-315° C and for one hour minimum.
- 10. Allow the weld to cool to ambient temperature gradually. Control cooling rate after PWHT to no more than 50° C per hour.

- 11. Grind the repaired area flush with base metal or the adjacent weld after post weld heating.
- 12. Wait 48 hours at least after the repair area has cooled to ambient temperature before performing NDT.

- 13. Perform MT inspection to all repair area according to Contract Drawings along with all additional NDT required by the applicable notes Special Provision Section 10-1.59 'Steel Structure', subsection 'inspection testing'. NDT include VT, MT and UT if it is a CJP weld.

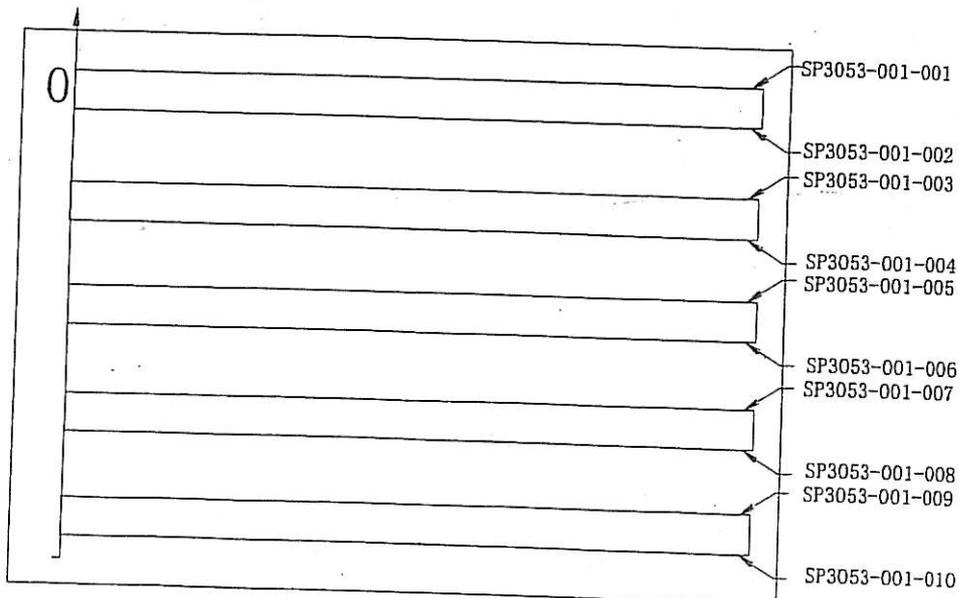
Draft of Welding Discontinuity:

Six transverse cracks were found by use of MT on SP3053-001-004.
 Four transverse cracks were found by use of MT on SP3053-001-006.
 Four transverse cracks were found by use of MT on SP3053-001-007.
 One transverse crack was found by use of MT on SP3053-001-008.
 One transverse crack was found by use of MT on SP3053-001-009.
 Three transverse cracks were found by use of MT on SP3053-001-010.

1. 火焰加热时, 水汽没有完全的去掉或者这个区域预热不够;
1. Moisture wasn't completely removed during drying operation (preheating) or the area wasn't preheated sufficiently.

1. QC and a Lead CWI shall be present, direct and supervise all grinding and welding operations during this repair to ensure the repair is per the disposition requirements

2. QC and a Lead CWI shall have an approved copy of the CWR in hand prior to the repair.
3. Remove paint $\geq 25\text{mm}$ in all direction of HAZ prior to MT.

4. Clean the excavation area of all loose debris including MT powder. Preheat to 65° C before removing cracks by grinding, repair area shall extend a minimum of 50mm beyond each end of single crack repairs, and 50mm beyond the outermost cracks for multiple crack repairs.

5. If base metal is damaged by grinding, the damaged area shall be ground clean prior to performing weld repair. If gap $> 5\text{mm}$ is found during or after grinding, comply with the notification on changing fillet weld to CJP which is submitted for Engineer's review and approval form.

6. Prepare excavation in accordance with the New Repair Procedure prior to welding.
7. Before this repair, Verify with VT and MT repair areas are defects free, and also MT shall be performed on the base metal laying abroad cracks to ensure that no cracks were propagated to the base metal. Separate CWR approval is needed if cracks are found in the base metal, and only after this new CWR's approval can continue the repair.

8. Clean excavation area of all loose debris including MT powder after excavation. Preheat and weld according to repair WPS, the minimum preheat shall between 160° C-230° C.

9. Perform post weld heating according to repair WPS, the postheat shall between 230° C-315° C and for one hour minimum.
10. Allow the weld to cool to ambient temperature gradually. Control cooling rate after PWHT to no more than 50° C per hour.

11. Grind the repaired area flush with base metal or the adjacent weld after post weld heating.
12. Wait 48 hours at least after the repair area has cooled to ambient temperature before performing NDT.

13. Perform MT inspection to all repair area according to Contract Drawings along with all additional NDT required by the applicable notes Special Provision Section 10-1.59 'Steel Structure', subsection 'inspect on testing'. NDT include VT, MT and UT if it is a CJP weld.
