Contract #: 04-0120F4Cty: SF/ALA Rte: 80 PM: 13.2/13.9File #: 69.25B**QUALITY ASSURANCE -- NON-CONFORMANCE REPORT****Location:** Changxing Island, Shanghai, P.R. China**Report No:** NCR-000423**Prime Contractor:** American Bridge/Fluor Enterprises, a JV**Date:** 03-Sep-2009**Submitting Contractor:** Zhenhua Port Machinery Company, Ltd (ZPMC), Changxing Island**NCR #:** ZPMC-0397**Type of problem:****Welding****Concrete****Other****Welding****Curing****Procedural****Bridge No:** 34-0006**Joint fit-up****Coating****Other****Component:** CW001B-PP072**Procedural****Procedural****Description:** Missed UT Indication on Counterweight at PP72**Reference Description:** Missed UT indications by QC on CW001B**Description of Non-Conformance:**

**Job Name:** SAS Superstructure

**Subject:** NCR No. ZPMC-0397

**Reference Description:** Missed UT indications by QC on CW001B

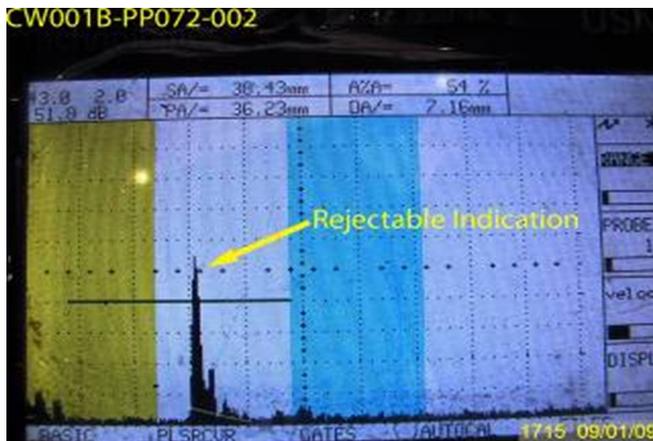
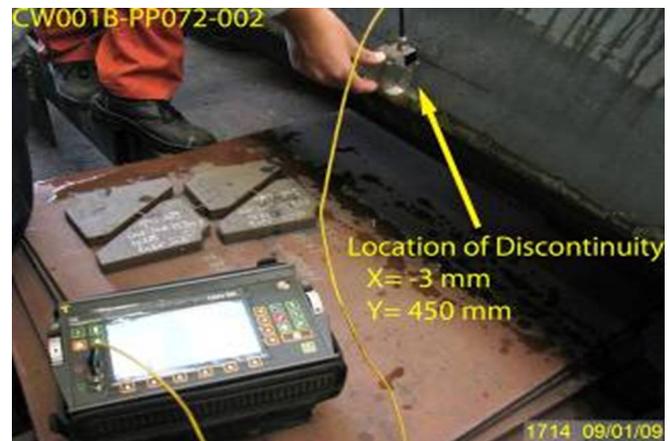
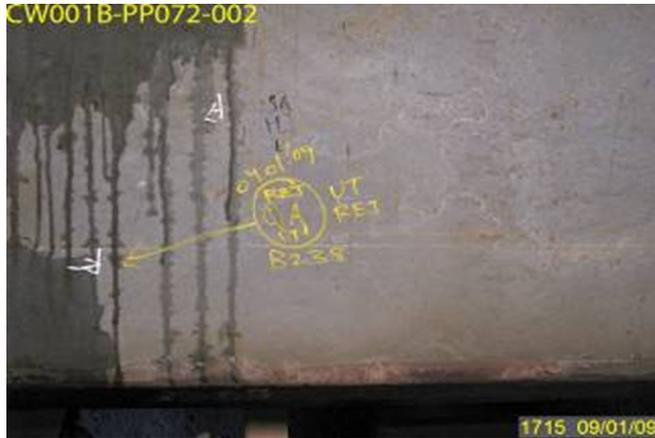
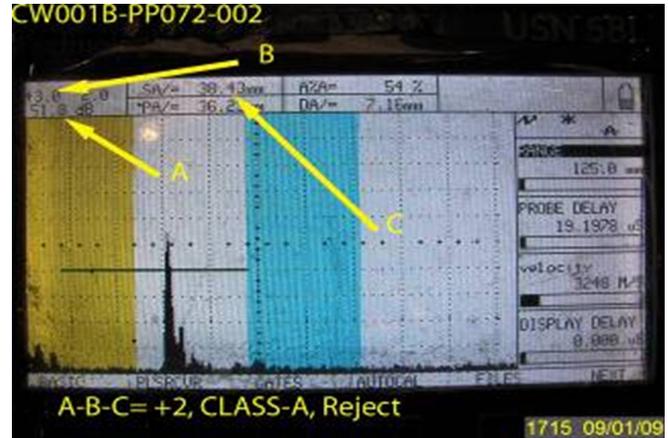
During a random verification of Ultrasonic Testing (UT) on weld joint identified as CW001B-PP072-002, the Caltrans Quality Assurance inspector discovered two (2) class A non-conforming indication measuring approximately 20 mm in length. This weld was previously tested and accepted by ZPMC QC UT technicians.

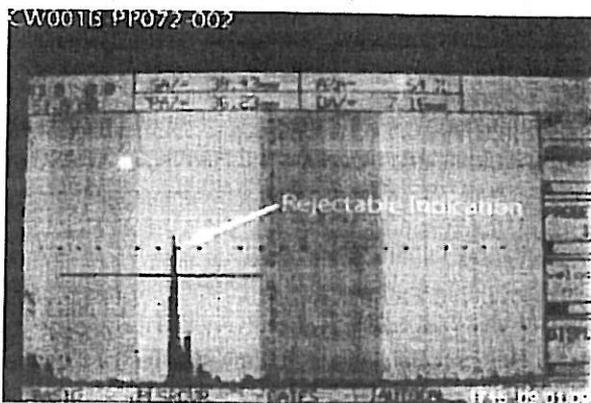
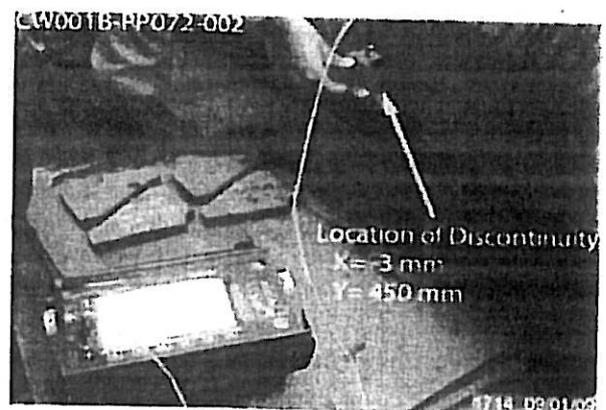
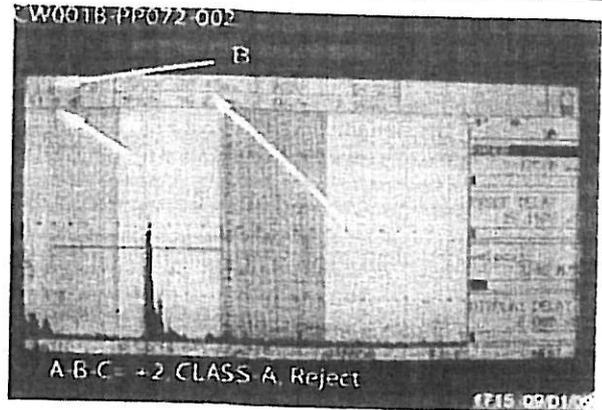
During a random verification of Ultrasonic Testing (UT) on weld joint identified as CW001B-PP072-002, the Caltrans Quality Assurance inspector discovered two (2) class A non-conforming indication measuring approximately 20 mm in length. This weld was previously tested and accepted by ZPMC QC UT technicians.

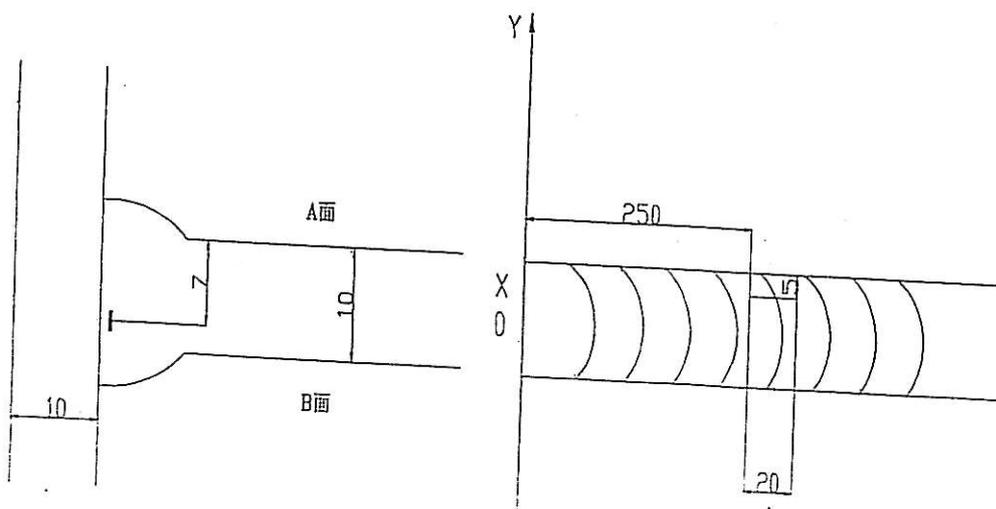
WELD NUMBER: CW001B-PP072-002

Rejected indication found by ultrasonic inspection is less than the maximum allowance aggregate length.

1. 焊道未及时处理干净。
1. Did not clear the weld pass completely in time.

1. 从缺陷距离端面较近一侧 ( $D \leq 0.65T$ , D为缺陷深度, T为板厚) 采用碳刨或打磨的方法去除焊缝缺陷;
  2. 参照返修焊接工艺规程 (WPS) 准备正确的接头型式, 预热和焊接;
  3. 焊前对修补区域进行VT检测保证缺陷完全被清除;
  4. 将修补区域打磨到与母材或邻近焊缝平齐;
  5. 对焊缝进行UT检测, 检测范围为返修区域以及其两端各延长50mm.
- 
1. Gouge or grind from nearer side from metal edge ( $D \leq 0.65T$ , "D" is depth of defects, "T" is thickness of metal) to remove all defects;
  2. Follow repair WPS for joint preparation, preheat, and weld deposit;
  3. Verify with VT no defects remain in the weld joint prior to welding;
  4. Grind the repaired area flush with base metal or the adjacent weld;
  5. Perform UT inspection to the weld along with 50mm on each end of the repair area.
