Contract #: 04-0120F4Cty: SF/ALA Rte: 80 PM: 13.2/13.9File #: 69.25B**QUALITY ASSURANCE -- NON-CONFORMANCE REPORT****Location:** Changxing Island, Shanghai, P.R. China**Report No:** NCR-000425**Prime Contractor:** American Bridge/Fluor Enterprises, a JV**Date:** 01-Sep-2009**Submitting Contractor:** Zhenhua Port Machinery Company, Ltd (ZPMC), Changxing Island**NCR #:** ZPMC-0399**Type of problem:**

Reference Description: Missed UT Transverse Indication on Transverse Splice of Segment 1AE to 1BE**Description of Non-Conformance:**

To:	AMERICAN BRIDGE/FLUOR, A JV 375 BURMA ROAD OAKLAND CA 95607	Date:	28-Sep-2009
Dear:	Mr. Charles Kanapicki	Contract No:	04-0120F4 04-SF-80-13.2 / 13.9
Attention:	Mr. Thomas Nilsson Project/Fabrication Manager	Job Name:	SAS Superstructure
Subject:	NCR No. ZPMC-0399	Document No:	05.03.06-000390

Critical Welding Repair Report (CWR)

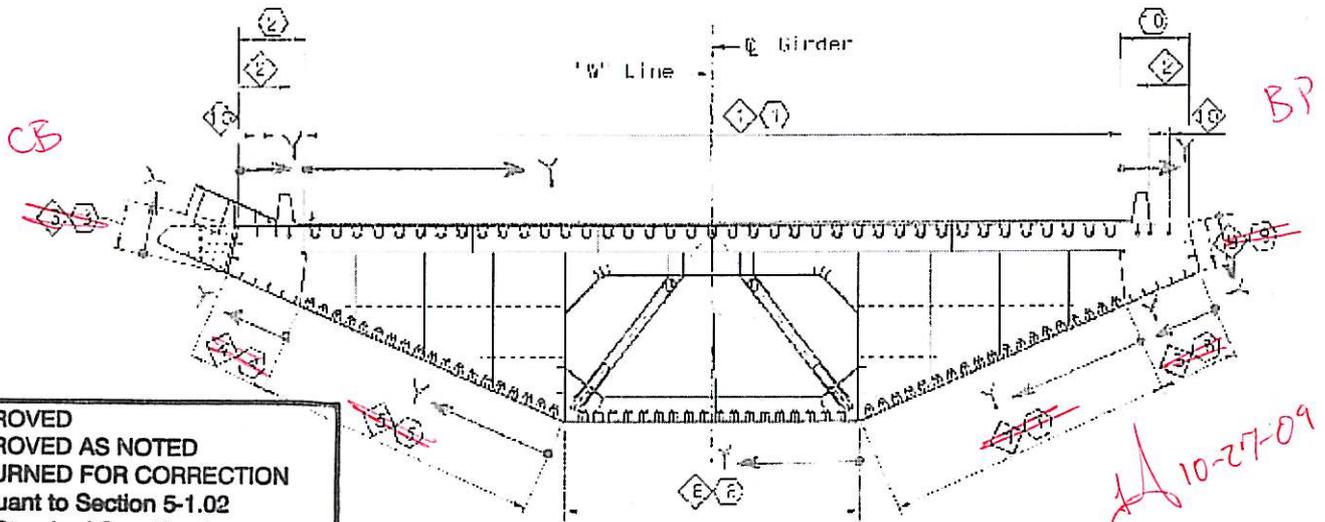
Draft of Welding Discontinuity:

Per the AWS D1.5 paragraph 6.26.3.2 (1), (2) & (3), ABF and Caltrans performed the Re-Ultrasonic inspection and revealed planar linear indications by scanning pattern D. The red point means the rejected discontinuity base on the AWS D 1.5 table 6.4, the blue point means that the acceptable with the criteria of the AWS, ~~but some~~ indications in the 2E were further evaluated by excavation and were determined by ZPMC, ABFJV and CT to be the defects of porosity /slag and also include transverse cracks etc. The detail of the location and finding please find from the attached report and draft.

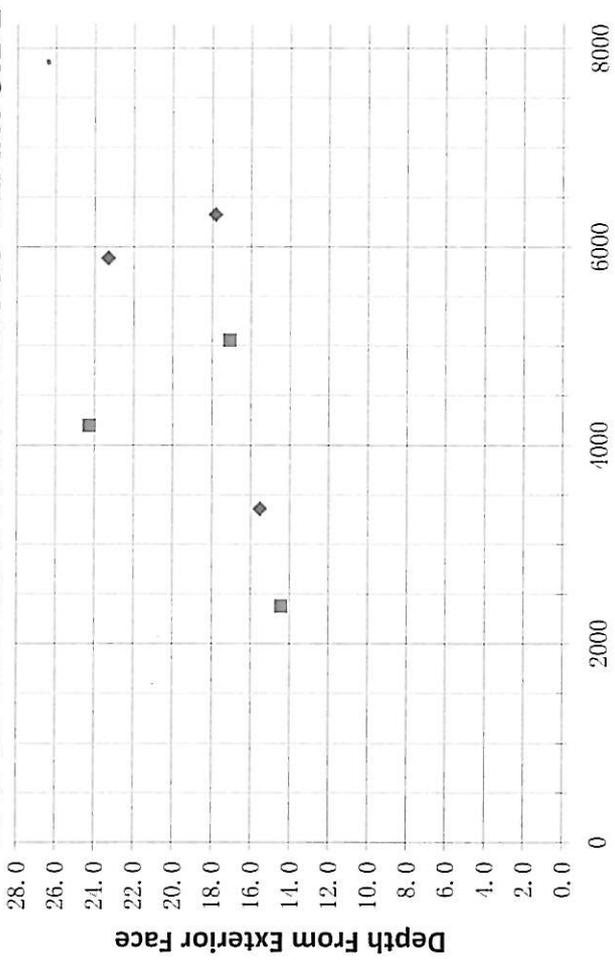
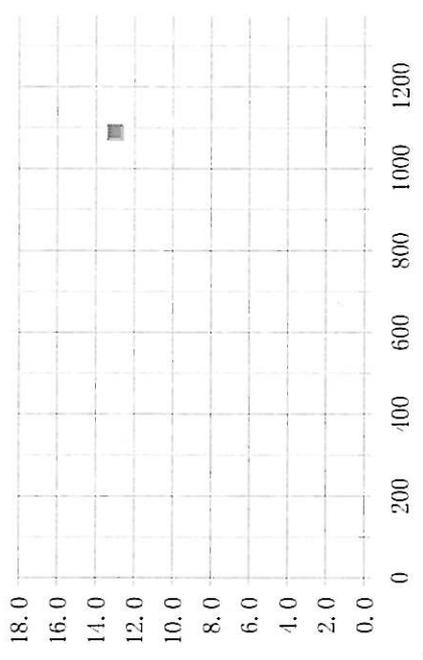
1AE to 1BE SIDE PANEL CROSS BEAM SIDE

◆ Class A Longitudinal Indications
 ■ Transverse Indication
