QUALITY ASSURANCE -- NON-CONFORMANCE REPORT

Location: Changxing Island, Shanghai, PRC **Report No:** NCR-000427
Prime Contractor: American Bridge/Fluor Enterprises, a JV **Date:** 22-Sep-2009
Submitting Contractor: Zhenhua Port Machinery Company, Ltd (ZPMC), Changxing Island **NCR #:** ZPMC-0401

Reference Description: Missed MT indications on West Tower, Lift 1, 43m Diaphragm to CD Diagonal Stiffener weld

To:	AMERICAN BRIDGE/FLUOR, A JV 375 BURMA ROAD OAKLAND CA 95607	Date:	23-Sep-2009
Dear:	Mr. Charles Kanapicki	Contract No:	04-0120F4 04-SF-80-13.2 / 13.9
Attention:	Mr. Thomas Nilsson Project/Fabrication Manager	Job Name:	SAS Superstructure
Subject:	NCR No. ZPMC-0401	Document No:	05.03.06-000387

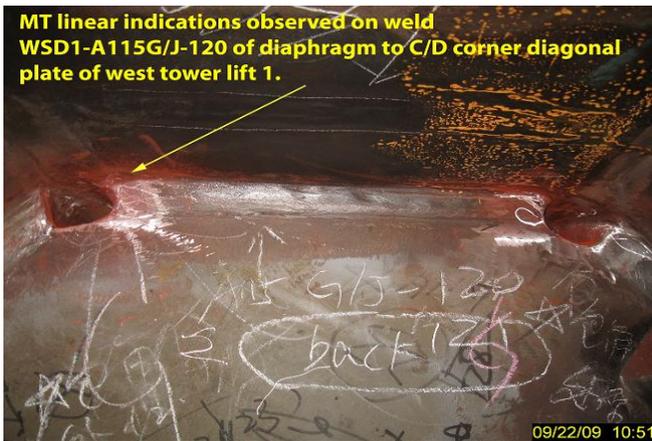
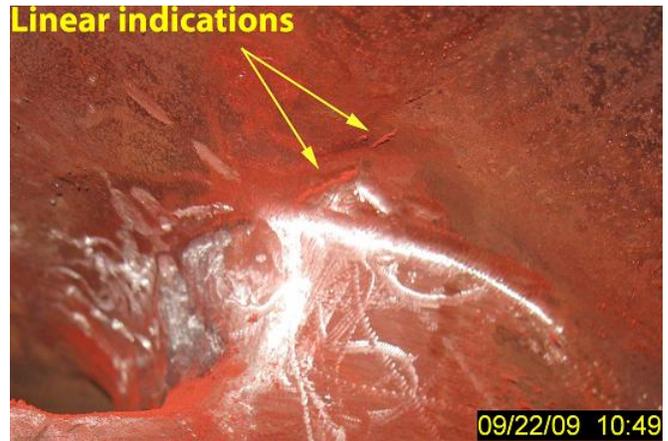
During Magnetic Particle Testing (MT) of West Tower, Lift 1, 43m diaphragm to C/D corner diagonal stiffener weld WSD1-A115G/J-120, QA observed two (2) transverse linear indications of approximately 12mm and 4mm in length. This weld had been previously tested and accepted by ZPMC Quality Control personnel.

AWS D1.5-2002 Section 6.26.2 – “Welds that are subject to MT in addition to visual inspection shall have no cracks.”

Propose a resolution for this systematic non-conformance that addresses the failure of Quality Control to identify the linear indications during magnetic particle testing of the welds. Provide documentation of the steps/actions taken by the Quality Control Manager to prevent future occurrences.

In addition to the Quality Control non-conformance, address the material/workmanship for the identified non-conformance including documentation that the deficiencies have been brought into compliance with the contract requirements. Additionally address the probable causes for the indications and the actions that will be taken to limit future occurrences.

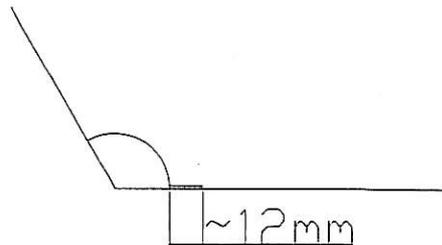
WSD1-A115G/J-120

The linear defect was found at first lifting 43m diaphragm CD corner, 12mm in length, see draft.

1. 火焰加热时, 水汽没有完全的去掉或者这个区域预热不够;
1. Moisture wasn't completely removed during drying operation (preheating) or the area wasn't preheated sufficiently.

1. QC 须监控碳刨、打磨和焊接过程
 2. 碳刨去除缺陷并打磨光滑
 3. VT 检测以确保缺陷被清除
 4. 焊接须符合 WPS 要求
 5. 在进入下道焊缝前, QC 须确保所有焊渣都已被去除干净
 6. 打磨返修区域使其与临近焊缝或母材齐平
 7. 对返修区域进行 VT, MT 和 UT 检测
-
1. QC shall monitor gouging/grinding/welding
 2. Gouge defects & grind smoothly
 3. Verify that defects have been removed with VT
 4. Welding shall be in accordance with WPS
 5. QC shall ensure all slag is removed prior to deposition of subsequent weld passes
 6. Blend repair area with adjacent base metal
 7. Perform VT, MT, & UT to repaired area

1. QC shall verify sufficient preheat has been applied, to remove moisture, prior to welding.
