Contract #: 04-0120F4
 Cty: SF/ALA Rte: 80 PM: 13.2/13.9
 File #: 69.25B

QUALITY ASSURANCE -- NON-CONFORMANCE REPORT

Report No: NCR-000432

Job Name: SAS Superstructure

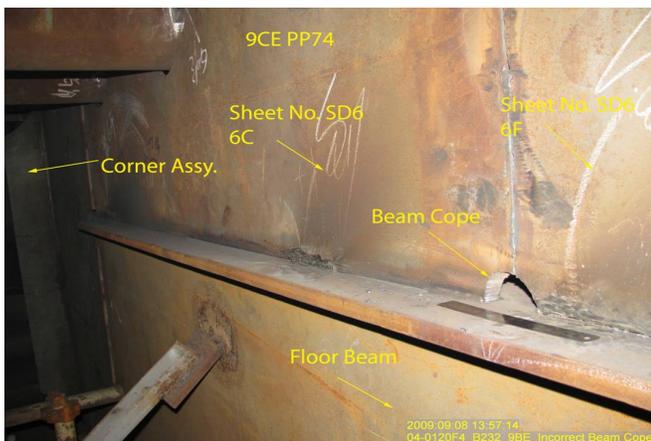
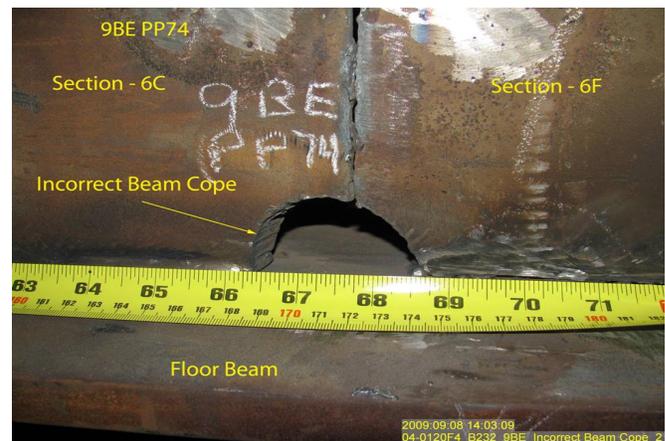
The Quality Assurance Inspector (QA) observed that the contractor deviated from approved drawing sheet no. SEGSD16A by cutting a beam cope/weld access hole. This non-approved beam cope/weld access was cut into the Deck Panel Diaphragm at the vertical splice connecting plates DP501A to DP339A to the Floor Beam on segment 9BE at PP74. The splice is located approximately 1730mm measured from the end of Deck Panel.

ZPMC cut a weld access hole to accommodate welding a vertical splice weld that should have been welded in position on the shop floor before assembling to the other deck panels and floor beam. ZPMC generated a CWR, has performed all required repair and inspections. See attached. ZPMC requests closure of this NCR.

1. QC and CWI should be present to witness the repair.
2. Repair to be perform in according with submittal 200 and letter No.:05.03.01-003474.
3. Elongate the hole by arc gouging, and grind smooth the surface. The elongated hole should conform to the joint detail in Repair WPS. Preheat before gouging according to relevant WPS.

4. Perform VT and MT to ensure no defects exist.
5. Add steel backing. Preheat and perform root welding according to the repair WPS, weld stringers longitudinally along the elongated direction of the hole. Grind the weld to make it have a smooth transition with adjacent base metal.

6. Perform MT before following operations to ensure no defects exist.
7. Preheat and weld according to repair WPS.
8. Remove steel backing and back gouge the root pass, and complete the welding.

9. Grind the repair area flush with adjacent base metal.
10. Check with VT, UT, MT after welding to the repair area.

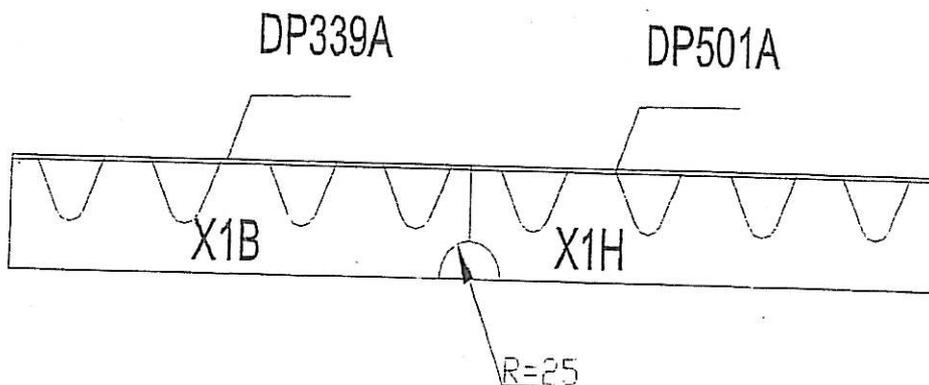
Draft of Welding Discontinuity:

After inspection: the r-hole was fabricated error at 9BE deck plate DP501A X1H and DP339A X1B, 25mm in radius, the detail see the following draft.

Worker didn't review drawing carefully caused weld through hole fabricated error.

8. Perform MT after backgouging to ensure backgouged material is free of defect.
