Contract #: 04-0120F4Cty: SF/ALA Rte: 80 PM: 13.2/13.9File #: 69.25B**QUALITY ASSURANCE -- NON-CONFORMANCE REPORT****Location:** Changxing Island, Shanghai, P.R. China**Report No:** NCR-000435**Prime Contractor:** American Bridge/Fluor Enterprises, a JV**Date:** 13-Sep-2009**Submitting Contractor:** Zhenhua Port Machinery Company, Ltd (ZPMC), Changxing Island**NCR #:** ZPMC-0409**Type of problem:****Welding****Concrete****Other****Welding****Curing****Procedural****Bridge No:** 34-0006**Joint fit-up****Coating****Other****Component:** OBG Segment 1AAE Bottom Panel**Procedural****Procedural****Description:****Reference Description:** Unapproved base metal repair to correct distortion at 1AAE Bottom Panel**Description of Non-Conformance:**

Job Name: SAS Superstructure

Subject: NCR No. ZPMC-0409

Component: OBG Segment 1AAE Bottom Panel

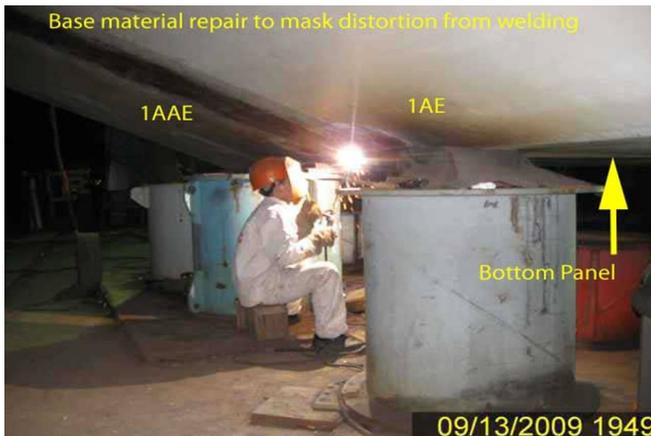
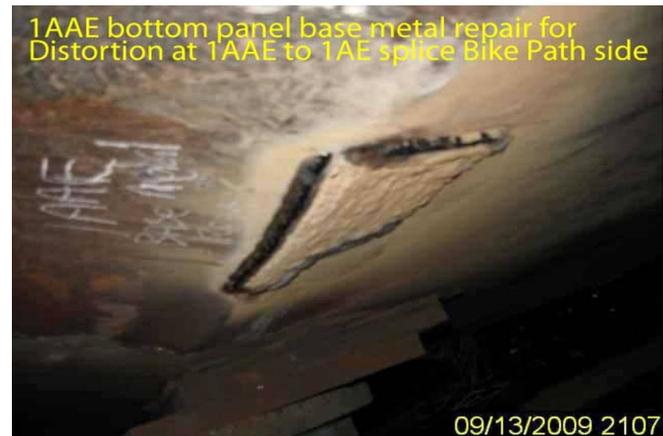
During random visual observations, this Quality Control Inspector observed ZMPC personnel performing Shielded Metal Arc Welding on the outer surface of OBG segment 1AAE near Panel point 8. The contractor performed un-approved base metal repair to correct panel distortion or deformation. The welding occurred at the bottom and side panel adjacent to transverse weld splice between 1AAE and 1AE near the bike path side. The welder presented document ZPMC welding repair report B-WR7494 for this procedure.

AWS D1.5 (02) Section 3.7.3 – “Members distorted by welding shall be straightened by mechanical means or by carefully supervised applications of a limited amount of localized heat as approved by the Engineer.”

Propose a resolution for the identified recurring non-conformance which constitutes a systematic problem on both materials/workmanship and quality control issues with revised procedures to remedy the defected work and to prevent future occurrences. A response for the resolution of this issue is expected within 14 days.

ZPMC acknowledges that Base metal repairs require Engineer approval. ZPMC will submit NDT documentation showing that the base metal was not adversely affected by the repair. These documents will be submitted at a later date. Once documents are submitted ZPMC will request closure. Currently, ZPMC requests that this non conformance proposed resolution be approved, with action pending.

ZPMC acknowledges that base metal repairs require Engineer approval. ZPMC has discussed this non conformance with the welder and CWI involved so they understand that base metal repairs must have a CWR. ZPMC is providing the weld repair report, and NDT documentation which shows the repair was acceptable. ZPMC requests closure of this NCR.

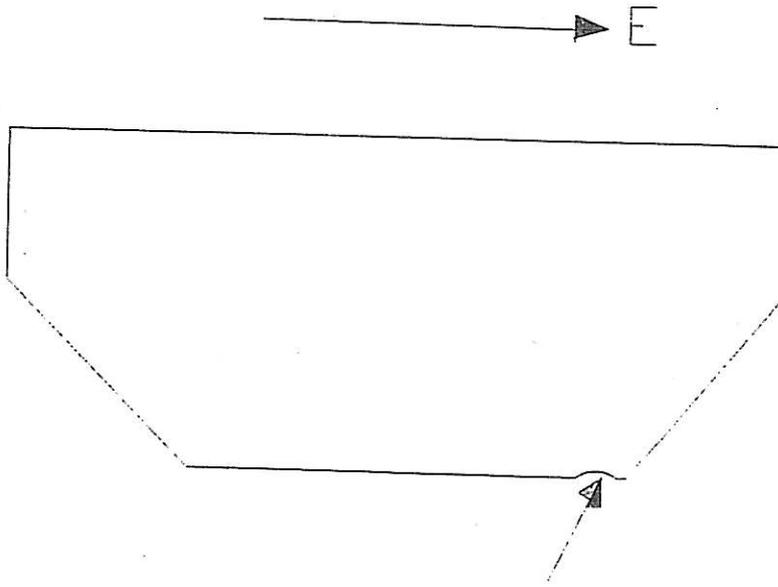
Draft of Welding Discontinuity:

After inspection: the flatness exceeded requirement at 1AAE south side, 200mm in length, 200mm in wide, it needed to build up, and the detail sees the following draft.

Remark: repair position

1. 焊接变形和制作误差。
1. Weld distortion and fabricate error.

1. 准备一个正确的接头型式, 具体参照相应的返修WPS ;
 2. 将修补区域打磨光滑, 开始和结束的接头交错布置 ;
 3. 对修补区域进行VT与MT检测 ;
 4. 根据批准的返修焊接工艺规程 (WPS) 进行预热及焊接 ;
 5. 将修补区域打磨与母材或相邻焊缝平齐 ;
 6. 对修补区域作100%VT与MT检测 ;
-
1. Prepare excavation according to the approved repair WPS.
 2. Grind the repaired area to a smooth and shiny finish, with tapered ends, to ensure staggered starts and stops.
 3. VT and MT the repair area.
 4. Preheat and weld according to the relevant repair WPS.
 5. Grind the repaired area flush with base metal or the adjacent weld.
 6. Perform VT and MT over 100% of the repair area.

Enhance supervision in process of fabrication to reduce error.
