Contract #: 04-0120F4
 Cty: SF/ALA Rte: 80 PM: 13.2/13.9
 File #: 69.25B

QUALITY ASSURANCE -- NON-CONFORMANCE REPORT

Location: Changxing Island, Shanghai, PRC **Report No:** NCR-000441
Prime Contractor: American Bridge/Fluor Enterprises, a JV **Date:** 08-Oct-2009
Submitting Contractor: Zhenhua Port Machinery Company, Ltd (ZPMC), Changxing Island **NCR #:** ZPMC-0415

Reference Description: Unapproved rotating of South Tower, Lift 4

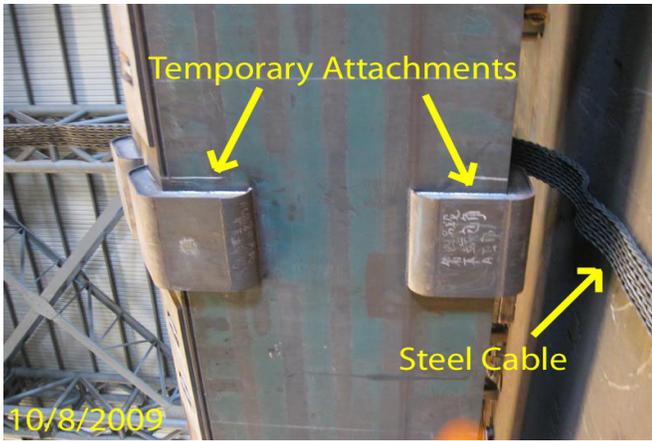
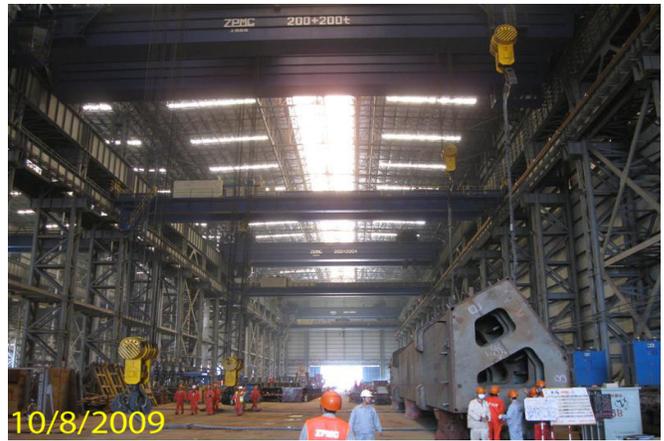
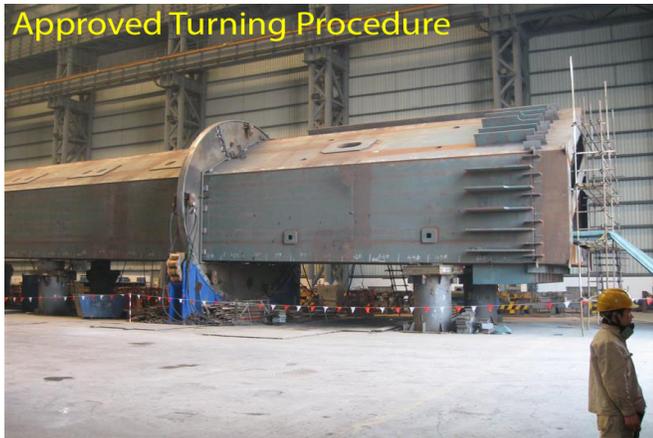
During in-process Visual Inspection (VT), QA observed South Tower, Lift 4 being rotated utilizing steel cables supported by temporary attachments. The approved Tower Shaft Fabrication Procedure outlines a procedure utilizing "roisserie rings" and a chain roller system.

Tower Shaft Segment Fabrication Procedure (Submittal 572R1), Sheet No. FP-MUG-18, Section 7.2 indicates that Tower Shafts will be rotated in turning jigs during welding.

Propose a resolution that addresses the non-conformance with regard to the failure to follow the submitted and approved procedures / fabrication plan. In the event that the Contractor's intent is to modify the procedure, a revised procedure must be submitted for review and approval prior to being implemented.

A revised fabrication procedure (ABF-SUB-000285R04) outlining the new shaft rotating method has been submitted and subsequently approved as noted.
