Contract #: 04-0120F4
 Cty: SF/ALA Rte: 80 PM: 13.2/13.9
 File #: 69.25B

QUALITY ASSURANCE -- NON-CONFORMANCE REPORT

Location: Changxing Island, Shanghai, P.R. China **Report No:** NCR-000442
Prime Contractor: American Bridge/Fluor Enterprises, a JV **Date:** 24-Sep-2009
Submitting Contractor: Zhenhua Port Machinery Company, Ltd (ZPMC), Changxing Island **NCR #:** ZPMC-0416

Reference Description: Vertical Weld in a Downward Progression in Crossbeam 8 and 12

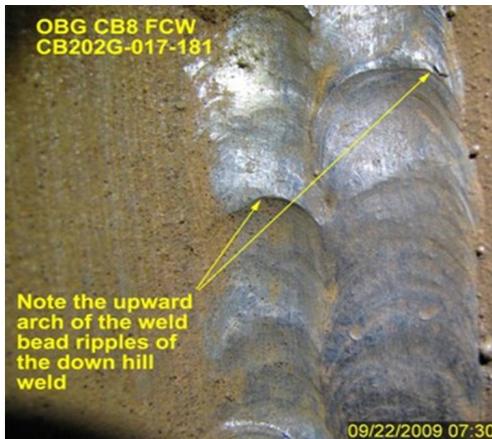
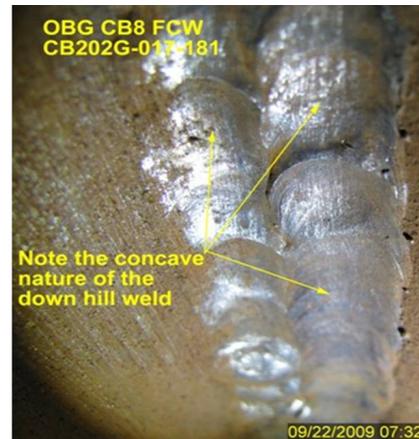
During random in process Visual Inspection (VT) of Fracture Critical Weld (FCW) at Crossbeam CB8, the Quality Assurance (QA) Inspector observed that ZPMC welding personnel have performed a vertical weld in a downward progression. The weld exhibits typical visual characteristics of a weld performed in a downward progression. This weld is identified as a FCW weld on the approved drawings. This weld ID is CB202G-017-181.

AWS D1.5 2002 section 4.6.8 "The progression for all passes in the vertical position shall be upward, unless a downward progression is qualified by tests approved by the Engineer".

Reference Resolution: ZPMC QC has generated a CWR to remove the down hand welds and replace the weld in conformance with the applicable WPS.

ZPMC removed the welds in question and performed the new welds in conformance with the approved WPS.

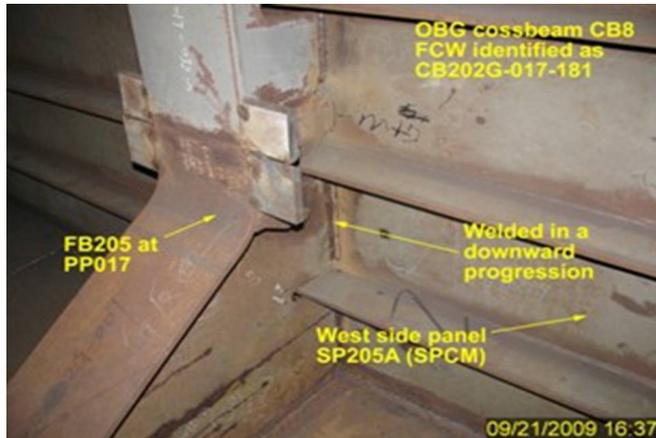
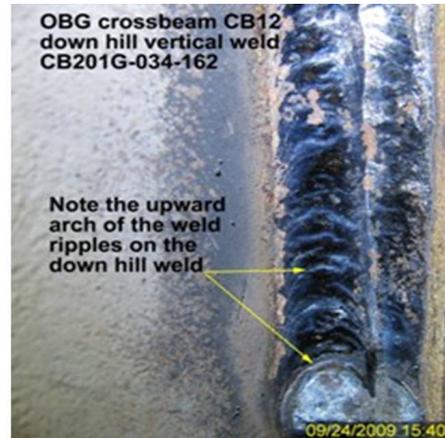
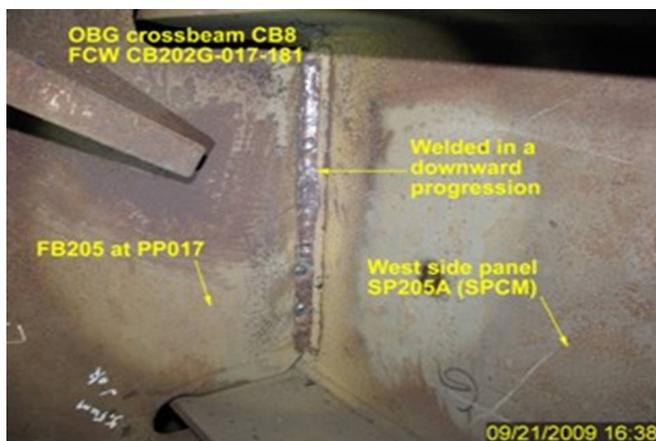
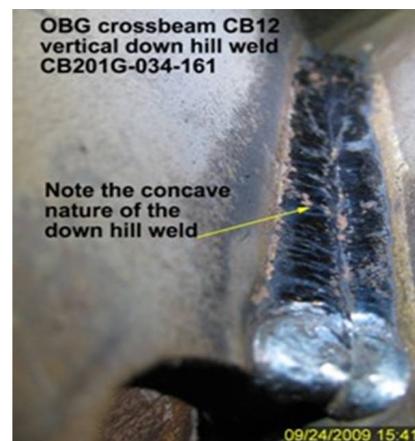
During random in process Visual Testing (VT) of Crossbeam CB 12. The Quality Assurance Inspector (QA) observed that the contractors welding personnel appears to have performed seven (7) vertical weld repairs in a downward progression. These repair welds appeared to exhibit typical visual characteristics of a weld performed in a downward progression. The affected welds are identified as CB201G-034-161, CB201G-035-143, 161, 145 and CB201G-036-163.
