Contract #: 04-0120F4
 Cty: SF/ALA Rte: 80 PM: 13.2/13.9
 File #: 69.25B

QUALITY ASSURANCE -- NON-CONFORMANCE REPORT

Report No: NCR-000445

Reference Description: Unapproved turning of East Tower, Lift 4

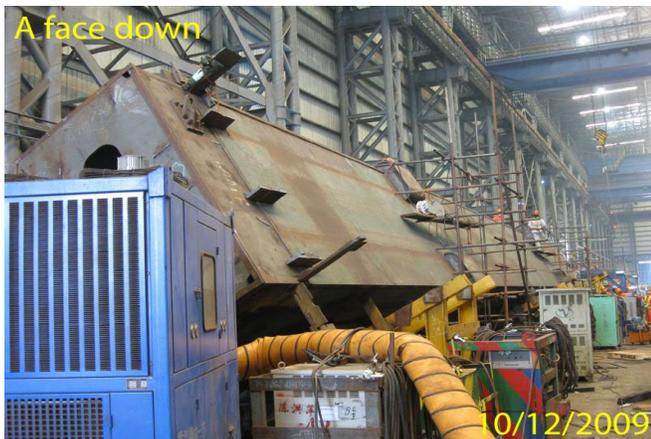
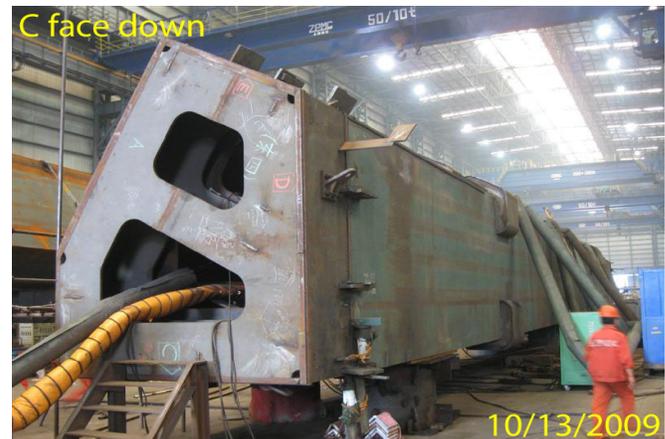
During in-process Visual Inspection (VT), QA observed that East Tower, Lift 4 had been rotated utilizing steel cables supported by temporary attachments. The approved Tower Shaft Fabrication Procedure outlines a procedure utilizing "rotisserie rings" and a chain roller system.

Tower Shaft Segment Fabrication Procedure (ABF-SUB-000285R03), Sheet No. FP-MUG-18, Section 7.2 indicates that Tower Shafts will be rotated in turning jigs during welding.

While it has been indicated that a previous submittal of the fabrication plan addressed the procedure being utilized, the final approved plan does not nor do the plans address the use of wire rope slings. Currently a modified procedure has been utilized in the initial lifting and rotation of both South and East lifts 4 and the subsequent rotation of South Lift 4.

Propose a resolution that addresses the non-conformance with regard to the failure to follow the submitted and approved procedures / fabrication plan.

If the Contractor intends to modify approved procedures, revised procedures must be submitted for review and approval prior to implementation.

A revised fabrication procedure (ABF-SUB-000285R04) outlining the new shaft rotating method has been submitted and subsequently approved as noted.
