Contract #: 04-0120F4  
 Cty: SF/ALA Rte: 80 PM: 13.2/13.9  
 File #: 69.25B

## QUALITY ASSURANCE -- NON-CONFORMANCE REPORT

**Report No:** NCR-000448

**Reference Description:** No preheat on South Tower, Lift 2, 53m Diaphragm to Bracket weld

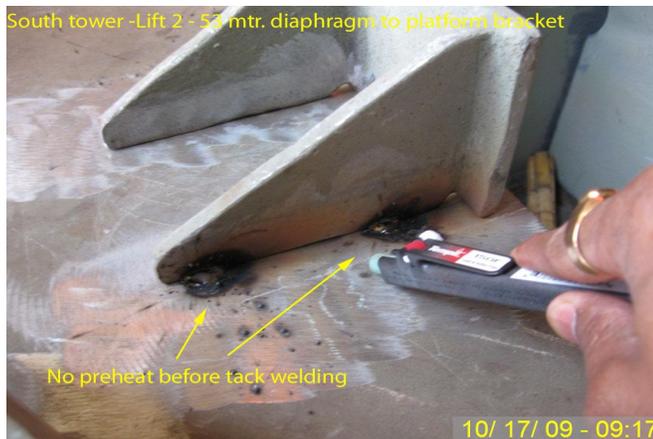
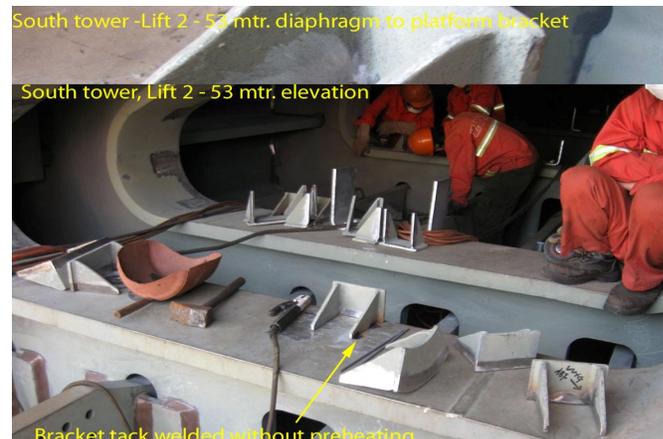
During in-process visual inspection of South Tower, Lift 2, 53 m diaphragm to support platform bracket welds, QA observed ZPMC personnel performing tack welding without preheating the base metal. The Welding Procedure Specification (WPS) used requires a minimum preheat of 65 degrees C.

AWS D1.5-2002, Section 3.3.7 - "Tack welds shall be subject to the same quality requirements as the final welds..."

Welding Procedure Specification WPS-B-P-2112 requires a minimum preheat of 65 degrees C.

Propose a resolution for this non-conformance including documentation that the welds placed are in compliance with the contract requirements. In addition to addressing Production's failure to perform the required preheat of the material, address the failure of Quality Control to identify the lack of preheat. Provide documentation of the steps/ actions taken by Production and Quality Control to prevent future occurrences. Also detail what steps/ actions are being taken by ABFJV to address the quality control failures of ABFJV's fabricator/ ZPMC.

ZPMC acknowledges the NCR and has discussed the issue with the foreman to ensure he understands the importance of oversight and control of preheating. The same topic was discussed with the QC inspector. In this case the tacks were removed, the area preheated and welded again. Attached is the NDT documentation showing the weld is sound. Based on this ZPMC requests closure of this NCR.

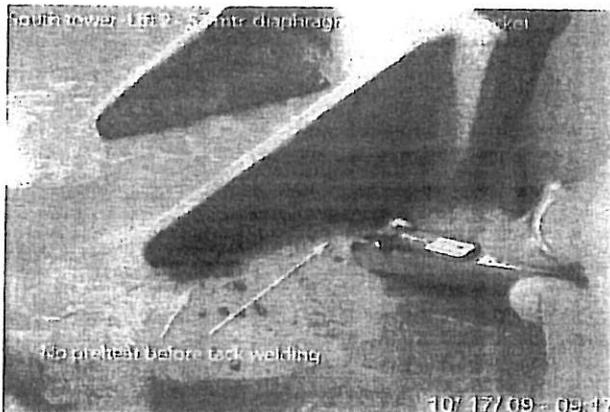
During in-process visual inspection of South Tower, Lift 2, 53 m diaphragm to support platform bracket welds, QA observed ZPMC personnel performing tack welding without preheating the base metal. The Welding Procedure Specification (WPS) used requires a minimum preheat of 65 degrees C.

AWS D1.5-2002, Section 3.3.7 - "Tack welds shall be subject to the same quality requirements as the final welds..."

Welding Procedure Specification WPS-B-P-2112 requires a minimum preheat of 65 degrees C.

ZPMC's QC inspector did not note the lack of preheat in this case because he mistakenly believed that tack welds do not require the base metal to be preheated. ABFJV has discussed this with ZPMC QA who concur that per AWS D1.5 tack welds should have the same quality as production welds. This has been discussed and reinforced the ZPMC QC department and the inspector who observed this non conformance.

ABFJV has recognized that lack of preheat has been an area of concern so the ABFJV QCM is scheduling training classes with ZPMC's QA, QC and Production departments to reinforce the importance and requirement of preheating. Based on this information, ZPMC requests closure of this NCR.
