Contract #: 04-0120F4
 Cty: SF/ALA Rte: 80 PM: 13.2/13.9
 File #: 69.25B

QUALITY ASSURANCE -- NON-CONFORMANCE REPORT

Report No: NCR-000449

Reference Description: Missed MT indication on West Tower, Lift 3, 85.25m Diaphragm to Skin A weld

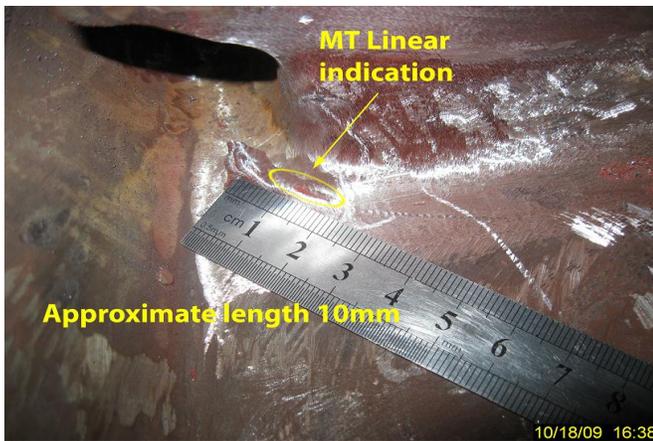
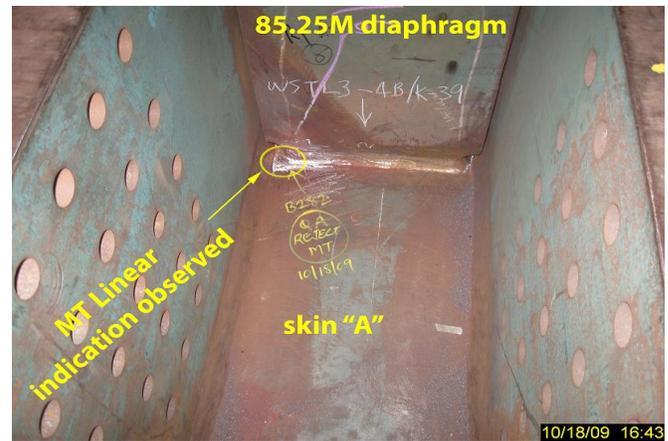
During Magnetic Particle Testing (MT) of West Tower, Lift 3, 85.25m Diaphragm to Skin A weld WSTL3-4B/K-39, QA discovered a linear indication of approximately 10mm in length. This weld had been previously tested and accepted by ZPMC NDT personnel (NDT Inspection Notification Sheet #004423).

AWS D1.5-2002, Section 6.26.2 – “Welds that are subject to MT in addition to visual inspection shall have no cracks.”

Propose a resolution for this systematic non-conformance that addresses the failure of Quality Control to identify the linear indication during magnetic particle testing of the weld. Provide documentation of the steps/actions taken by the Quality Control Manager to prevent future occurrences.

In addition to the Quality Control non-conformance, address the material/workmanship for the identified non-conformance including documentation that the deficiency has been brought into compliance with the contract requirements. Additionally address the probable causes for the indication and the actions that will be taken to limit future occurrences.

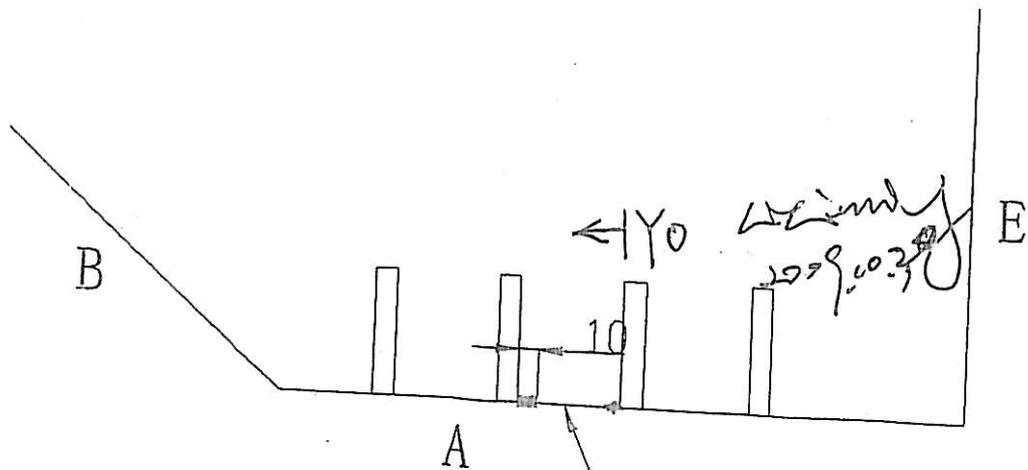
WELD NUMBER: WSTL3-4B/K-39

One longitudinal crack was found by use of MT on WSTL3-4B/K-39.

1. The access space was quite narrow resulting in making it difficult to arc-gouge the defects effectively.
2. The grinder was not observant during the grinding operation resulting in the indications not being completely removed.

1. QC shall monitor and direct the welder and the grinder doing the repair operation.
2. Preheat before gouging; the temperature shall be at least 65°C.
3. Gouge the weld to remove identified defects.
4. Joint details shall refer to the approved WPS repair.
5. Grind the gouged areas to a smooth and shiny surface.
6. Verify with VT and MT to ensure no defects remain in the weld joint prior to welding.
7. QC shall monitor all welding passes being deposited.
8. QC shall ensure all slag has been removed prior the deposition of next pass.
9. Preheat and maintain interpass temperature control in accordance with the WPS.
10. Blend the weld repaired areas into the adjacent weld or base metal by grinding.
11. Perform VT, MT and UT NDT inspection to the repaired areas.

1. Grind smoothly transition after gouging. Perform VT and MT to ensure all the defects have been removed.
2. Instruct the welder that it is his responsibility to produce sound welds and perform interpass cleaning.
3. Greater QC presence during critical welding operations.
