QUALITY ASSURANCE -- NON-CONFORMANCE REPORT

Location: Changxing Island, Shanghai, P.R.**Report No:** NCR-000451**Prime Contractor:** American Bridge/Fluor Enterprises, a JV**Date:** 03-Oct-2009**Submitting Contractor:** Zhenhua Port Machinery Company, Ltd (ZPMC), Changxing Island**NCR #:** ZPMC-0424**Type of problem:**

Reference Description: Missed UT indications by QC on OBG 2AW Floor Beam Flange Weld**Description of Non-Conformance:**

Job Name: SAS Superstructure

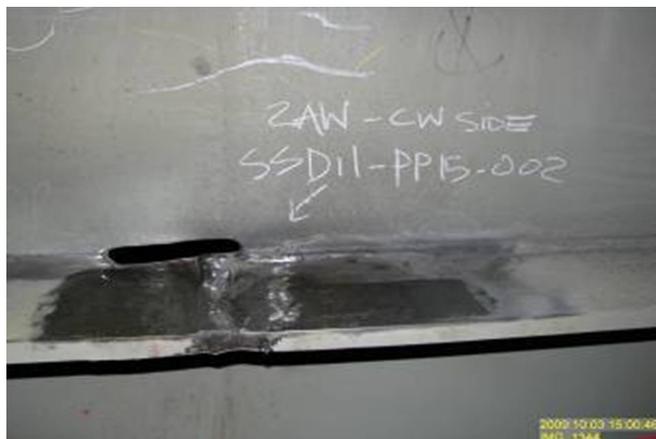
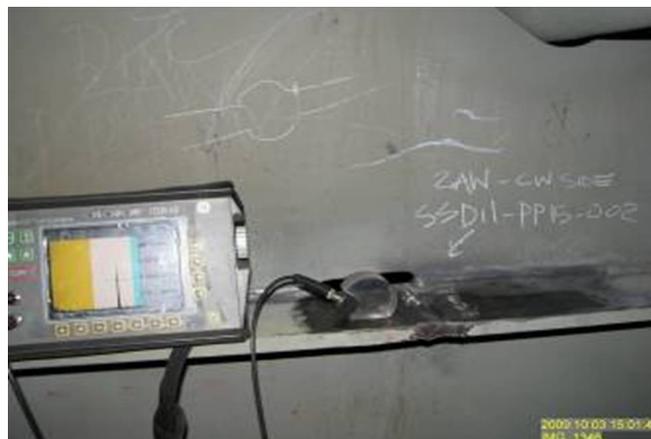
During the random Quality Assurance (QA) verification of Ultrasonic Testing (UT) on weld joint identified as SSD11-PP15-002 located at panel point 15 2AW. The QA inspector discovered one (1) class "A" indication measuring approximately 15 mm in length. This inspection was performed in response to ZMPC's NDT Inspection Notification Sheet document No. 004340.

This weld was previously UT tested and accepted by ZPMC QC personnel.

AWS D1.5-2002 Section 6, Table 6.3; Class A, any indication in this category shall be rejected (regardless of length).

Submit a repair procedure to the engineer for approval.
Note: This indication was found after acceptance by ZPMC QC personnel.

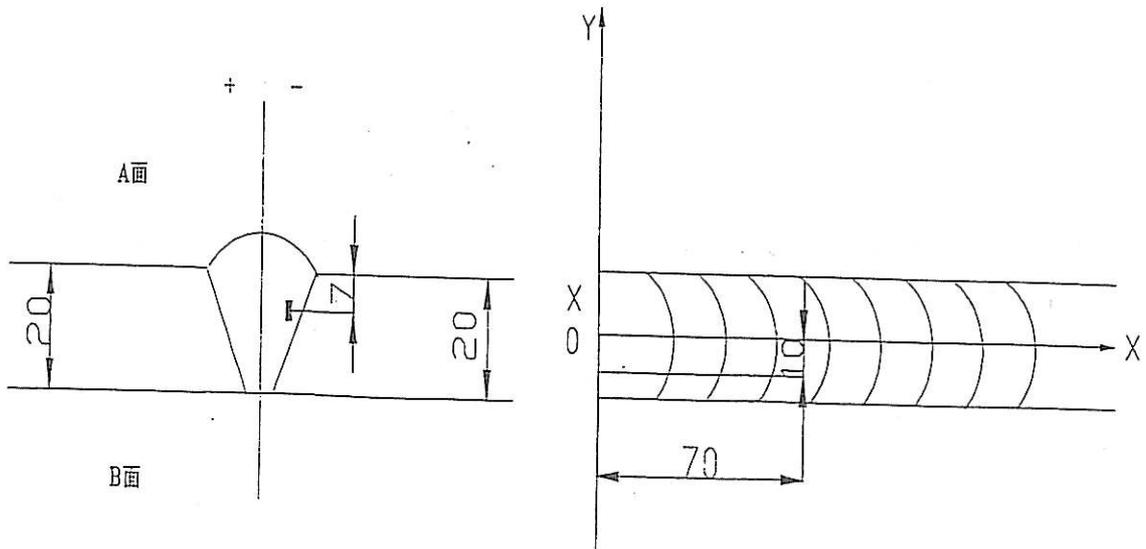
WELD NUMBER: SSD11-PP15-002

Rejected indication found by ultrasonic inspection is less than the maximum allowance aggregate length.

1. Did not clear the weld pass completely in time.

1. Gouge or grind from nearer side from metal edge ($D \leq 0.65T$, "D" is depth of defects, "T" is thickness of metal) to remove all defects;

2. Follow repair WPS for joint preparation, preheat, and weld deposit;

3. Verify with VT no defects remain in the weld joint prior to welding;

4. Grind the repaired area flush with base metal or the adjacent weld;

5. Check the welds according to the working drawings.
