Contract #: 04-0120F4Cty: SF/ALA Rte: 80 PM: 13.2/13.9File #: 69.25B**QUALITY ASSURANCE -- NON-CONFORMANCE REPORT****Location:** Changxing Island, Shanghai, P.R. China**Report No:** NCR-000457**Prime Contractor:** American Bridge/Fluor Enterprises, a JV**Date:** 24-Sep-2009**Submitting Contractor:** Zhenhua Port Machinery Company, Ltd (ZPMC), Changxing Island**NCR #:** ZPMC-0430**Type of problem:**

Reference Description: Cold bending of SPCM Member: Crossbeam 14 Intermediate Web Plate CB202E**Description of Non-Conformance:**

Subject: NCR No. ZPMC-0430

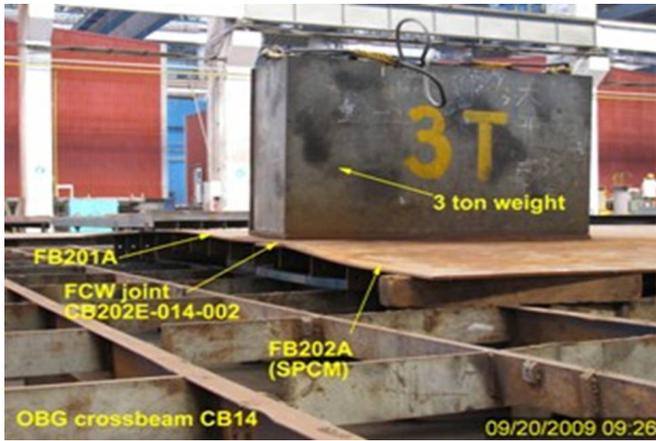
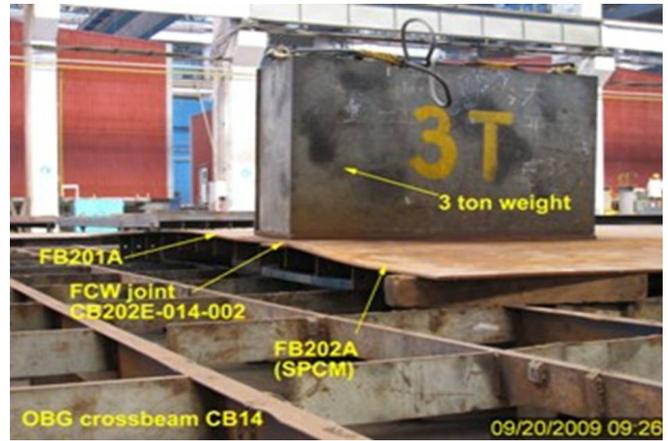
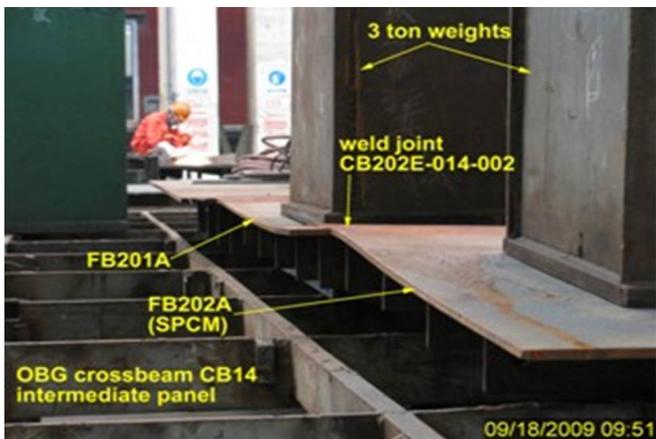
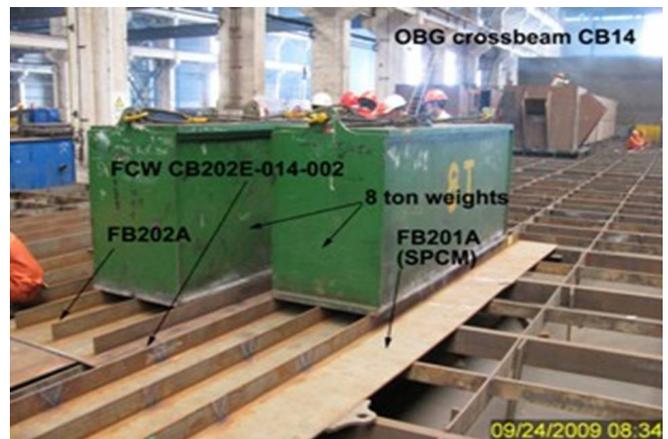
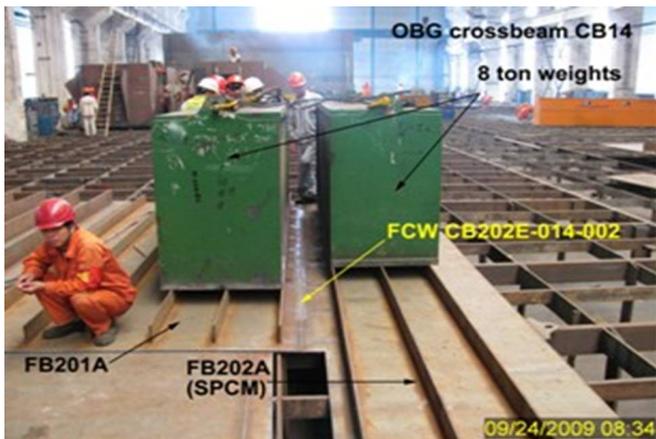
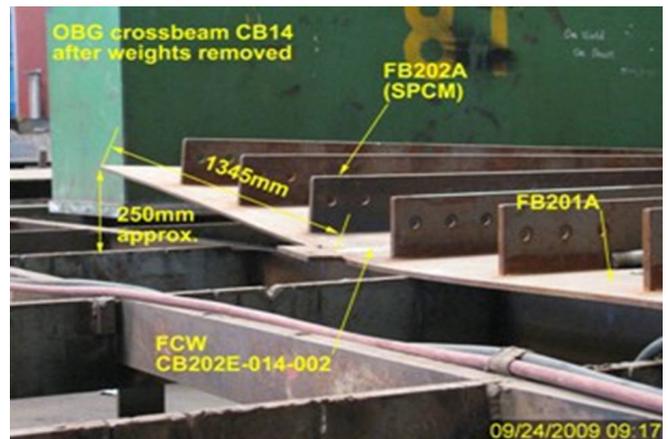
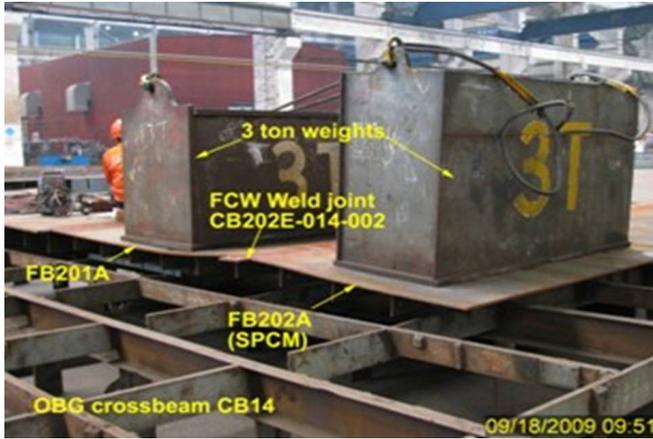
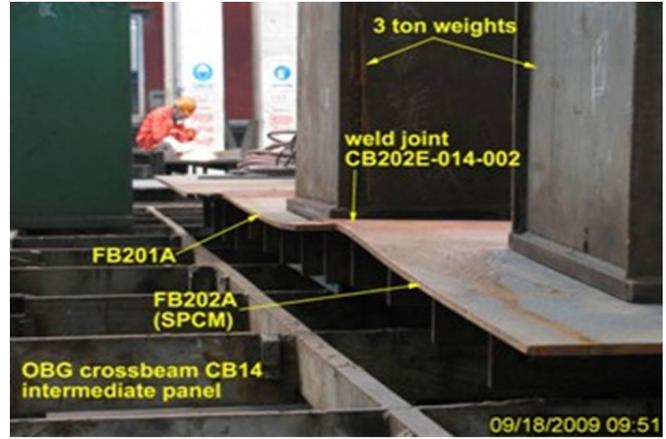
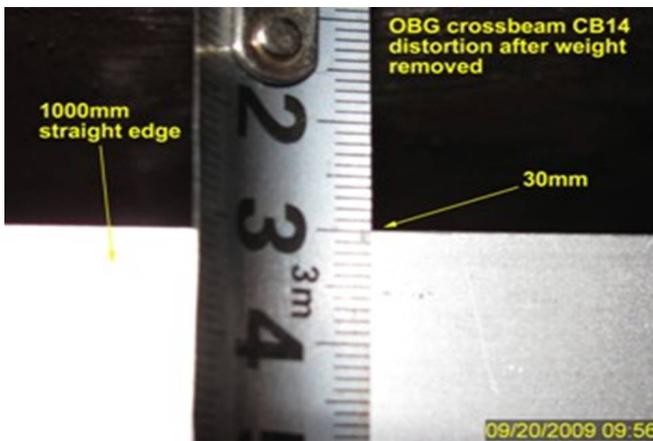
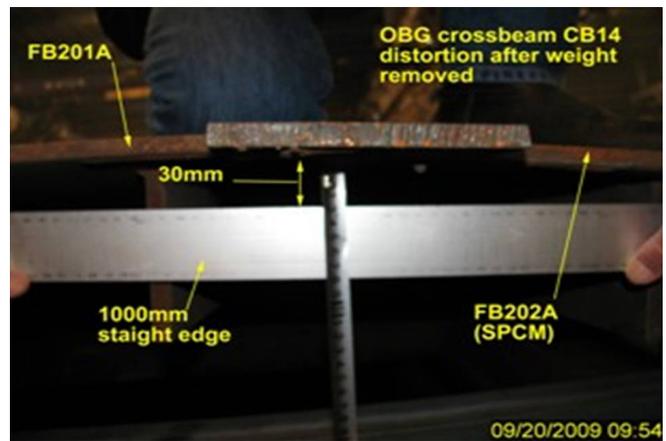
On Sept. 18, 2009, this Quality Assurance Inspector (QA) observed that the contractor performed "cold bending" of the Seismic Performance Critical Material (SPCM) and a Fracture Critical Weld (FCW). This QA observed two (2) three (3) ton weights had been placed on the material, one on each side of the FCW. The weights appeared to be for the purpose of bending the material. The SPCM is identified as FB202A. The FCW joint is identified as CB202E-014-002. See attached photos for details.

On Sept. 20, 2009, this Quality Assurance Inspector (QA) observed that the contractor performed "cold bending" Seismic Performance Critical Material (SPCM) and a Fracture Critical Weld (FCW). The QA inspector observed one (1) three (3) ton weight had been placed on the material near the FCW. The weight appeared to be for the purpose of correcting excessive weld distortion of the base metal material. The SPCM material is identified as FB202A and the FCW weld joint is identified as CB202E-014-002.

On Sept. 24, 2009, this Quality Assurance Inspector (QA) observed that the contractor performed "cold bending" Seismic Performance Critical Material (SPCM) and a Fracture Critical Weld (FCW). This QA observed two eight (8) ton weights had been placed on the material near the FCW. The weights appeared to be for the purpose of correcting excessive weld distortion of the material. The SPCM is identified as FB202A and the FCW joint is identified as CB202E-014-002.

AWS D1.5 2002 section 12.12 "Cold bending shall be prohibited for all fracture critical steels."

Submit a repair procedure to the engineer for approval and discontinue any further cold bending on similar members.

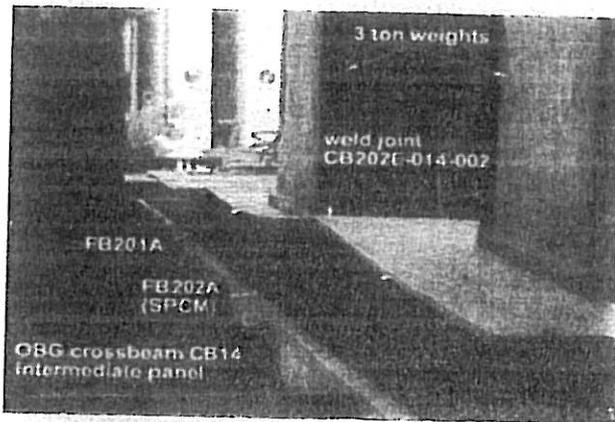
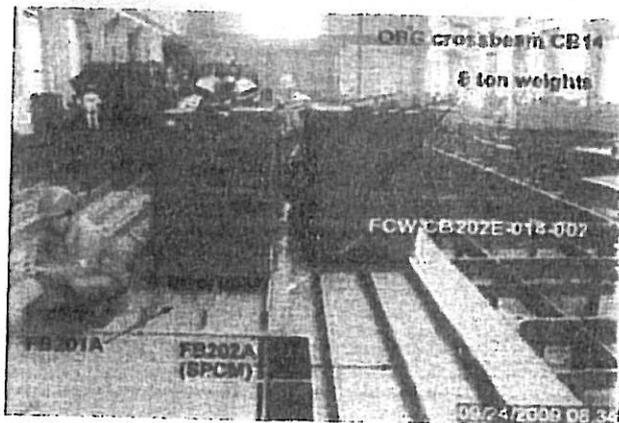
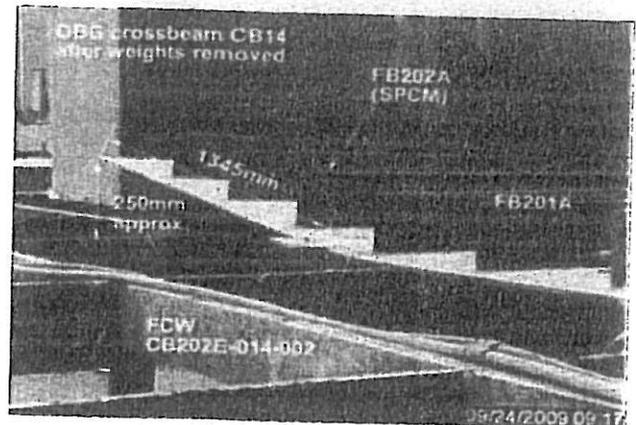
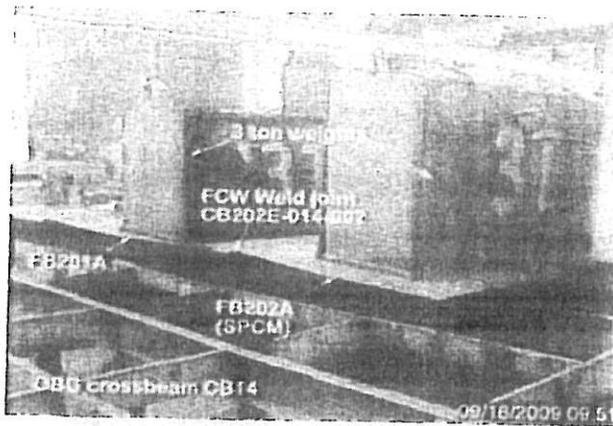
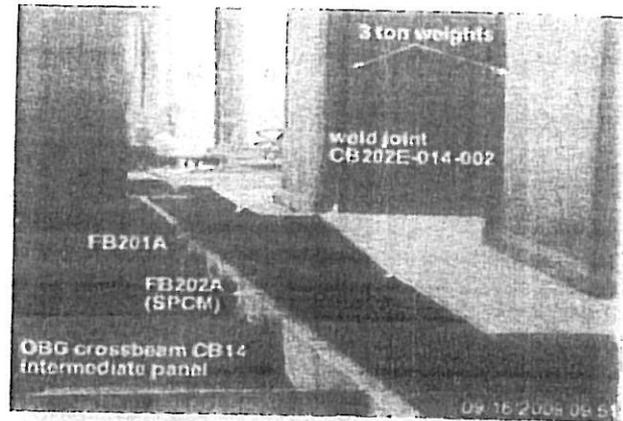
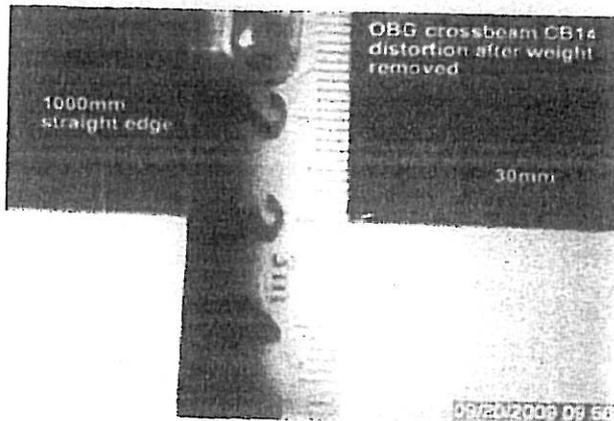
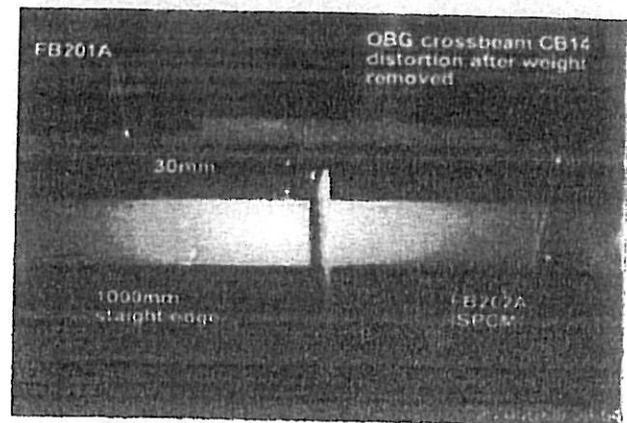
On Sept. 18, 2009, this Quality Assurance Inspector (QA) observed that the contractor performed "cold bending" of the Seismic Performance Critical Material (SPCM) and a Fracture Critical Weld (FCW). This QA observed two (2) three (3) ton weights had been placed on the material, one on each side of the FCW. The weights appeared to be for the purpose of bending the material. The SPCM is identified as FB202A. The FCW joint is identified as CB202E-014-002. See attached photos for details.

On Sept. 20, 2009, this Quality Assurance Inspector (QA) observed that the contractor performed "cold bending" Seismic Performance Critical Material (SPCM) and a Fracture Critical Weld (FCW). The QA inspector observed one (1) three (3) ton weight had been placed on the material near the FCW. The weight appeared to be for the purpose of correcting excessive weld distortion of the base metal material. The SPCM material is identified as FB202A and the FCW weld joint is identified as CB202E-014-002.

On Sept. 24, 2009, this Quality Assurance Inspector (QA) observed that the contractor performed "cold bending" Seismic Performance Critical Material (SPCM) and a Fracture Critical Weld (FCW). This QA observed two eight (8) ton weights had been placed on the material near the FCW. The weights appeared to be for the purpose of correcting excessive weld distortion of the material. The SPCM is identified as FB202A and the FCW joint is identified as CB202E-014-002.

AWS D1.5 2002 section 12.12 "Cold bending shall be prohibited for all fracture critical steels."

Submit a repair procedure to the engineer for approval and discontinue any further cold bending on similar members.

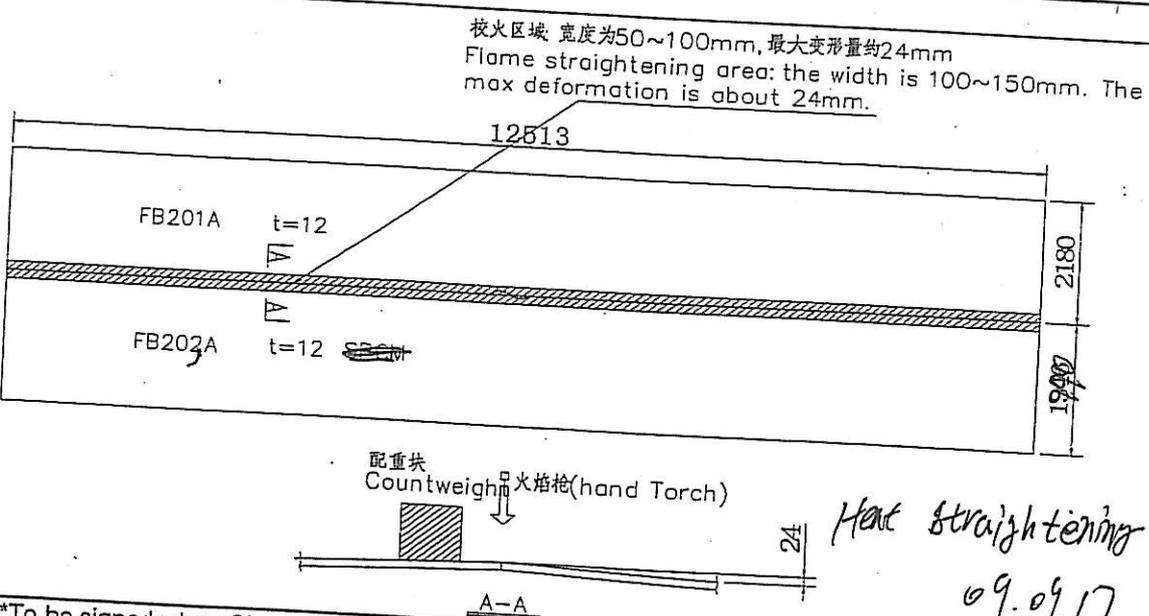
简图 Sketch

Cause原因 Welding distortion 焊接变形

Type of Defect缺陷类型 Welding distortion 焊接变形

缺陷去除方法(Defect Removal Method): Flame Straightening by oxygen acetylene 运用氧乙炔进行校火

后续NDE(Post-Removal NDE): After finishing heat straightening, the weld of the heat area shall perform NDT according to the approved shop drawing 校火后, 根据图纸要求对热影响区域进行NDT检测.
Control current, voltage and weld speed according to relevant WPS. If necessary anti-deformation or hold down device can be added. 依据相应的WPS的要求控制电流, 电压和焊接速度. 如有必要, 可使用反变形设施进行校正.

实施次数(Number of application): 1~3

最高温度(Maximum temperature): <600°C
