Contract #: 04-0120F4Cty: SF/ALA Rte: 80 PM: 13.2/13.9File #: 69.25B**QUALITY ASSURANCE -- NON-CONFORMANCE REPORT****Location:** Changxing Island, Shanghai, P.R. China**Report No:** NCR-000460**Prime Contractor:** American Bridge/Fluor Enterprises, a JV**Date:** 05-Oct-2009**Submitting Contractor:** Zhenhua Port Machinery Company, Ltd (ZPMC), Changxing Island**NCR #:** ZPMC-0433**Type of problem:**

Reference Description: Third time repair without the Engineer's Approval**Description of Non-Conformance:**

Job Name: SAS Superstructure

Subject: NCR No. ZPMC-0433

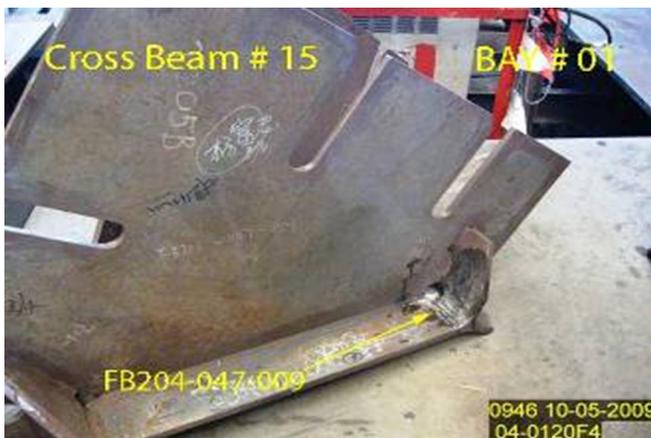
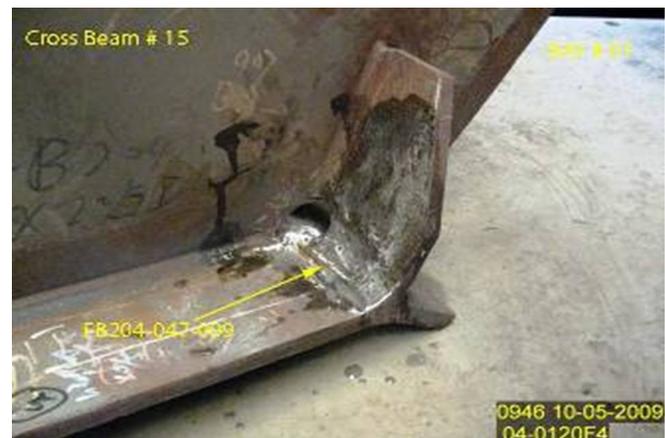
During a random visual inspection of OBG Cross Beam #15, the Caltrans Quality Assurance (QA) Inspector observed that ZPMC personnel performed the third time repair without the Engineer's approval. The following two joints FB205-045-013 and FB204-047-009 have been previously repaired three (3) times by ZPMC personal due to non-conforming indications found with ultrasonic testing (UT).

Special Provision Section 8.3: "In addition to the provisions in AWS D1.5, Section 3.7.4 and Section 12.17, third-time repairs of welds or base metal, regardless of NDT method, and all repairs of cracks require prior approval of the Engineer."

Submit a repair plan to the engineer for approval.

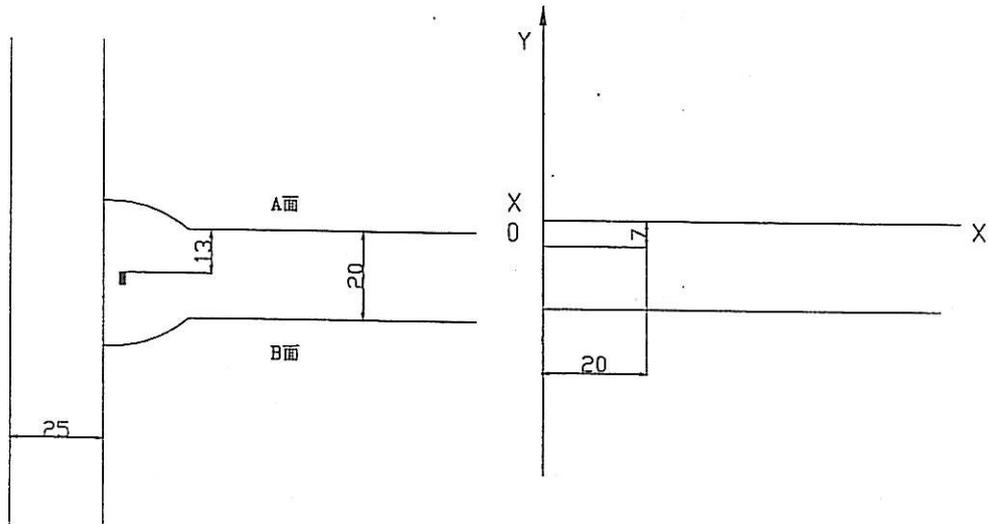
WELD NUMBER: FB205-045-013

Rejected indication found by ultrasonic inspection is less than the maximum allowance aggregate length.

1. Did not clear the weld pass completely in time.

1. Gouge or grind from nearer side from metal edge ($D \leq 0.65T$, "D" is depth of defects, "T" is thickness of metal) to remove all defects;
2. Follow repair WPS for joint preparation, preheat, and weld deposit;
3. Verify with VT no defects remain in the weld joint prior to welding;
4. Grind the repaired area flush with base metal or the adjacent weld;
5. Check the welds according to the working drawings.

1. Improve monitoring of welding and interpass cleaning.

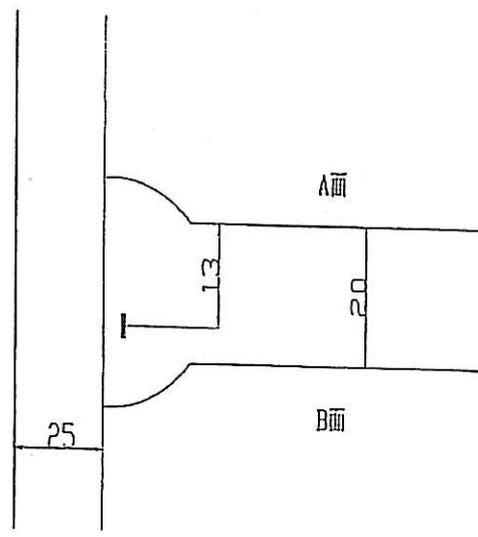
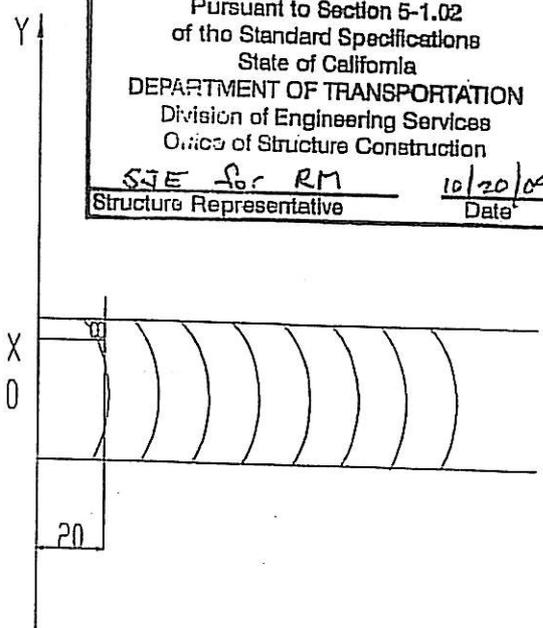
WELD NUMBER: FB205-045-013

A Rejectable indication was found by Ultrasonic Inspection for a third repair.
(UT三次缺陷) FB205-045-013

1. 焊工在第一次反面清根时, 没有注意, 导致焊接缺陷没有全部去除;
2. 在焊返修前, QC没有确认所有的焊接缺陷已经去除。
1. The welder was not observant during the first backgouging operation resulting in the Indications not being completely removed.
2. QC did not verify the indications had been removed prior to re-welding.

1. QC and a Lead CWI shall be present and monitor all gouging, grinding and welding operations during this repair.
2. QC shall have a copy of the CWR available to ensure the repair is per the disposition requirements.
3. If gouging is performed, preheat per the repair WPS minimum requirements.
4. Gouge and/or grind to remove all the defects from the Face A.
5. Prepare the repair joint according to the relevant repair WPS.
6. Grind area smooth to a shiny finish.
7. Perform VT and MT to ensure the defects have been removed.
8. Preheat and weld according to the relevant repair WPS.
9. Perform VT, MT and UT to the repair areas.
10. Grind the weld flush with the adjacent weld.
- ~~11. Check the weld according to the working drawings.~~ *REMOVE*

- 返修前, QC必须VT和MT确认所有的缺陷已经去除;
 - 教导在烧熔透焊缝和焊道清理时, 焊工必须负责任;
 - QC指导碳刨工将所有的缺陷去除;
 - 关键焊缝返修时, 主要的QC负责人要在现场;
- QC to verify VT and MT has been performed and all the defects have been removed prior to the repair.
 - QC to instruct the welder that it is his responsibility to produce sound welds and perform interpass cleaning.
 - QC to instruct the grinder all defects shall be removed.
 - Greater QC presence during critical welding operations.

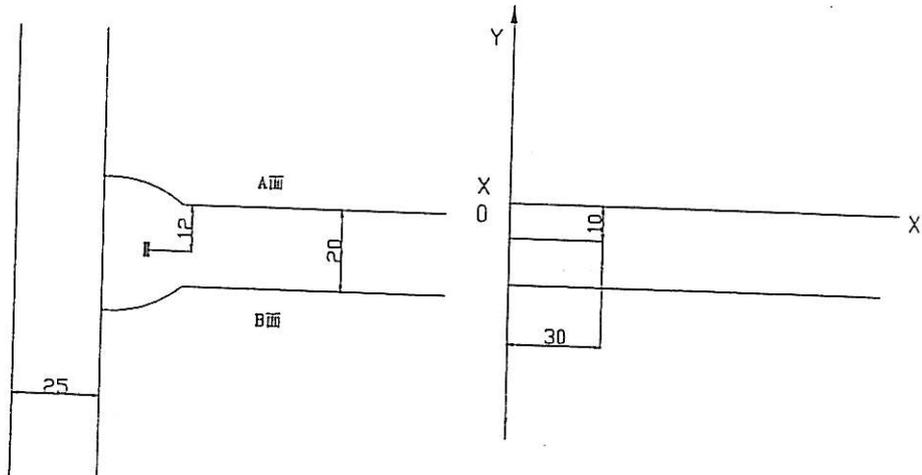
WELD NUMBER: FB204-047-009

Rejected indication found by ultrasonic inspection is less than the maximum allowance aggregate length.

1. Gouge or grind from nearer side from metal edge ($D \leq 0.65T$, "D" is depth of defects, "T" is thickness of metal) to remove all defects;
2. Follow repair WPS for joint preparation, preheat, and weld deposit;
3. Verify with VT no defects remain in the weld joint prior to welding;
4. Grind the repaired area flush with base metal or the adjacent weld;
5. Check the welds according to the working drawings.

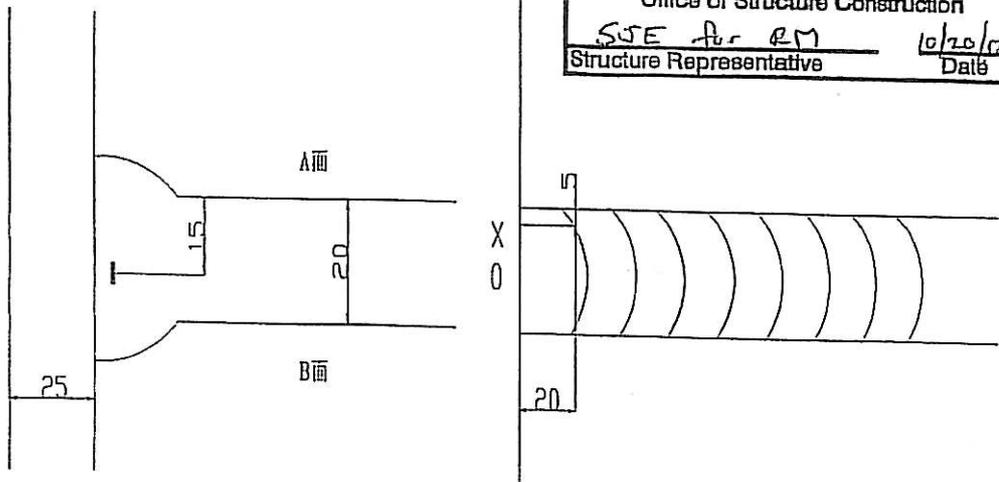
WELD NUMBER: FB204-047-009

A Rejectable indication was found by Ultrasonic Inspection for a third repair.
(UT三次缺陷) FB204-047-009

1. 焊工在第一次反面清根时, 没有注意, 导致焊接缺陷没有全部去除;
2. 在焊返修前, QC没有确认所有的焊接缺陷已经去除。
1. The welder was not observant during the first backgouging operation resulting in the Indications not being completely removed.
2. QC did not verify the indications had been removed prior to re-welding.

1. QC and a Lead CWI shall be present and monitor all gouging, grinding and welding operations during this repair.
2. QC shall have a copy of the CWR available to ensure the repair is per the disposition requirements.
3. If gouging is performed, preheat per the repair WPS minimum requirements.
4. Gouge and/or grind to remove all the defects from the Face A.
5. Prepare the repair joint according to the relevant repair WPS.
6. Grind area smooth to a shiny finish.
7. Perform VT and MT to ensure the defects have been removed.
8. Preheat and weld according to the relevant repair WPS.
9. Perform VT, MT and UT to the repair areas.
10. Grind the weld flush with the adjacent weld.
- ~~11. Check the weld according to the working drawings. REMOVE~~

1. QC to verify VT and MT has been performed and all the defects have been removed prior to the repair.
2. QC to instruct the welder that it is his responsibility to produce sound welds and perform interpass cleaning.
3. QC to instruct the grinder all defects shall be removed.
4. Greater QC presence during critical welding operations.
