Contract #: 04-0120F4
 Cty: SF/ALA Rte: 80 PM: 13.2/13.9
 File #: 69.25B

QUALITY ASSURANCE -- NON-CONFORMANCE REPORT

Location: Changxing Island, Shanghai, P. R. China **Report No:** NCR-000461
Prime Contractor: American Bridge/Fluor Enterprises, a JV **Date:** 05-Oct-2009
Submitting Contractor: Zhenhua Port Machinery Company, Ltd (ZPMC), Changxing Island **NCR #:** ZPMC-0434

Welding	Concrete	Other	
Welding	Curing	Procedural	Bridge No: 34-0006
Joint fit-up	Coating	Other	Component: OBG 1AAW-1AW Splice Weld
Procedural	Procedural	Description:

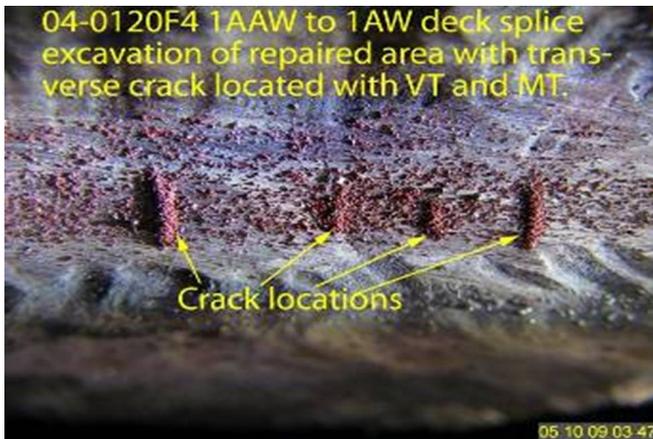
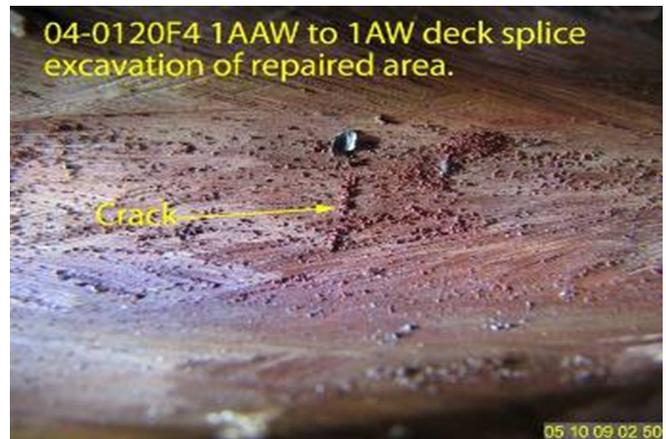
During a random visual inspection of repair work located at 1AAW to 1AW splice weld OBW1-001. The Caltrans Quality Assurance (QA) Inspector observed ZPMC workers performing weld repair excavations at two (2) separate areas along this weld splice. ZPMC performed this repair utilizing the welding repair report (B-WR8006). This welding repair report did not describe any magnetic particle testing (MT) verifications in the excavation prior to re-welding nor after the completion of welding to ensure that the joint is free of defect. METS QA Inspector performed Magnetic Particle (MT) testing at the excavated areas and found some transverse cracks present in 2 excavated areas as shown below.

The Y locations, length of excavation area and number of Transverse Cracks in OBW1-001:

1. Y location 21,480~23,620mm (off Cross Beam side), length of excavation 2,140mm, twelve (12) indications verified.
2. Y location 660~3,090mm (off Cross Beam side), length of excavation 2,430mm, fifty nine (59) indications verified.

AWS D1.5-2002 Section 3,7,2,4 Crack in Weld or Base Metal; The extent of the crack shall be ascertained by the use of MT, PT, or other equally positive means; the metal shall be removed for the full length of the crack plus 50mm [2"] beyond the end of each crack and re-welded.

Submit a repair procedure to the engineer for approval.

ZPMC has repaired the indications documented in the NCR. ABFJV conducted the NDT and found that the welds are acceptable.
