QUALITY ASSURANCE -- NON-CONFORMANCE REPORT

Report No: NCR-000466

Reference Description: Missed MT indication on South Tower, Lift 3

Dear: Mr. Charles Kanapicki
Job Name: SAS Superstructure

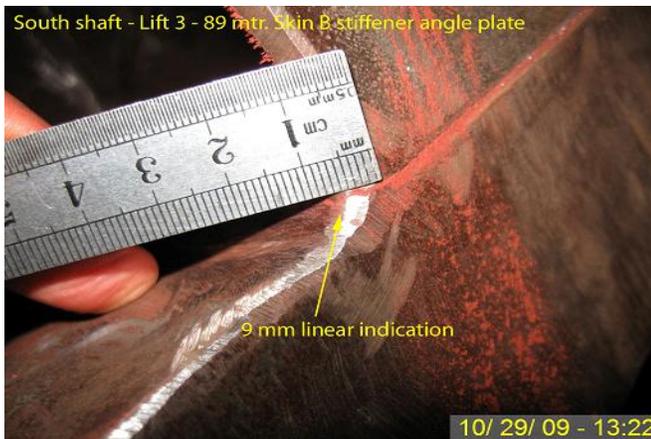
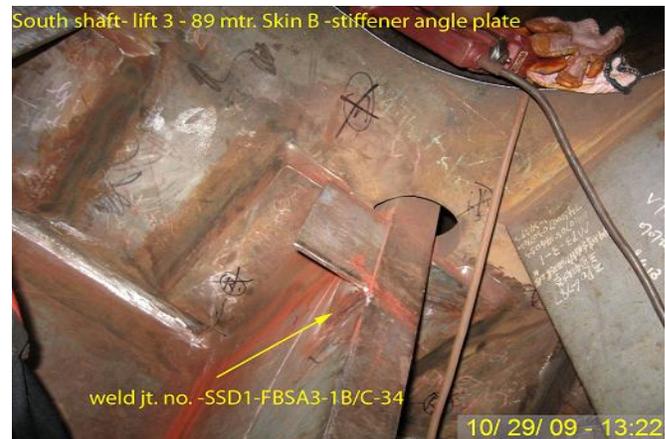
During Magnetic Particle (MT) inspection of South Tower, Lift 3, 89m Skin B stiffener angle plate weld SSD1-FBSA3-1B/C-34, QA discovered a linear indication of approximately 9 mm in length. This weld has been previously tested and accepted by ZPMC NDT personnel.

AWS D1.5-2002, Section 6.26.2 – “Welds that are subject to MT in addition to visual inspection shall have no cracks.”

Repair affected weld and submit NDT documentation indicating weld soundness.

The affected weld has been repaired, NDT documentation indicating weld soundness has been submitted, and the weld has been subsequently green tagged. To resolve the recurring failure for QC to detect MT indications, ABFJV QCM has implemented training with ZPMC to improve quality of inspectors. Topics include: inspection of equipment prior to use, proper conditions for inspection, proper technique for MT & UT. In addition, ABFJV is performing weld over-checks. This will serve two purposes, first to monitor if the training is effective at reducing the number of missed indications and second, to ensure missed indications are prevented.
