**QUALITY ASSURANCE -- NON-CONFORMANCE REPORT**

**Location:** Changxing Island, Shanghai, PRC**Report No:** NCR-000470**Prime Contractor:** American Bridge/Fluor Enterprises, a JV**Date:** 04-Nov-2009**Submitting Contractor:** Zhenhua Port Machinery Company, Ltd (ZPMC), Changxing Island**NCR #:** ZPMC-0443**Type of problem:**

**Reference Description:** Missed UT indications on Tower Spare Strut**Description of Non-Conformance:**

**Job Name:** SAS Superstructure  
**Document No:** 05.03.06-000433

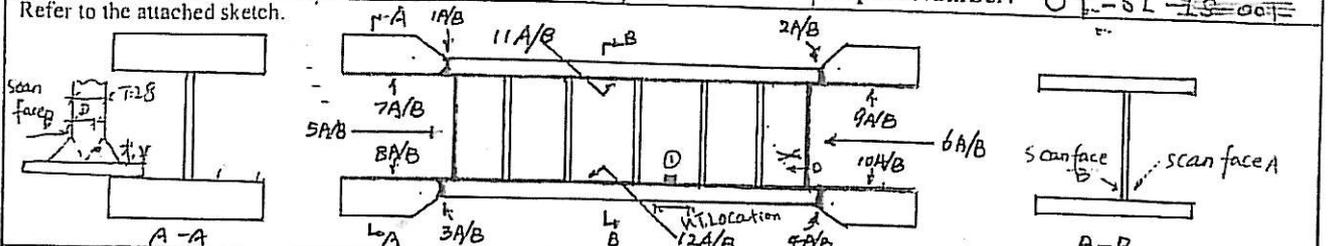
Lift / Segment No.: IV/A Location: HD2 Report Number: UT-SL-15-007

Weld No.	Indication No.	Scan Face	Dimensions (mm)				Indication Rating "d"	Evaluation	Inspector	Inspection Date
			"X" from O Axis	"y"	Length "L"	Depth "D"				
WD1-A683-2-12-0		B	715	15	15	2.4	78	Rej.	Wang ZH	09.11.05
<p>* Verification of CT identified rejectable indications on captioned weld. Confirm the result.</p>

Observation:- Scanning Pattern:- A.B.C. is rejected, ZPMC shall repair the weld as procedure in Green Top.

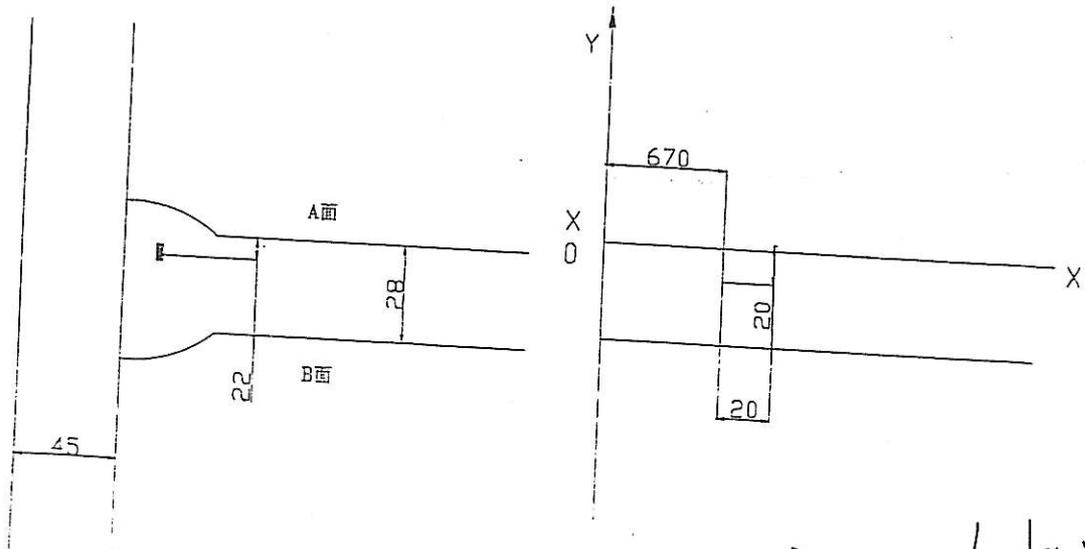
WELD NUMBER: WD1-A6003-2-12A/B Note: Remove only by grinding

Rejected indication found by ultrasonic inspection is less than the maximum allowance aggregate length.

(UT探伤发现的缺陷总长度小于最大允许长度) WD1-A6003-2-12A/B

1. The weld joint was not ground sufficiently after arc-gouging.
2. The arc starts and stops were not staggered to minimize slag entrapment.
3. Interpass cleaning was not performed properly.

1. Gouge off the defect weld;
2. Grind smoothly the gouged surface;
3. If User's request, check with MT or other NDT method to make sure the defect remove completely;
4. Preheat and the interpass temperature control according to the relative WPS-repair;
5. Check the welding according to the approved shop drawing.

1. 切割后的接头位置打磨要过渡, 保证每道焊缝的接头可以交错布置;
  2. 认真仔细检查每道焊缝和加强焊缝的清渣;
  3. 焊缝中所有的焊渣全部去除后, 表面的缺陷全部打磨干净.
1. The joint shall be ground to a smooth transition to ensure that arc starts and stops are in a staggered Arrangement.
  2. QC shall inspect the weld passes more carefully and enforcing interpass cleaning.
  3. All weld slag shall be removed and surface defects ground during interpass cleaning.
