Contract #: 04-0120F4Cty: SF/ALA Rte: 80 PM: 13.2/13.9File #: 69.25B**QUALITY ASSURANCE -- NON-CONFORMANCE REPORT****Location:** Changxing Island, Shanghai, P.R. China**Report No:** NCR-000471**Prime Contractor:** American Bridge/Fluor Enterprises, a JV**Date:** 07-Oct-2009**Submitting Contractor:** Zhenhua Port Machinery Company, Ltd (ZPMC), Changxing Island**NCR #:** ZPMC-0444**Type of problem:**

Reference Description: ZPMC performed weld repair without performing MT to ensure the excavation is free of defect.

Job Name: SAS Superstructure

Subject: NCR No. ZPMC-0444

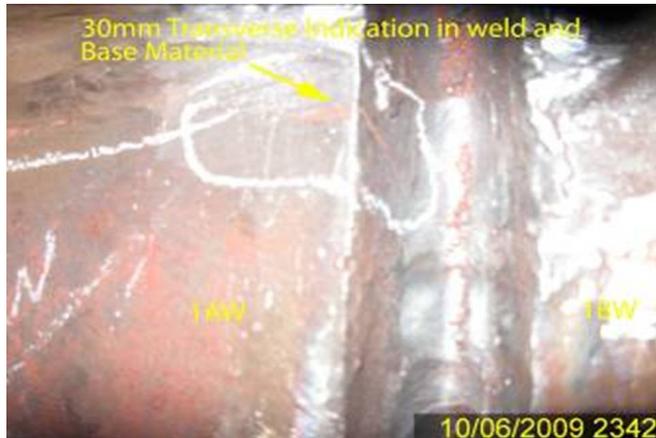
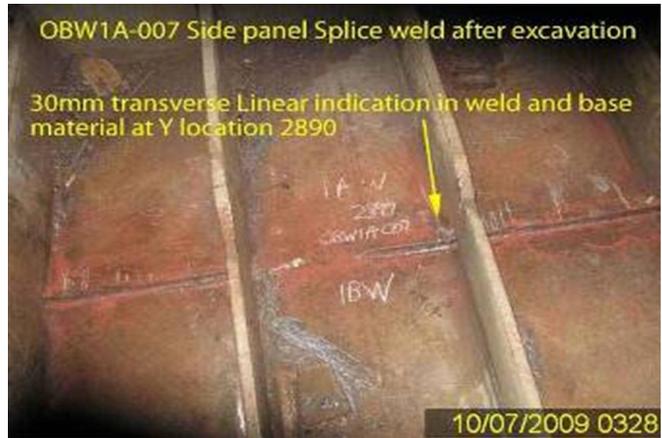
During a random visual observation of ZPMC personnel performing air carbon arc gouging of segment 1AW to 1BW Side Panel transverse splice weld OBW1A-007 at the Counterweight side, the Caltrans Quality Assurance (QA) inspector observed ZPMC was performing this repair utilizing the weld repair report (B-WR8086). This weld repair report did not describe any magnetic particle testing (MT) verifications in the excavation prior to re-welding nor after the completion of welding to ensure that the joint is free of defects. The QA Inspector had the opportunity to perform MT after air carbon arc gouging and observed numerous transverse cracks present ranging from 2 mm to 30 mm in length. No Critical Weld Repair Report was obtained for this weld repair.

The Y locations and the number of Transverse Cracks observed in weld # OBW1A-007:

- 1) Y=50~2475mm, (14) Transverse Cracks
- 2) Y=2720~5030mm, (29) Transverse Cracks

Note: Y location taken from Bottom Panel to Side Panel splice weld at the Counterweight side.

AWS D1.5-2002 Section 3.7.2.4 Crack in Weld or Base Metal; The extent of the crack shall be ascertained by the use of MT, PT, or other equally positive means; the metal shall be removed for the full length of the crack plus 50mm [2"] beyond the end of each crack and re-welded.

Submit a repair procedure to the engineer for approval. Include MT procedure using a competent MT technician.

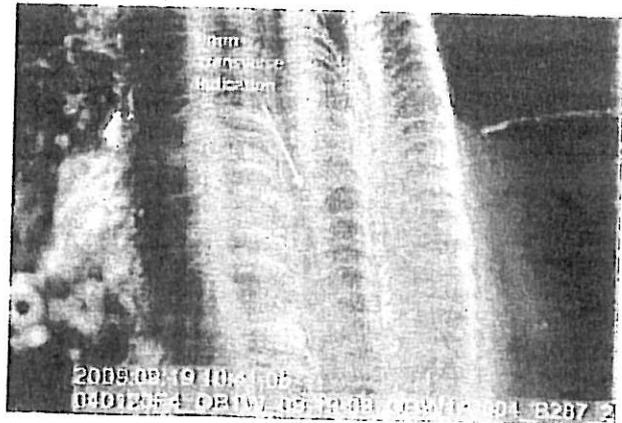
The Quality Assurance (QA) Inspector observed on Sept 18, 2009 and Sept 19, 2009 three (3) visual Transverse Linear Indications in the repair gouges of weld OBW1A-004 (1AAW to 1AW Side Panel Splice at the crossbeam side). The indications were located and documented at Y locations of 5842mm, 6165mm and 6520mm respectively. These visual Transverse Indications were measured from the weld of the Bottom Panel to Side Panel progressing toward the Edge Panel. Subsequently, ZPMC QC performed MT and confirmed that these are transverse indications. This weld joint had been previously tested and accepted by ZPMC QC NDT department.

AWS D1.5 (02) Section 6.26.1.1 "The weld shall have no cracks"

Propose a resolution for the identified recurring non-conformance which constitutes a systematic problem on both materials/workmanship and quality control issues with revised procedures to remedy the defected work and to prevent future occurrences. A response for the resolution of this issue is expected within 14 days.

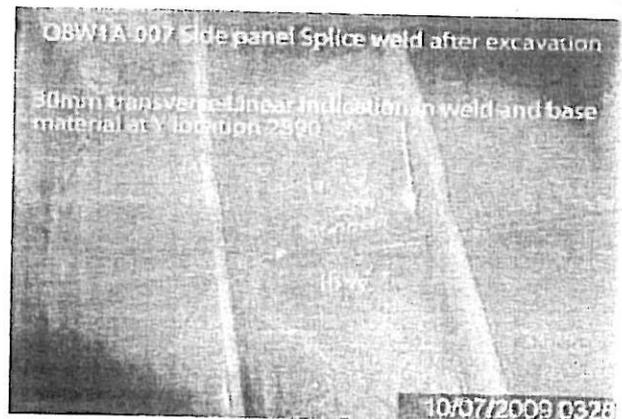
During a random visual observation of ZPMC personnel performing air carbon arc gouging of segment 1AW to 1BW Side Panel transverse splice weld OBW1A-007 at the Counterweight side, the Caltrans Quality Assurance (QA) inspector observed ZPMC was performing this repair utilizing the weld repair report (B-WR8086). This weld repair report did not describe any magnetic particle testing (MT) verifications in the excavation prior to re-welding nor after the completion of welding to ensure that the joint is free of defects. The QA Inspector had the opportunity to perform MT after air carbon arc gouging and observed numerous transverse cracks present ranging from 2 mm to 30 mm in length. No Critical Weld Repair Report was obtained for this weld repair.

The Y locations and the number of Transverse Cracks observed in weld # OBW1A-007:

- 1) Y=50~2475mm, (14) Transverse Cracks
- 2) Y=2720~5030mm, (29) Transverse Cracks

AWS D1.5-2002 Section 3.7.2.4 Crack in Weld or Base Metal; The extent of the crack shall be ascertained by the use of MT, PT, or other equally positive means; the metal shall be removed for the full length of the crack plus 50mm [2"] beyond the end of each crack and re-welded.
