Contract #: 04-0120F4Cty: SF/ALA Rte: 80 PM: 13.2/13.9File #: 69.25B**QUALITY ASSURANCE -- NON-CONFORMANCE REPORT****Location:** Changxing Island, Shanghai, P.R. China**Report No:** NCR-000473**Prime Contractor:** American Bridge/Fluor Enterprises, a JV**Date:** 08-Oct-2009**Submitting Contractor:** Zhenhua Port Machinery Company, Ltd (ZPMC), Changxing Island**NCR #:** ZPMC-0446**Type of problem:****Welding****Concrete****Other****Welding****Curing****Procedural****Bridge No:** 34-0006**Joint fit-up****Coating****Other****Component:** Floor Beam FB303-003-096**Procedural****Procedural****Description:****Reference Description:** Damage to the base metal at the top of a cope hole during weld repair.**Description of Non-Conformance:**

Job Name: SAS Superstructure

Reference Description: Damage to the base metal at the top of a cope hole during weld repair.

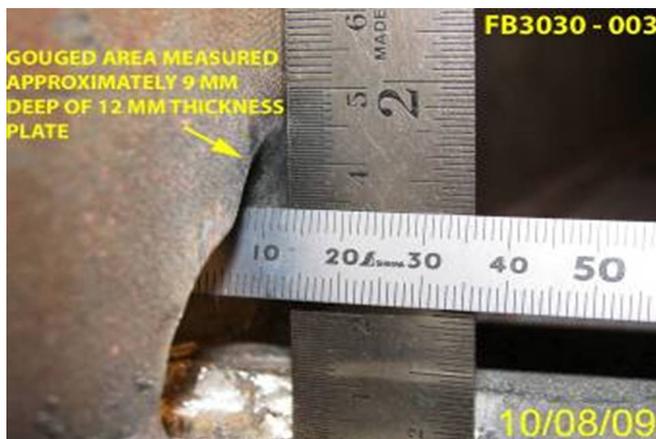
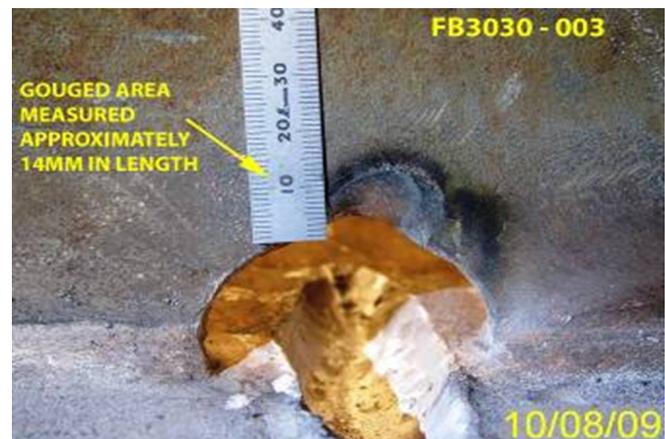
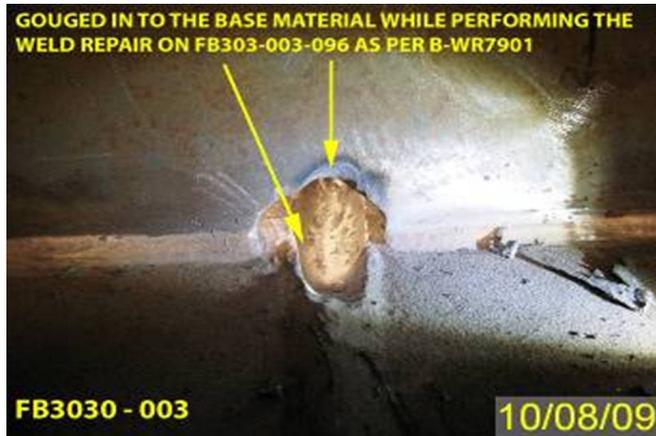
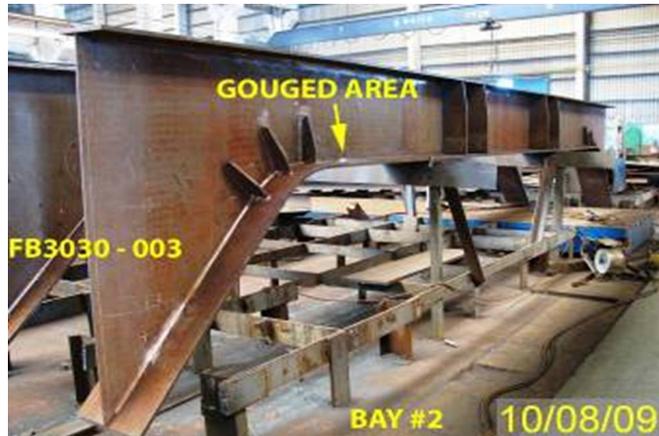
During a random visual inspection of Floor Beams located in BAY 2, the Caltrans Quality Assurance (QA) Inspector observed ZPMC performing a weld repair on Floor Beam FB303-003-096 (Lift 12E at PP 113, 114 and 115) as per weld repair report B-WR7901. During this repair process, it was observed that the welder gouged into the top of the cope hole area approximately 14mm in length and 9mm in deep. This created damage to the base metal at the top of the cope hole. The cope's radius and size is now deviated from the approved drawings.

AWS D1.5 2002 Section 3.3.2; "In all thermal cutting, the cutting flame shall be so adjusted and manipulated as to avoid cutting beyond (inside) the prescribed lines. Steel and weld metal may be thermally cut, provided a smooth and regular surface free from cracks and notches is secured, and provided that an accurate profile is secured by the use of mechanical guide."

AWS D1.5 2002 Section 3.7.4; "Prior approval of the Engineer shall be obtained for repairs to base metal, or for a revised design to compensate for deficiencies."

Submit a repair procedure to the engineer for approval.

Base metal damage was repaired and NDT was performed to verify the repair is in compliance with Contract specifications.
