DEPARTMENT OF TRANSPORTATION

Contract #: 04-0120F4Cty: SF/ALA Rte: 80 PM: 13.2/13.9File #: 69.25B**QUALITY ASSURANCE -- NON-CONFORMANCE REPORT****Location:** Changxing Island, Shanghai, P. R. China**Report No:** NCR-000474**Prime Contractor:** American Bridge/Fluor Enterprises, a JV**Date:** 09-Oct-2009**Submitting Contractor:** Zhenhua Port Machinery Company, Ltd (ZPMC), Changxing Island**NCR #:** ZPMC-0447**Type of problem:**

Reference Description: Missed MT Indications by QC on OBG Segment 1AW/1BW Transverse Splice**Description of Non-Conformance:**

QUALITY ASSURANCE -- NON-CONFORMANCE REPORT

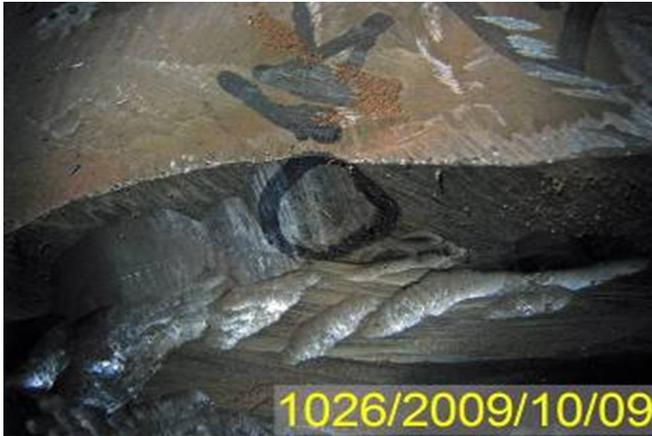
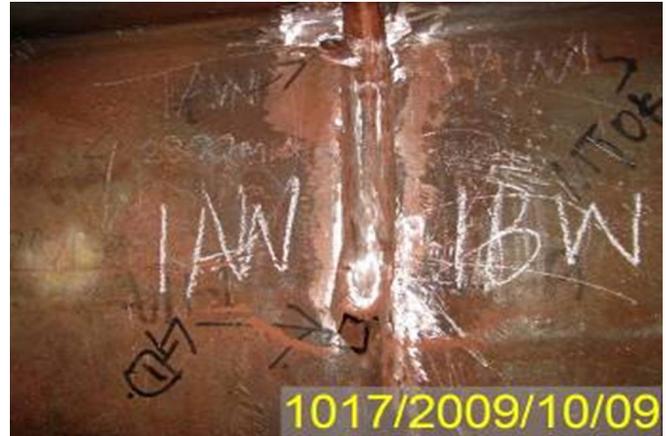
During a random visual inspection of repair work located at 1AW to 1BW side panel segment transverse splice weld OBW1A-007, the Caltrans Quality Assurance (QA) Inspector observed ZPMC workers performing repair excavations at two (2) separate areas along this weld splice. The QA Inspector performed Magnetic Particle testing (MT) at the excavated areas that had been previously tested and accepted by ZPMC MT technician. This QA inspector observed seven (7) Transverse Cracks present in the 2 excavation areas. The submitted critical weld repair procedure (CWR) for this location has not been approved by the Engineer prior to the repair work being started. The Y locations, length of excavated area and number of Transverse Cracks are as followed:

Transverse Weld Splice OBW1A-007

1. Y location 150mm, length of excavation 2,400mm, one (1) indication verified.
2. Y location 760~920mm, length of excavation 2,400mm, three (3) indications verified.
3. Y location 2,650mm, length of excavation 2,300mm, one (1) indication verified.
4. Y location 2,800mm, length of excavation 2,300mm, one (1) indication verified (in 1AW base metal).
5. Y location 3,400mm, length of excavation 2,300mm, one (1) indication verified.
6. Y location 4,600mm, length of excavation 2,300mm, one (1) indication verified.

Note: Measurements were pulled from the Bottom Plate to Side Plate weld joint at W3.

Submit a repair procedure for the approval of the engineer. Do not start weld repair until the CWR has been approved by the engineer. Missed MT indications have become a chronic problem. Provide training and tests to verify MT technician competency.

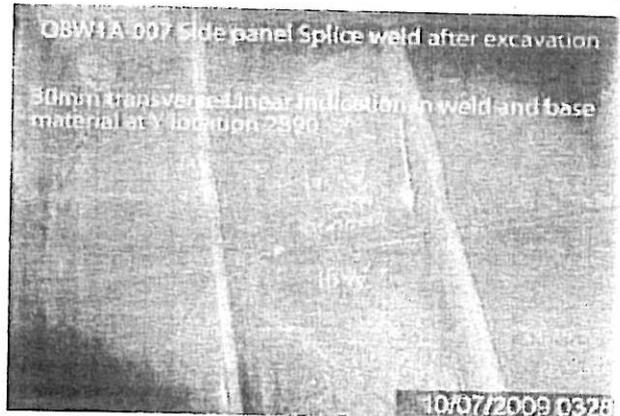
During a random visual observation of ZPMC personnel performing air carbon arc gouging of segment 1AW to 1BW Side Panel transverse splice weld OBW1A-007 at the Counterweight side, the Caltrans Quality Assurance (QA) inspector observed ZPMC was performing this repair utilizing the weld repair report (B-WR8086). This weld repair report did not describe any magnetic particle testing (MT) verifications in the excavation prior to re-welding nor after the completion of welding to ensure that the joint is free of defects. The QA Inspector had the opportunity to perform MT after air carbon arc gouging and observed numerous transverse cracks present ranging from 2 mm to 30 mm in length. No Critical Weld Repair Report was obtained for this weld repair.

The Y locations and the number of Transverse Cracks observed in weld # OBW1A-007:

- 1) Y=50~2475mm, (14) Transverse Cracks
- 2) Y=2720~5030mm, (29) Transverse Cracks
