Contract #: 04-0120F4
 Cty: SF/ALA Rte: 80 PM: 13.2/13.9
 File #: 69.25B

QUALITY ASSURANCE -- NON-CONFORMANCE REPORT

Report No: NCR-000476

Reference Description: Missed UT indications by QC on 1AAW/1AW Segment Transverse Splice

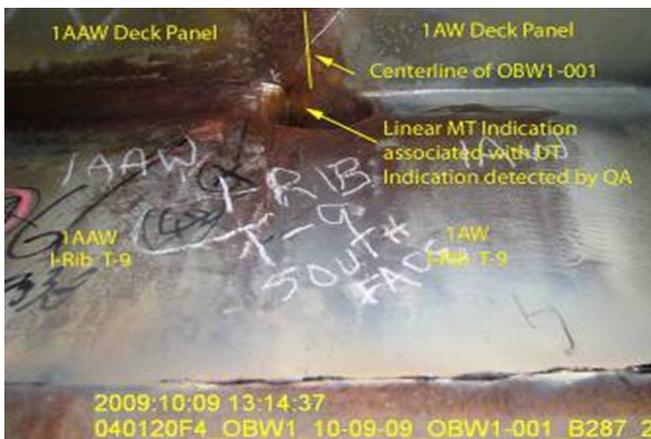
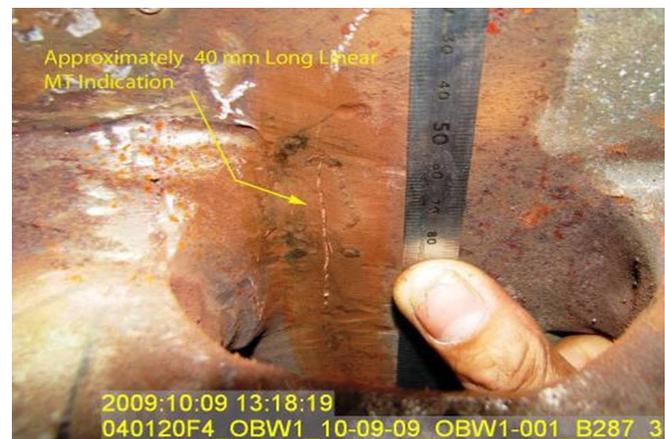
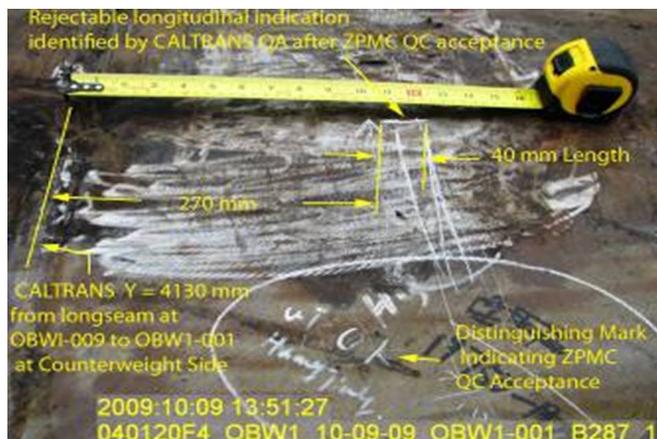
The QA inspector discovered one (1) class "A" rejectable Longitudinal Linear indication in the OBW1-001 (deck panel) weld. This weld was previously tested and accepted by the contractor. This acceptance by the contractor is evident by the presence of the contractor's distinguishing mark indicating QC acceptance. The QA inspector was also able to verify this UT longitudinal indication by magnetic particle (MT) testing from the interior side of the splice weld.

NOTE: The Y location of the Class "A" rejectable Longitudinal Linear Crack is at 5310-5340mm measured from Point W1, or 19750-19780mm if measured from W6. This indication is identified as #25 on ZPMC UT Report B787-UT-8548-1 associated with B-WR7867. The QA inspector verified a 40mm Magnetic Particle (MT) Linear Crack from the interior surface that is associated with Class "A" UT" Rejectable Indication mentioned above.

Submit a repair procedure to the engineer for approval.

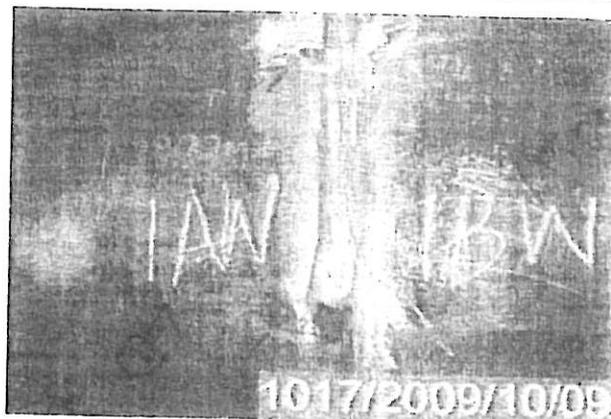
During a random visual inspection of repair work located at 1AW to 1BW side panel segment transverse splice weld OBW1A-007, the Caltrans Quality Assurance (QA) Inspector observed ZPMC workers performing repair excavations at two (2) separate areas along this weld splice. The QA Inspector performed Magnetic Particle testing (MT) at the excavated areas that had been previously tested and accepted by ZPMC MT technician. This QA inspector observed seven (7) Transverse Cracks present in the 2 excavation areas. The submitted critical weld repair procedure (CWR) for this location has not been approved by the Engineer prior to the repair work being started. The Y locations, length of excavated area and number of Transverse Cracks are as followed:

Submit a repair procedure for the approval of the engineer. Do not start weld repair until the CWR has been approved by the engineer. Missed MT indications have become a chronic problem. Provide training and tests to verify MT technician competency.

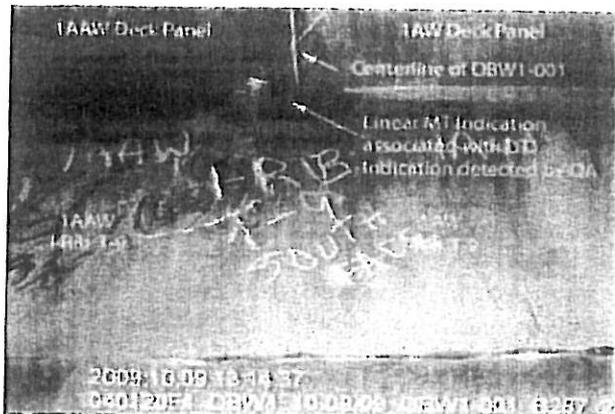
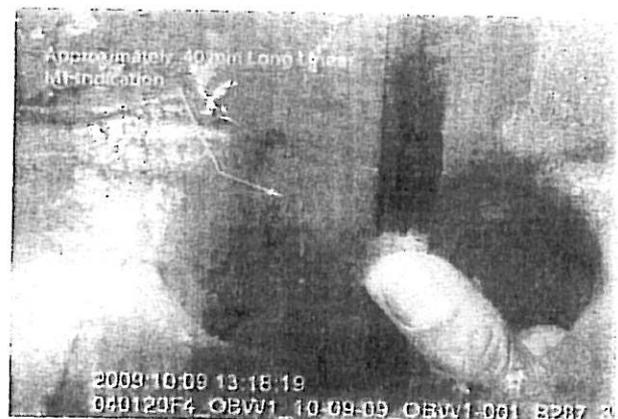
The QA inspector discovered one (1) class "A" rejectable Longitudinal Linear indication in the OBW1-001 (deck panel) weld. This weld was previously tested and accepted by the contractor. This acceptance by the contractor is evident by the presence of the contractor's distinguishing mark indicating QC acceptance. The QA inspector was also able to verify this UT longitudinal indication by magnetic particle (MT) testing from the interior side of the splice weld.

NOTE: The Y location of the Class "A" rejectable Longitudinal Linear Crack is at 5310-5340mm measured from Point W1, or 19750-19780mm if measured from W6. This indication is identified as #25 on ZPMC UT Report B787-UT-8548-1 associated with B-WR7867. The QA inspector verified a 40mm Magnetic Particle (MT) Linear Crack from the interior surface that is associated with Class "A" UT" Rejectable Indication mentioned above.

Submit a repair procedure to the engineer for approval.

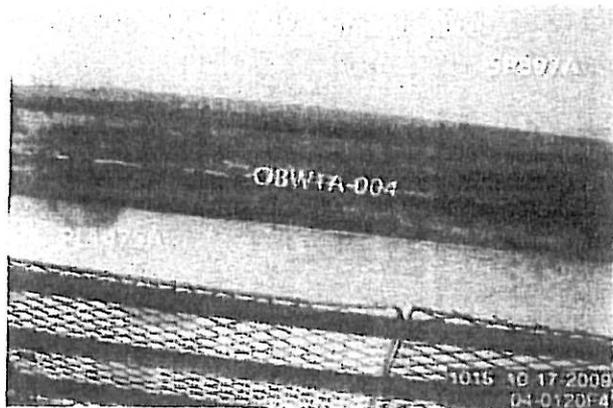
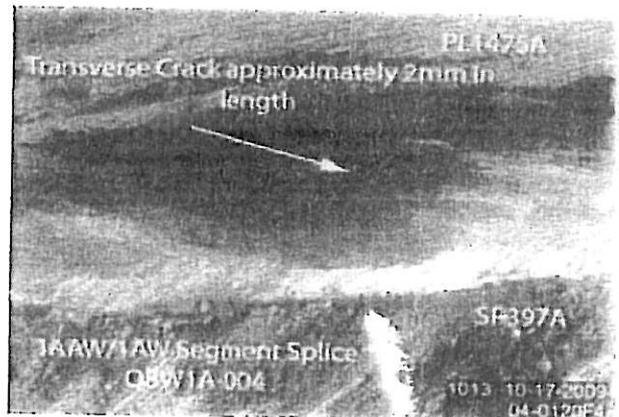
During random visual inspection the QA Inspector performed Magnetic Particle Testing (MT) of an Ultrasonic Testing (UT) reject excavation in the segment CJP Side Plate splice (OBW1A-004), cross beam side joining SP397A (1AW) and PL1475A (1AAW). During this verification the QA Inspector discovered three (3) Transverse Cracks in the excavation. One (1) 2 mm crack was located at Y location 1945mm and two (2) 1mm cracks at Y location 2785mm from the cross beam side Edge Plate.

Submit a repair procedure to the engineer for approval.
