**DEPARTMENT OF TRANSPORTATION**

Contract #: 04-0120F4Cty: SF/ALA Rte: 80 PM: 13.2/13.9File #: 69.25B**QUALITY ASSURANCE -- NON-CONFORMANCE REPORT****Location:** Changxing Island, Shanghai, P.R. China**Report No:** NCR-000479**Prime Contractor:** American Bridge/Fluor Enterprises, a JV**Date:** 15-Oct-2009**Submitting Contractor:** Zhenhua Port Machinery Company, Ltd (ZPMC), Changxing Island**NCR #:** ZPMC-0452**Type of problem:****Welding****Concrete****Other****Welding****Curing****Procedural****Bridge No:** 34-0006**Joint fit-up****Coating****Other****Component:** 5AE Bike Path Cantilever Brackets BK1 @ PP29**Procedural****Procedural****Description:** Visual Cracks on Bike Path Cantilever Brackets**Reference Description:** Visual Cracks found on fillet welds of Bike Path Cantilever Brackets on 5AE PP29**Description of Non-Conformance:**

**Job Name:** SAS Superstructure

**Reference Description:** Visual Cracks found on fillet welds of Bike Path Cantilever Brackets on 5AE PP29

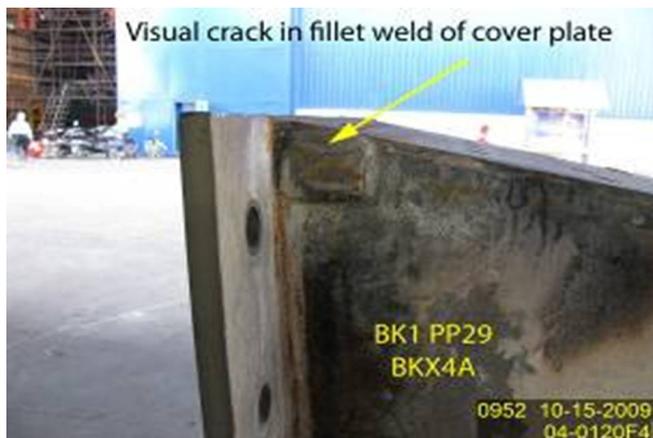
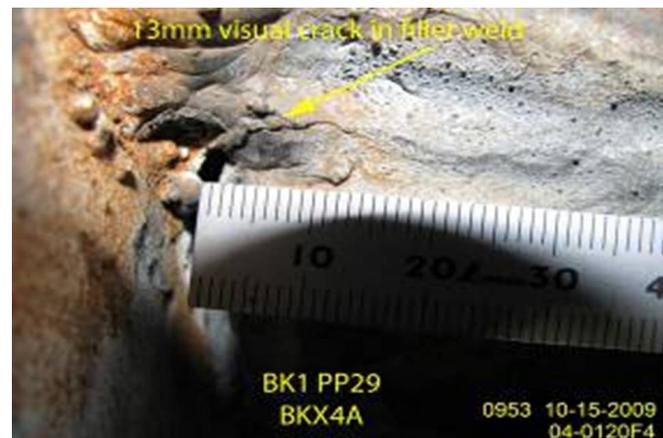
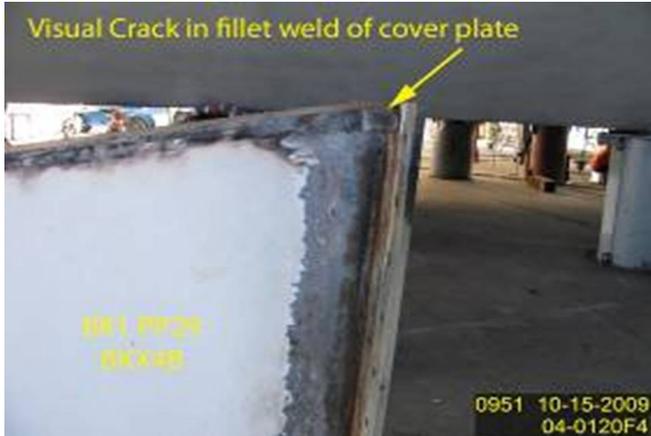
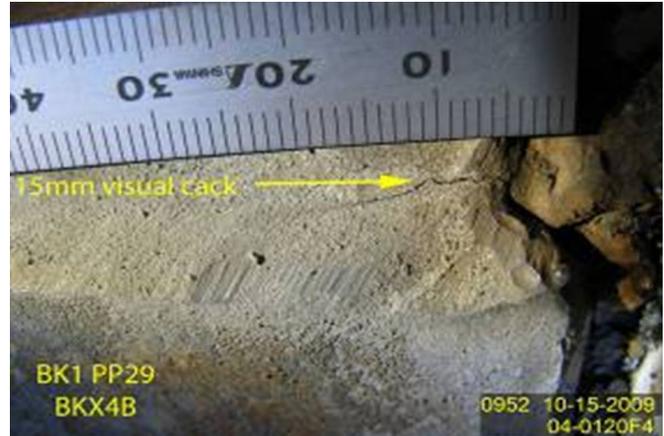
During a random visual inspection of OBG Segment 5AE Bike Path Cantilever Brackets (BK1), Caltrans Quality Assurance (QA) Inspector discovered visual cracks in the fillet welds on the top cope hole cover plates BKX4A and BKX4B at panel point 29. The visual crack observed on BKX4A measured 13mm in length and 15mm in length on BKX4B.

AWS D1.5-2002 Section 6.26.1.1; The weld shall have no cracks.

Submit a repair procedure to the engineer for approval.

Repair said indications and perform NDT required to verify weld quality

The Department issued NCR ZPMC-466 in regards to ZPMC personnel performing repairs without prior approval of the Engineer. Contractor submitted NDT report verifying the welds are now in conformance with Contract specifications.
