Contract #: 04-0120F4
 Cty: SF/ALA Rte: 80 PM: 13.2/13.9
 File #: 69.25B

QUALITY ASSURANCE -- NON-CONFORMANCE REPORT

Report No: NCR-000480

Reference Description: Distortion of an upper flange of Floor Beam member at PP43 after weld repair

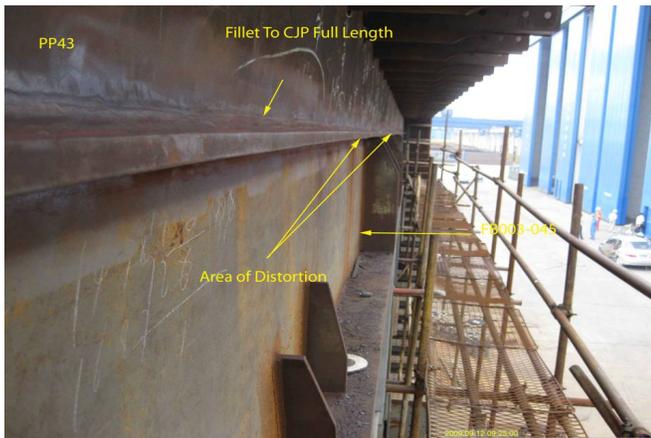
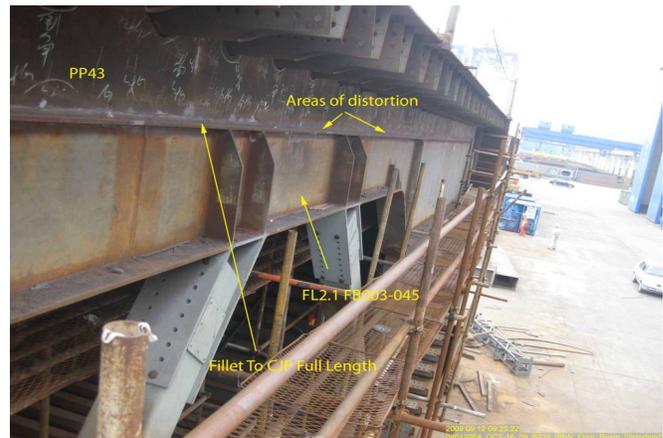
During random visual inspection of OBG Segment 6BW at panel point 43, Caltrans Quality Assurance (QA) Inspector observed that the FL2-1 Floor Beam designated as FB003-045 was distorted on the upper flange plate X6F after the weld repair at the adjacent weld joint. The adjacent deck panel diaphragm weld that connects to this upper flange plate was changed from a fillet weld to a complete joint penetration (CJP) weld due to fit up issues. The maximum distortion at this upper flange X6F measured 12mm.

Submit a repair procedure to the engineer for approval.

Reference Resolution: ZPMC has corrected the distortion noted in the NCR by heat straightening. Attached is the heat straightening report used.

Contractor performed heat straightening at said location and the flange is now in conformance with Contract specifications.

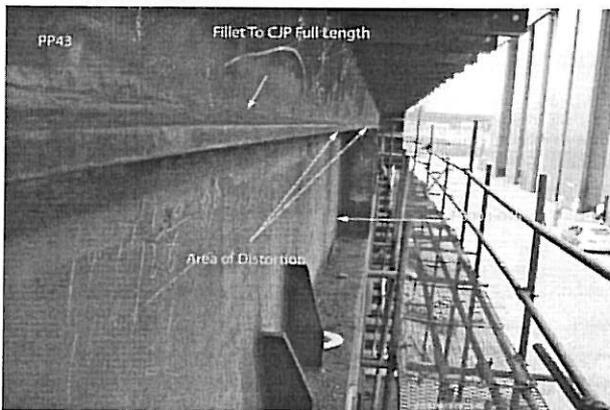
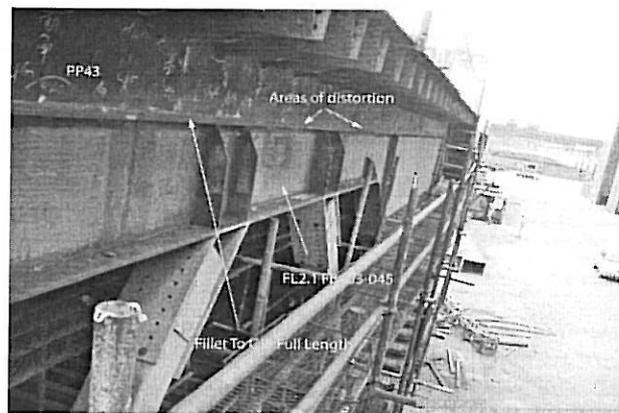
Reference Description: Distortion of an upper flange of Floor Beam member at PP43 after weld repair

During random visual inspection of OBG Segment 6BW at panel point 43, Caltrans Quality Assurance (QA) Inspector observed that the FL2-1 Floor Beam designated as FB003-045 was distorted on the upper flange plate X6F after the weld repair at the adjacent weld joint. The adjacent deck panel diaphragm weld that connects to this upper flange plate was changed from a fillet weld to a complete joint penetration (CJP) weld due to fit up issues. The maximum distortion at this upper flange X6F measured 12mm.

Submit a repair procedure to the engineer for approval.

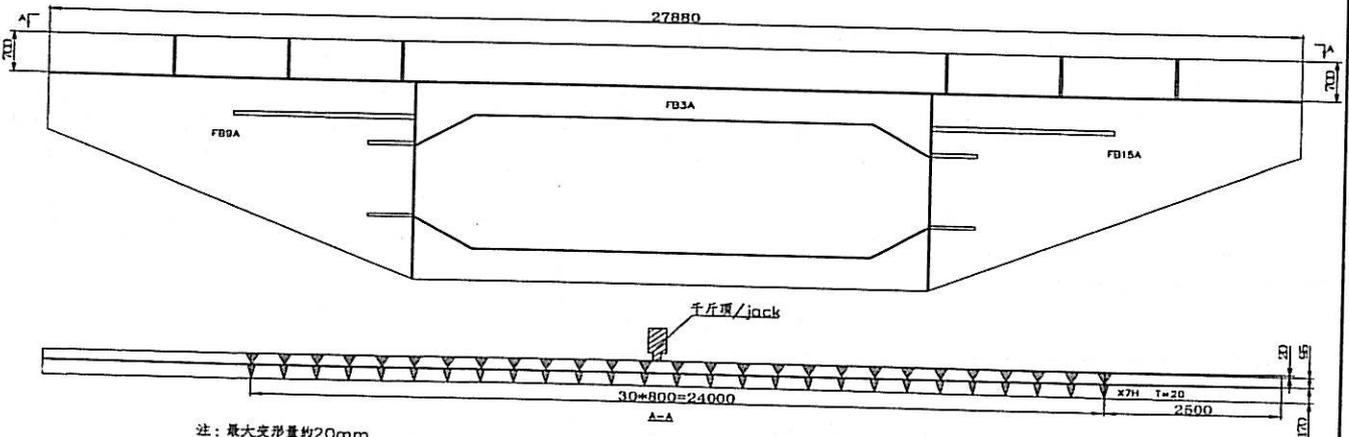
简图 Sketch

Welding distortion 焊接变形

注: 最大变形量约20mm
NOTE: the max deformation is about 20mm

After finishing heat straightening, the weld of the heat area shall perform NDT according to the approved shop drawing 校火后, 根据图纸要求对热影响区域进行 NDT 检测。

Control current, voltage and weld speed according to relevant WPS. If necessary anti-deformation or hold down device can be added. 依据相应的 WPS 的要求控制电流, 电压和焊接速度。如有必要, 可使用反变形设施进行校正。
