Contract #: 04-0120F4Cty: SF/ALA Rte: 80 PM: 13.2/13.9File #: 69.25B**QUALITY ASSURANCE -- NON-CONFORMANCE REPORT****Location:** Changxing Island, Shanghai, P. R. China**Report No:** NCR-000481**Prime Contractor:** American Bridge/Fluor Enterprises, a JV**Date:** 16-Oct-2009**Submitting Contractor:** Zhenhua Port Machinery Company, Ltd (ZPMC), Changxing Island**NCR #:** ZPMC-0454**Type of problem:**

| <b>Reference Description:</b> Heat Straightening without Engineer's Approval on Seg 6BW Upper Flange of FB003-045 | | | |

**Job Name:** SAS Superstructure

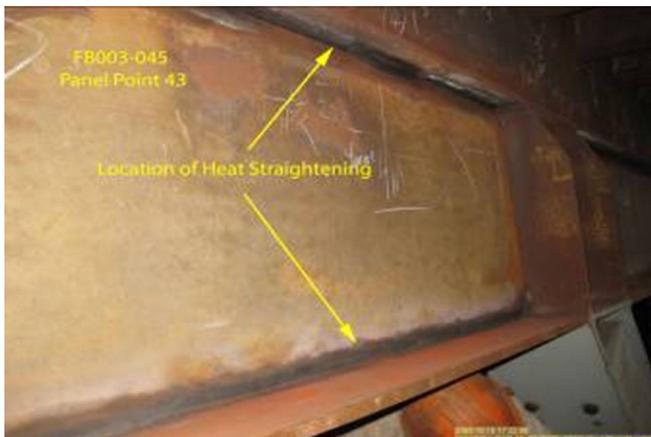
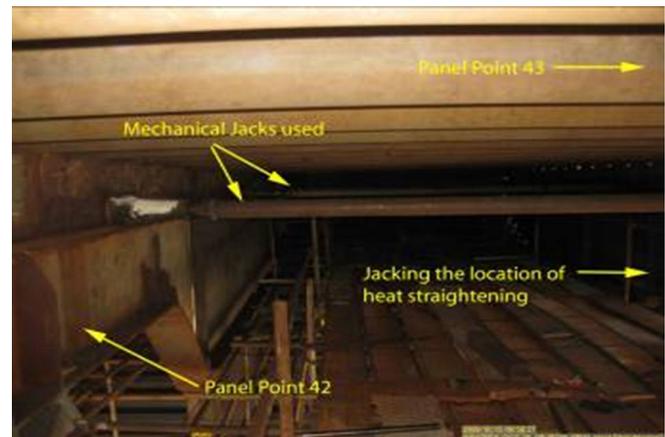
During random visual inspection of OBG Segment 6BW at panel point 43. The Caltrans Quality Assurance (QA) Inspector observed that contractor was Heat Straightening the FL2-1 floor beam FB003-045 of the upper flange X6F at panel point 43 by the use of a mechanical jack without the approval of the Engineer. The maximum distortion measurements that were taken at this upper flange is 12mm prior to the Heat Straightening and mechanical jacking.

AWS D1.5/2002 Section 3.7.3; Members distorted by welding shall be heat straightened by mechanical means or by carefully supervised application of a limited amount of localized heat as approved by the engineer.

Contract Special Provisions 8-3.01 "For material more than 16mm, the Contractor shall not notified immediately when weld distortion occurs that cannot be corrected using the standard procedures for heat straightening submitted in the WQCP."

Submit HSR to the engineer.

- The upper flange of FB003-045 is NON SPCM material. The heat straightening was performed according to HSR1(B)-7745. According to WQCP Section 11.1.5: As approved by this procedure mechanical means may be used to achieve the required flatness. For this case, with the approved HSR1(B), this heat straightening won't be required the approval of Engineer.
- MT was performed after heat straightening to warrant the affected welds' quality.

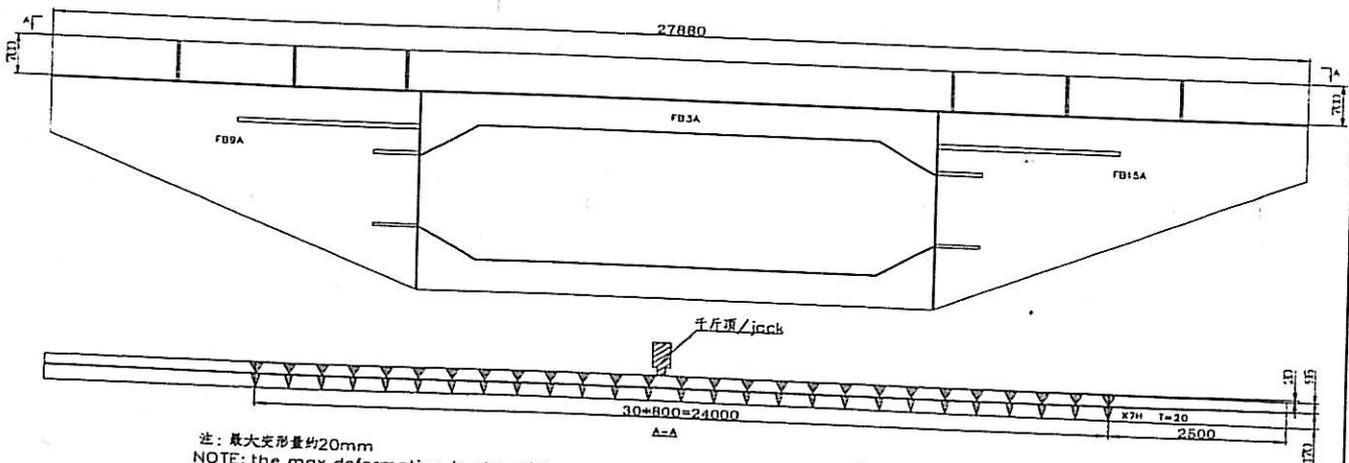
### 简图 Sketch

Cause 原因: Welding distortion 焊接变形

Type of Defect 缺陷类型: Welding distortion 焊接变形

后续 NDE (Post-Removal NDE): After finishing heat straightening, the weld of the heat area shall perform NDT according to the approved shop drawing 校火后, 根据图纸要求对热影响区域进行 NDT 检测。

纠正措施 (Corrective Action(s)): Control current, voltage and weld speed according to relevant WPS. If necessary anti-deformation or hold down device can be added. 依据相应的 WPS 的要求控制电流, 电压和焊接速度。如有必要, 可使用反变形设施进行校正。
