Contract #: 04-0120F4Cty: SF/ALA Rte: 80 PM: 13.2/13.9File #: 69.25B**QUALITY ASSURANCE -- NON-CONFORMANCE REPORT****Location:** Changxing Island, Shanghai, P. R. China**Report No:** NCR-000482**Prime Contractor:** American Bridge/Fluor Enterprises, a JV**Date:** 17-Oct-2009**Submitting Contractor:** Zhenhua Port Machinery Company, Ltd (ZPMC), Changxing Island**NCR #:** ZPMC-0455**Type of problem:**

Welding	Concrete	Other	
Welding	Curing	Procedural	Bridge No: 34-0006
Joint fit-up	Coating	Other	Component: 6AW Deck Panel
Procedural	Procedural	Description:	Unapproved base metal repair for distortion

Reference Description: Distortion near the 6AW deck panel splice weld was repaired by unapproved base metal repair

Job Name: SAS Superstructure

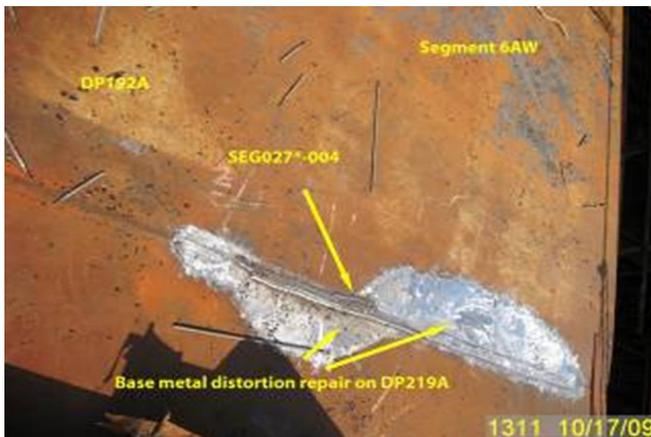
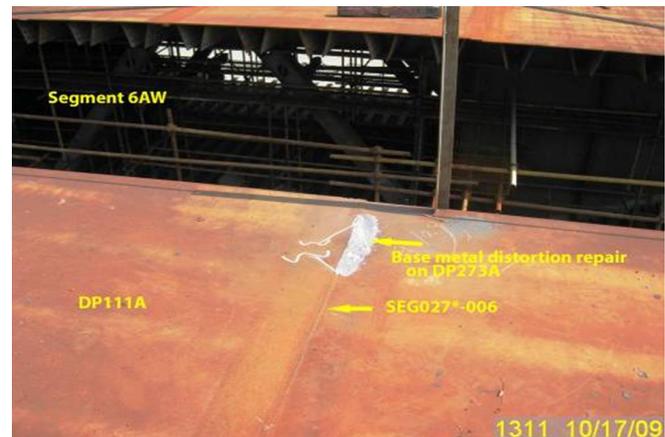
The Quality Assurance (QA) Inspector observed that the distortion of the 6AW deck panels (DP273, DP192, DP219) near the splice weld was repaired by ZPMC performing base metal repair on the deck surface. The Deck Plate splice weld numbers were identified as SEG027*-006, 004. ZPMC was observed depositing SMAW filler material in repair areas approximately 250mm x 100mm. This base metal repair was performed without the approval of the Engineer.

AWS D1.5-2002 Section 3.7.4; Prior approval of the Engineer shall be obtained for repairs to base metal, or for a revised design to compensate for deficiencies.

Standard Specifications (99) section 55-3.02 Straightening of Material; "If straightening is necessary, it shall be done by methods acceptable to the Engineer. Details for methods proposed for straightening shall be submitted in writing to the Engineer prior to their use.

Submit a repair procedure for approval of the engineer.

Contractor submitted a WRR documenting the procedure and locations along with NDT documentation verifying the welds are in conformance with Contract specifications. ZPMC also issued an internal NCR regarding the issue.

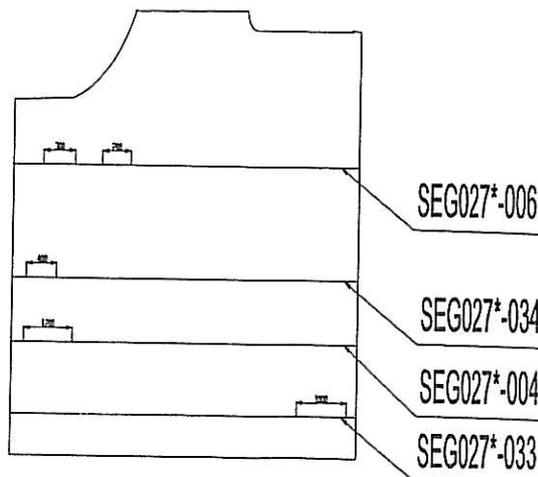
焊缝返修位置示意图:

Two side at deck plate butt weld, the base metal gouged, maximum 4mm in depth, 100mm in wide, total 5 position, the detail position sees following draft.

Worker operated error caused base metal gouged.

1. 按照焊接返修工艺规程 (WPS) 打磨缺陷区域;
 2. 对该区域作100%MT检查, 确保缺陷全部去除;
 3. 根据批准的焊接返修工艺规程 (WPS) 进行预热及焊接;
 4. 将焊接区域打磨至与母材平齐;
 5. 对修补区域进行VT和MT检测,检测范围为返修区域以及返修两端各延长50mm;
-
1. Remove all the defects according to the approved repair WPS by means of grinding.
 2. Verify with MT and VT no defects remain in the repair area prior to weld;
 3. Preheat and weld according to the relevant WPS.
 4. Grind the weld flush with base metal after welding.
 5. Perform VT and MT inspection of the repaired area along with an additional 50mm at each end of the weld repair.

Train and educate operator to improve operation skill.
