Contract #: 04-0120F4Cty: SF/ALA Rte: 80 PM: 13.2/13.9File #: 69.25B**QUALITY ASSURANCE -- NON-CONFORMANCE REPORT****Location:** Changxing Island, Shanghai, P. R. China**Report No:** NCR-000488**Prime Contractor:** American Bridge/Fluor Enterprises, a JV**Date:** 22-Oct-2009**Submitting Contractor:** Zhenhua Port Machinery Company, Ltd (ZPMC), Changxing Island**NCR #:** ZPMC-0461**Type of problem:****Welding****Concrete****Other****Welding****Curing****Procedural****Bridge No:** 34-0006**Joint fit-up****Coating****Other****Component:** Crossbeam CB13 Side Panel**Procedural****Procedural****Description:****Reference Description:** No preheat on CB13 SPCM material prior to tack welding temporary fixtures**Description of Non-Conformance:**

To:	AMERICAN BRIDGE/FLUOR, A JV 375 BURMA ROAD OAKLAND CA 95607	Date:	02-Dec-2009
Dear:	Mr. Charles Kanapicki	Contract No:	04-0120F4 04-SF-80-13.2 / 13.9
Attention:	Mr. Thomas Nilsson Project/Fabrication Manager	Job Name:	SAS Superstructure
Subject:	NCR No. ZPMC-0461	Document No:	05.03.06-000451

Reference Description: No preheat on CB13 SPCM material prior to tack welding temporary fixtures

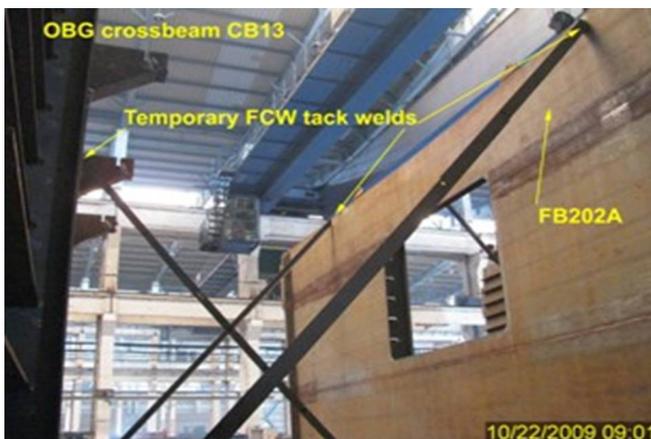
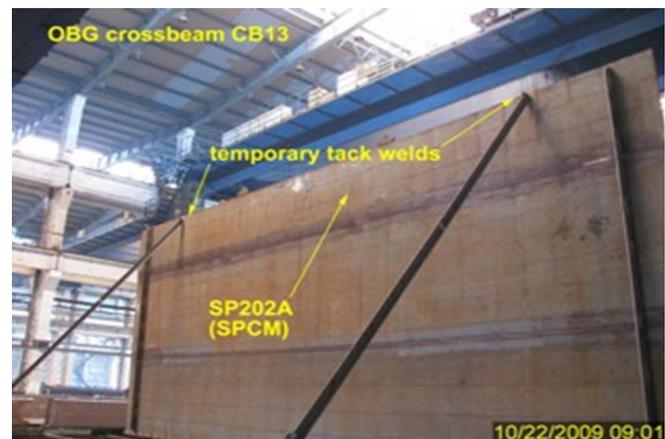
The Quality Assurance Inspector (QA) observed the contractors welding personnel tack weld a temporary fixture to the SPCM portion of the east Side Panel of Crossbeam CB13. The SPCM material is identified as SP202A. The QA inspector observed the worker did not preheat the material prior to tack welding and no approved welding procedure specification (WPS) was available for review. Prior to the QA inspector arrival, it was noted that the contractor has previously tack welded three (3) temporary fixtures, each on SPCM panels identified as SP205A and FB202A.

AWS D1.5 2002 section 12, table 12.2: tack weld requirements

AWS D1.5 2002 section 12, table 12.3: minimum preheat and interpass temperatures

Submit a repair procedure to the engineer that include correct preheat.

Contractor submitted MT report verifying the plates in question are in conformance with Contract specifications after temporary attachments were removed.

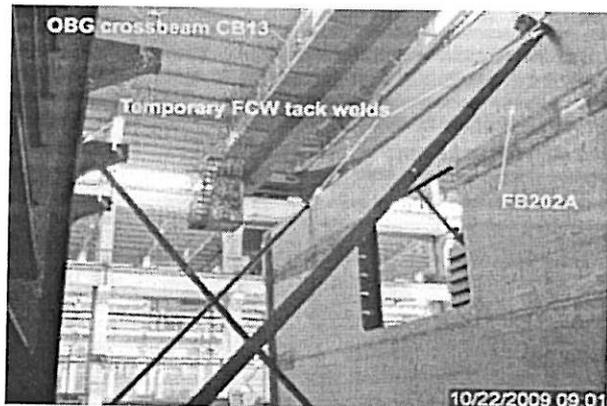
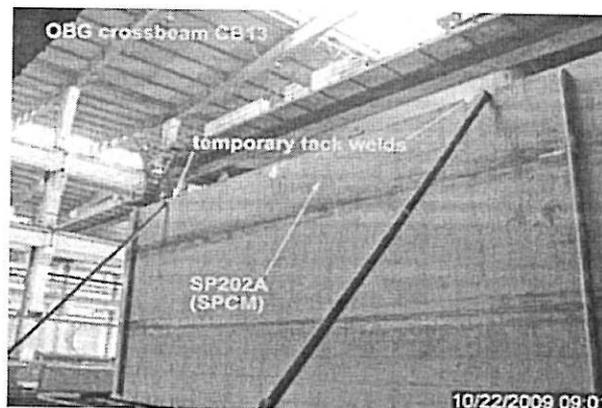
The Quality Assurance Inspector (QA) observed the contractors welding personnel tack weld a temporary fixture to the SPCM portion of the east Side Panel of Crossbeam CB13. The SPCM material is identified as SP202A. The QA inspector observed the worker did not preheat the material prior to tack welding and no approved welding procedure specification (WPS) was available for review. Prior to the QA inspector arrival, it was noted that the contractor has previously tack welded three (3) temporary fixtures, each on SPCM panels identified as SP205A and FB202A.

AWS D1.5 2002 section 12, table 12.2: tack weld requirements

AWS D1.5 2002 section 12, table 12.3: minimum preheat and interpass temperatures

Submit a repair procedure to the engineer that include correct preheat.
