Contract #: 04-0120F4Cty: SF/ALA Rte: 80 PM: 13.2/13.9File #: 69.25B**QUALITY ASSURANCE -- NON-CONFORMANCE REPORT****Location:** Changxing Island, Shanghai, P.R. China**Report No:** NCR-000492**Prime Contractor:** American Bridge/Fluor Enterprises, a JV**Date:** 17-Oct-2009**Submitting Contractor:** Zhenhua Port Machinery Company, Ltd (ZPMC), Changxing Island**NCR #:** ZPMC-0465**Type of problem:**

Reference Description: Blasting and Painting of OBG Segment 6CE prior to obtaining the "QA Approval Form"

QUALITY ASSURANCE -- NON-CONFORMANCE REPORT

Job Name: SAS Superstructure

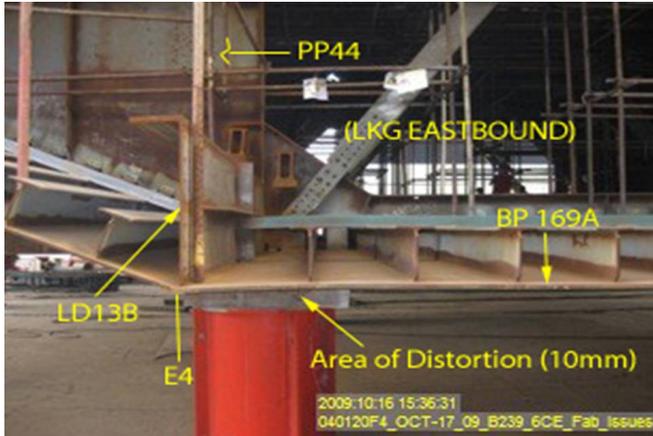
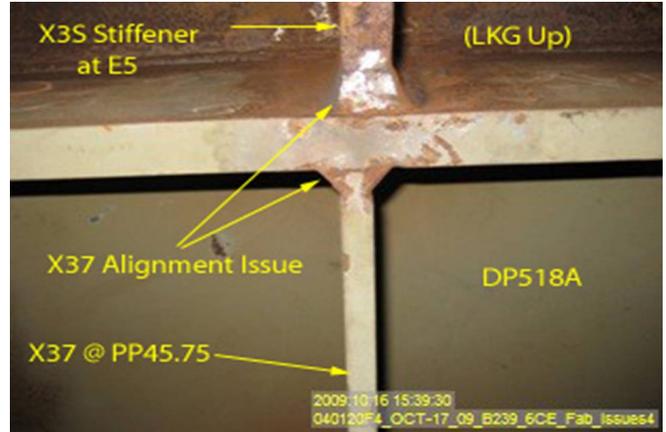
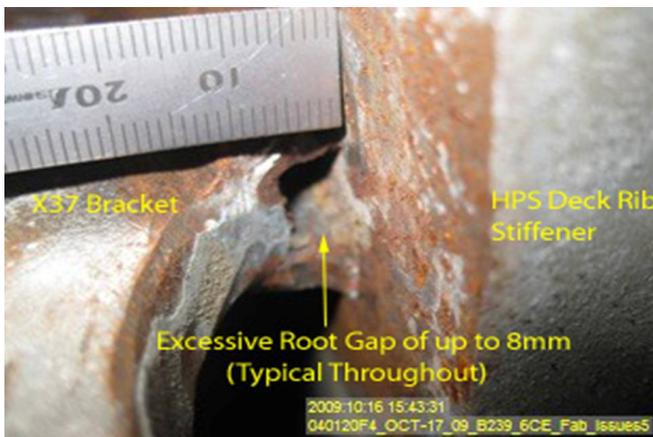
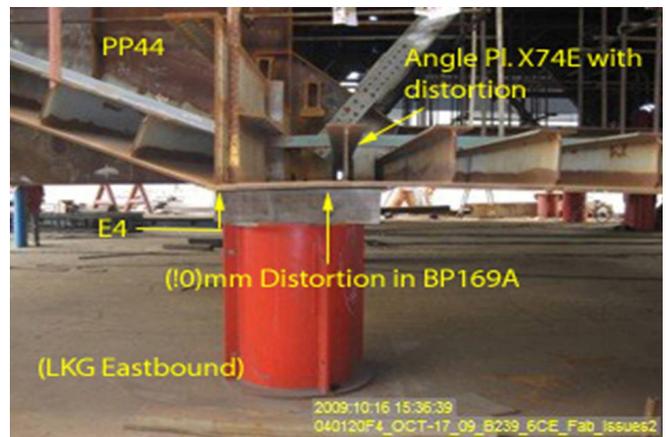
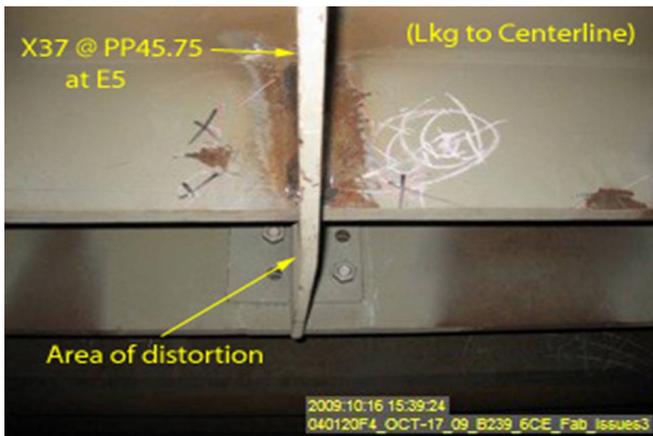
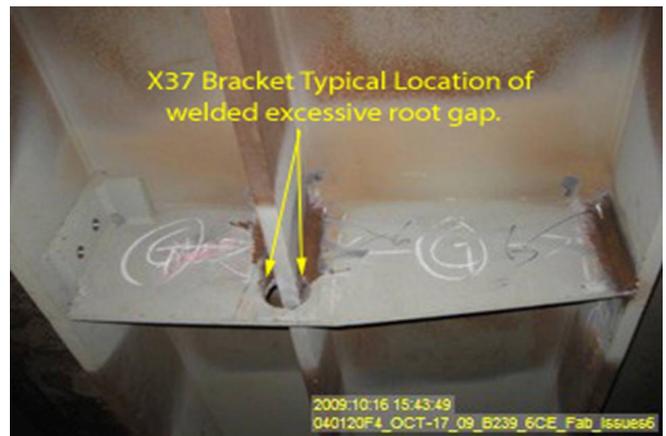
The Caltrans Quality Assurance (QA) Inspector arrived onsite at the ZPMC fabrication facility at 0700 on October 17th, 2009 and observed that the OBG segment 6CE had been moved to the shop for blasting and painting the previous night prior to the completion of the following fabrication and obtaining the "QA Approval Form" per CCO77.

1. Bottom Panel BP169A and the transverse angle X74E were found with distortion measured up to 10mm at the storage block location for panel point 43.5 at work point E4.
2. The transverse X37 Deck Brackets in this segment require a fillet weld per approved drawings with the maximum root opening not to exceed 5mm as allowed by AWS D1.5/2002 Section 3.3.1. The termination of these fillet welds at the following locations show a root gap greater than that allowed by the code:
 - X37 Brackets at Location E2 at the following panel points: 43.25, 43.75, 44.25, 44.75, 45.25, 45.75, 46.25, and 46.75.
 - X37 Brackets at Location E5 at the following panel points: 45.25, 45.75, 46.25, and 46.75.
3. The transverse X37 Deck Bracket at panel point 45.75 at location E5 is distorted and misaligned with the adjacent X3S Deck Stiffener.

1. Special Provisions Section 10-1.59 Shop Welding, Dimensional Tolerances- Component walls of box girder shall be straight within 1:1000, measured in the direction of the axis of the girder or crossbeam, where the girder axis is defined to be in the longitudinal direction of the bridge and the crossbeam axis is defined to be along the transverse axis of the bridge.

2. AWS D1.5/2002 Section 3.3.1- "The parts to be joined by fillet welds shall be brought into as close contact as practicable. The root opening shall not exceed 5 mm [3/16 in.] except in cases involving either shapes or

Submit a repair procedure to the engineer for approval. Obtain QA Approval Form.

Part 1. The Bottom Plate BP169A is assisting with the bottom transverse splice weld. The bottom splice weld has been finished and is now acceptable.

Part 2. All the X37s where the root opening exceed 5mm have been removed from CA and the free edges were built up to ensure the root opening to be satisfied.

Part 3. ZPMC has adjusted the misalignment of X3S at PP45.75.

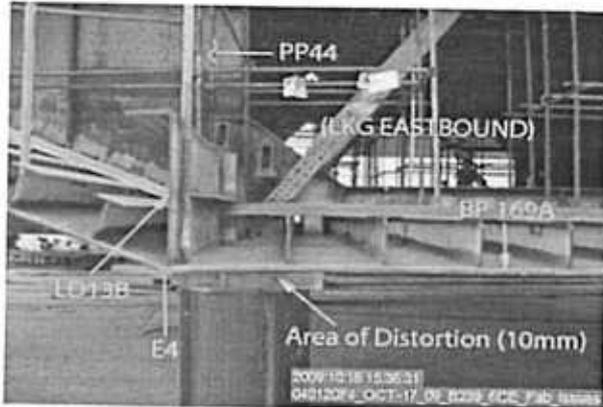
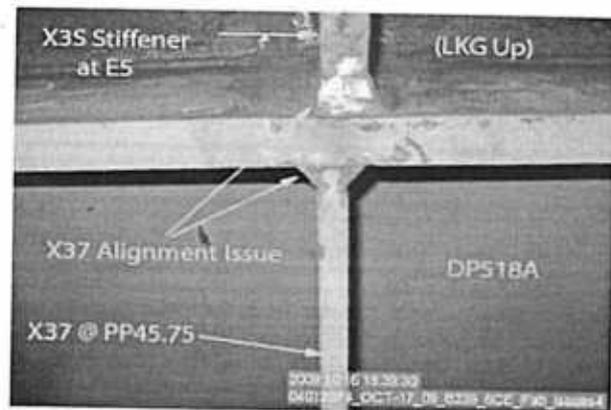
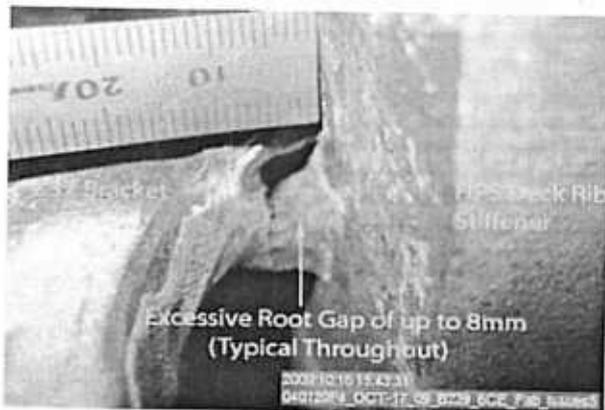
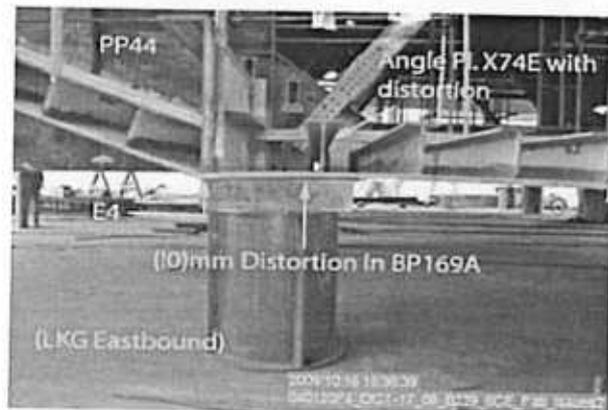
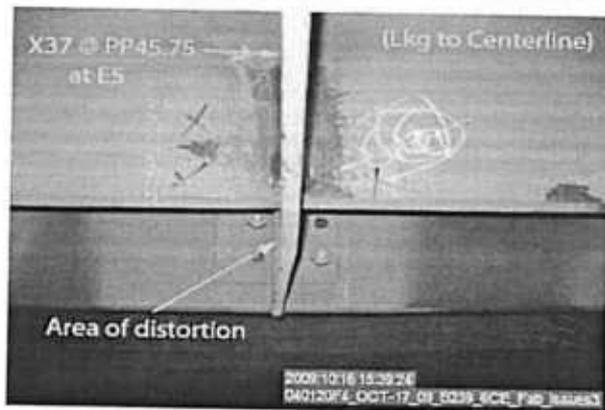
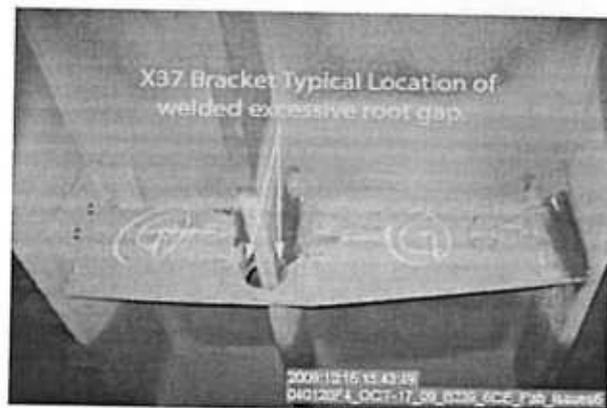
The Caltrans Quality Assurance (QA) Inspector arrived onsite at the ZPMC fabrication facility at 0700 on October 17th, 2009 and observed that the OBG segment 6CE had been moved to the shop for blasting and painting the previous night prior to the completion of the following fabrication and obtaining the "QA Approval Form" per CCO77.

1. Bottom Panel BP169A and the transverse angle X74E were found with distortion measured up to 10mm at the storage block location for panel point 43.5 at work point E4.
2. The transverse X37 Deck Brackets in this segment require a fillet weld per approved drawings with the maximum root opening not to exceed 5mm as allowed by AWS D1.5/2002 Section 3.3.1. The termination of these fillet welds at the following locations show a root gap greater than that allowed by the code:
 - X37 Brackets at Location E2 at the following panel points: 43.25, 43.75, 44.25, 44.75, 45.25, 45.75, 46.25, and 46.75.
 - X37 Brackets at Location E5 at the following panel points: 45.25, 45.75, 46.25, and 46.75.
3. The transverse X37 Deck Bracket at panel point 45.75 at location E5 is distorted and misaligned with the adjacent X3S Deck Stiffener.

Submit a repair procedure to the engineer for approval. Obtain QA Approval Form.

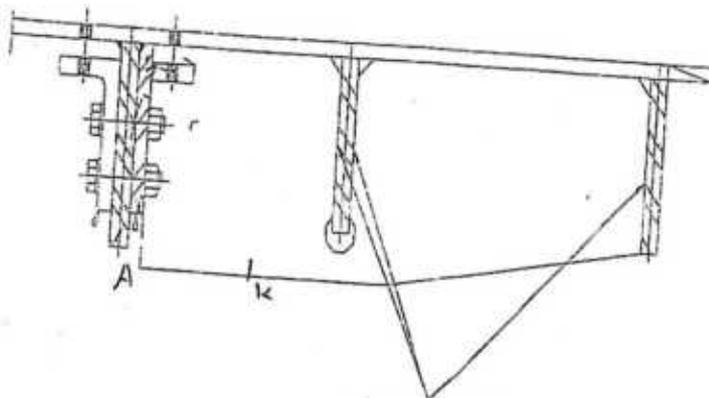
由于X37A与顶板I肋螺栓连接处的贴合面存在较大间隙，需去除部分焊缝，调整间隙，共15处。
The gap was exceeded requirement at X37A and deck plate I-rib bolt connect, and need to remove weld to adjusted gap, total 15 positions.

Weld distortion and fabricated error.

1. Remove the welds mentioned above by the way of cutting or gouging. Preheat according to the WPS prior to gouging.
2. Adjust item X37K after removing welds, if gap between I-Rib and item X37K exceed allowance, weld the item X37K before reassembling it.
3. Grind the edge of the repair area cleanly;
4. Prepare an right joint according to the approved WPS;
5. Perform 100%VT and 100%MT to the repair area to make sure no defects exist;
6. Preheat and weld according to the relevant WPS;
7. Grind the welds to flush with the adjacent base metal;
8. Perform relevant NDT inspection to the repair welds according to the working drawings.
