Contract #: 04-0120F4  
 Cty: SF/ALA Rte: 80 PM: 13.2/13.9  
 File #: 69.25B

## QUALITY ASSURANCE -- NON-CONFORMANCE REPORT

**Report No:** NCR-000494

**Reference Description:** Missed UT indication on Tower Strut WD1-A305-65M

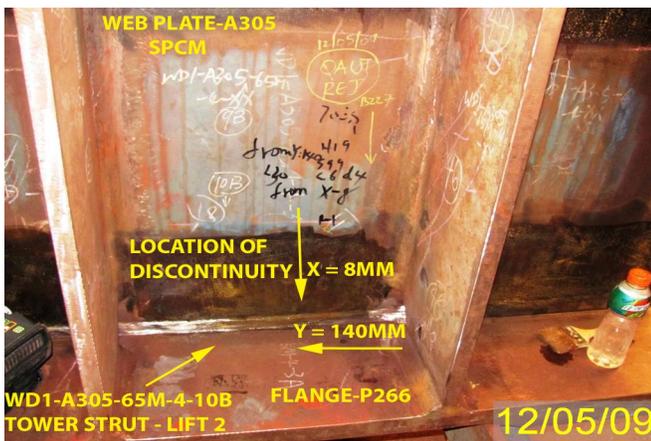
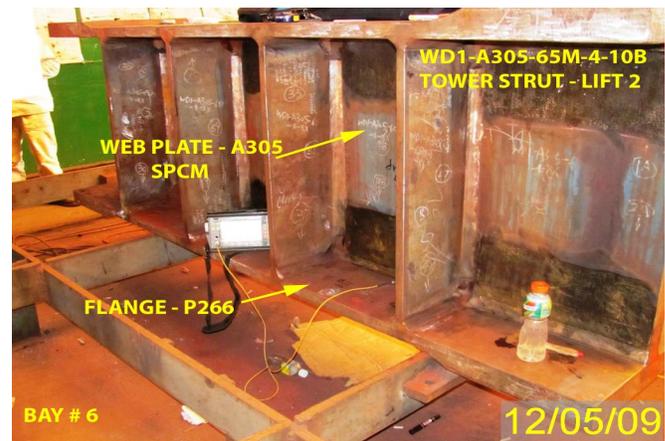
During Ultrasonic Testing (UT) of Strut Web to Flange CJP weld joint WD1-A305-65M-4-10B, QA discovered one (1) Class "A" longitudinal indication, with an indication rating of +6, measuring approximately 30 mm in length. The plate thickness at the location of the indication is 28 mm. This weld was previously tested and accepted by ZPMC QC UT technicians.

AWS D1.5-2002, Section 6, Table 6.3 specifies for material thicknesses of 20mm through 38mm, a decibel (db) indication rating of 8 db or less shall be categorized as Class A (large flaws) and any indication in this category shall be rejected (regardless of length).

Propose a resolution for the identified non-conformance that addresses the failure of Quality Control to identify the linear indications(UT). Provide documentation of the steps taken by the Quality Control Manager to prevent future occurrences.

In addition to the Quality Control failure, propose a resolution for the identified material/workmanship non-conformance documenting that the repaired weld is in compliance with the contract requirements.

The affected weld has been repaired, NDT documentation indicating weld soundness has been submitted, and the strut has been green tagged. Furthermore, ABF QCM has conducted a training session with ZPMC QC personnel on 12/22/2009 to reinforce previously covered topics.

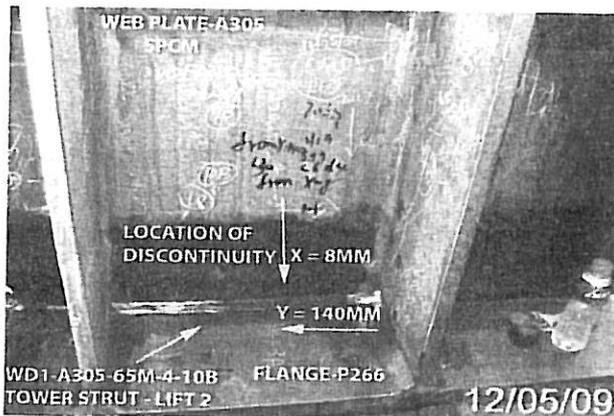
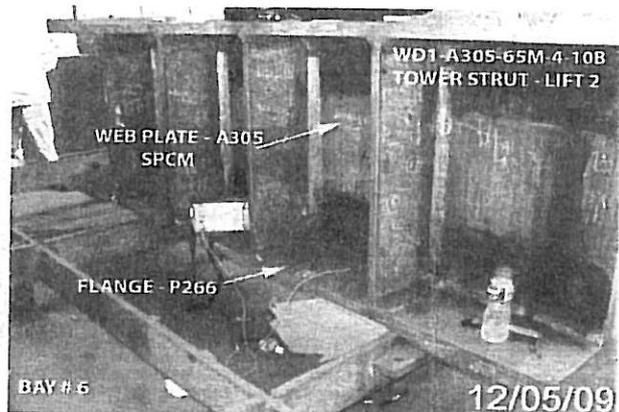
During Ultrasonic Testing (UT) of Strut Web to Flange CJP weld joint WD1-A305-65M-4-10B, QA discovered one (1) Class "A" longitudinal indication, with an indication rating of +6, measuring approximately 30 mm in length. The plate thickness at the location of the indication is 28 mm. This weld was previously tested and accepted by ZPMC QC UT technicians.

AWS D1.5-2002, Section 6, Table 6.3 specifies for material thicknesses of 20mm through 38mm, a decibel (db) indication rating of 8 db or less shall be categorized as Class A (large flaws) and any indication in this category shall be rejected (regardless of length).

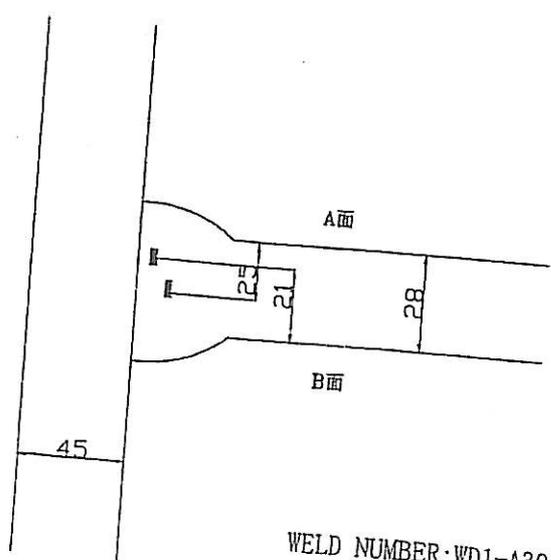
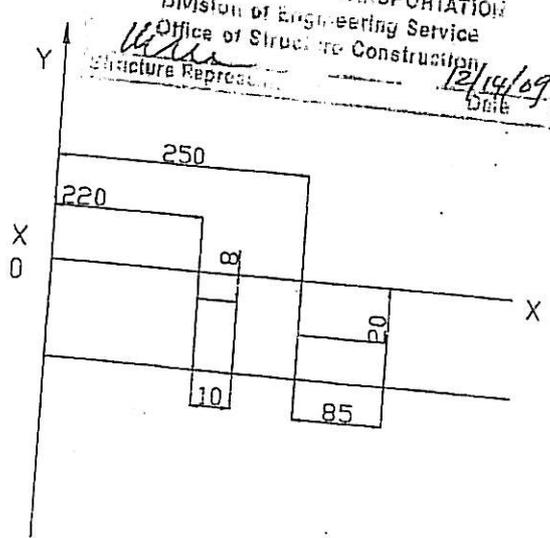
WELD NUMBER: WD1-A305-65M-4-10A/B

Rejectable indications were found by ultrasonic inspection for a second repair on the A709SL-GR485/345 plate.  
(UT探伤返修第二次, 并且该板为A709M-GR485/345板) WD1-A305-65M-4-10A/B

1. The weld defect location may not have been properly identified prior to grinding, i.e, the X and Y location was incorrect or the excavation was not centered on the defect, therefore the excavation did not encompass the whole defect.

- QC and production to properly lay out the UT defect, mark the X, Y, D on the base metal and the location on the surface of weld by use of rectangle or circle, by doing this, UT operator will verify the exact location of the defect prior to excavation.
  - The UT operator and or CWI will take the responsibility to verify the excavation has completely removed the defect
1. QC和生产部门应该正确的标出缺陷的位置, 在母材上标出缺陷X, Y, D的值, 在焊接, 用长方形和圆圈标出缺陷的位置, 这样, 在碳刨前, 能够准确的确认缺陷的位置;
2. UT检验员和CWI必须确认缺陷已经完全刨除.

1. QC shall monitor and direct the welder and the grinder doing the repair operation.
2. Preheat before gouging; the temperature shall be at least 65°C.
3. Gouge the weld to remove identified defects.
4. Joint details shall refer to the approved WPS repair.
5. Grind the gouged areas to a smooth and shiny surface.
6. Verify with VT and MT to ensure no defects remain in the weld joint prior to welding.
7. QC shall monitor all welding passes being deposited.
8. QC shall ensure all slag has been removed prior the deposition of next pass.
9. Preheat and maintain interpass temperature control in accordance with the WPS.
10. Blend the weld repaired areas into the adjacent weld or base metal by grinding.
11. Perform VT, MT and UT NDT inspection to the repaired areas.
