Contract #: 04-0120F4Cty: SF/ALA Rte: 80 PM: 13.2/13.9File #: 69.25B**QUALITY ASSURANCE -- NON-CONFORMANCE REPORT****Location:** Changxing Island, Shanghai, P.R. China**Report No:** NCR-000495**Prime Contractor:** American Bridge/Fluor Enterprises, a JV**Date:** 27-Oct-2009**Submitting Contractor:** Zhenhua Port Machinery Company, Ltd (ZPMC), Changxing Island**NCR #:** ZPMC-0468**Type of problem:**

Reference Description: Missed MT indication by QC on various components in Segment 6CW**Description of Non-Conformance:**

Job Name: SAS Superstructure

Subject: NCR No. ZPMC-0468

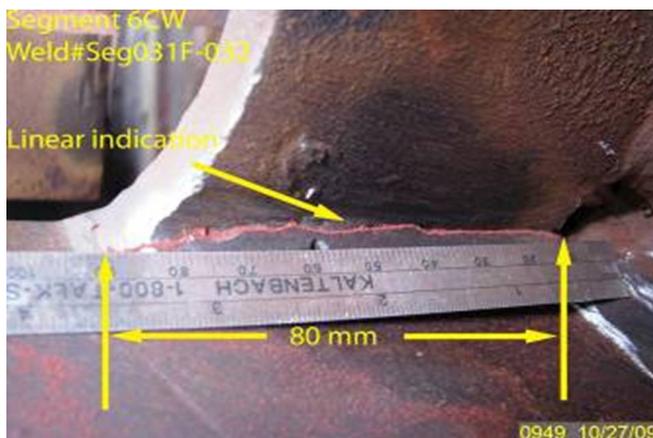
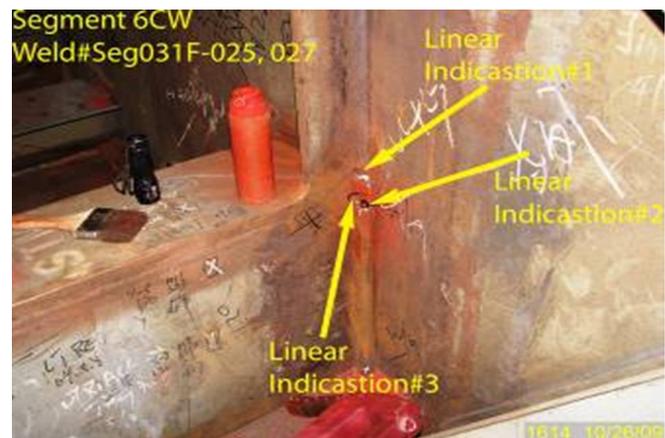
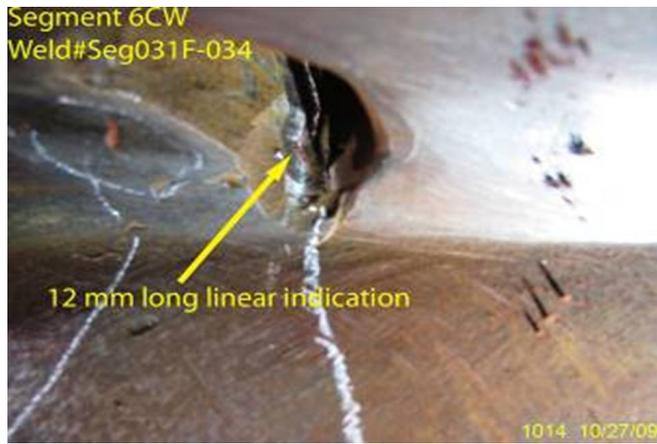
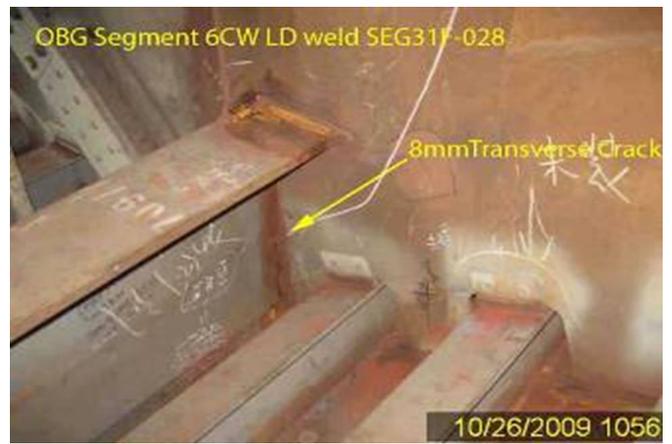
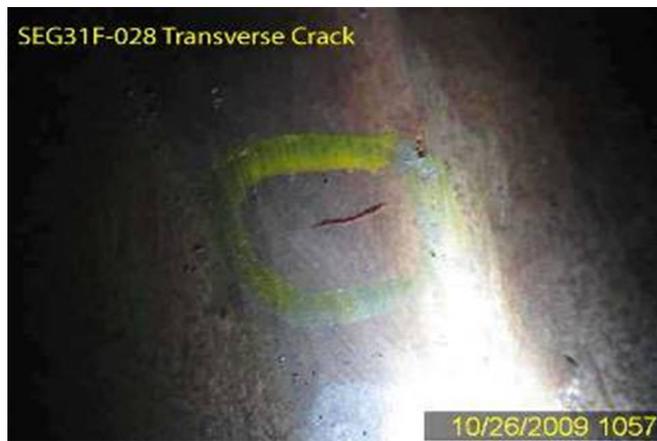
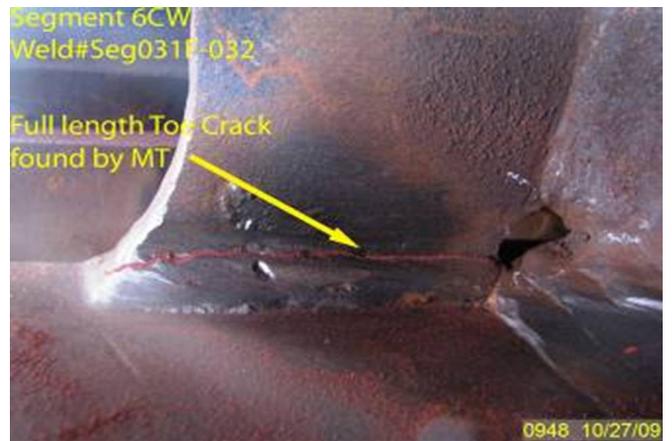
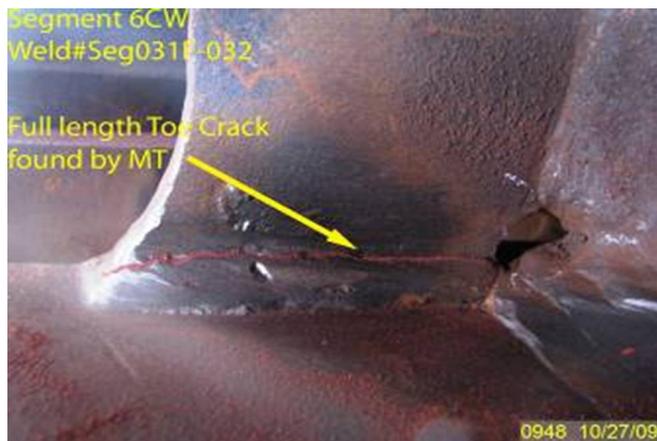
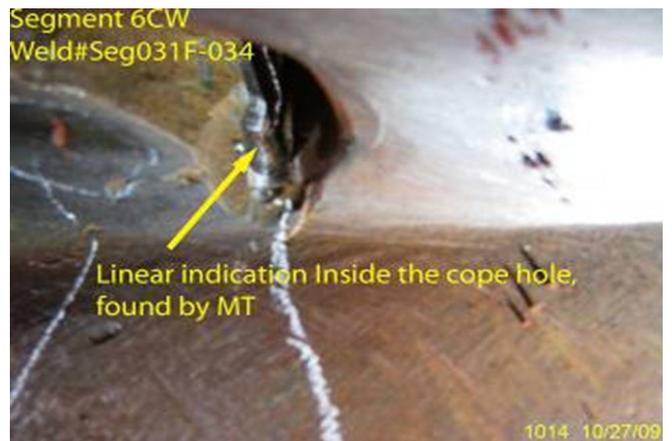
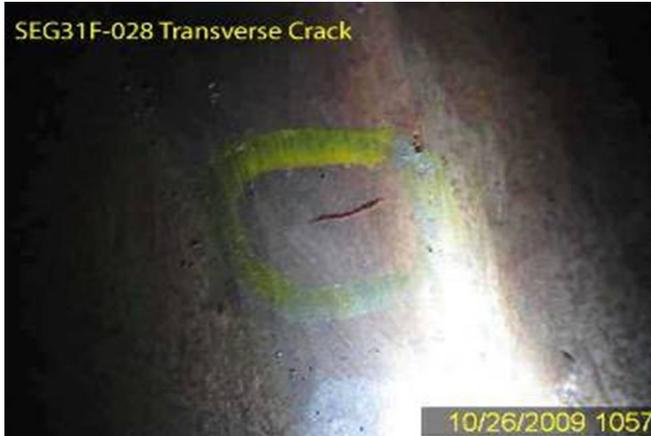
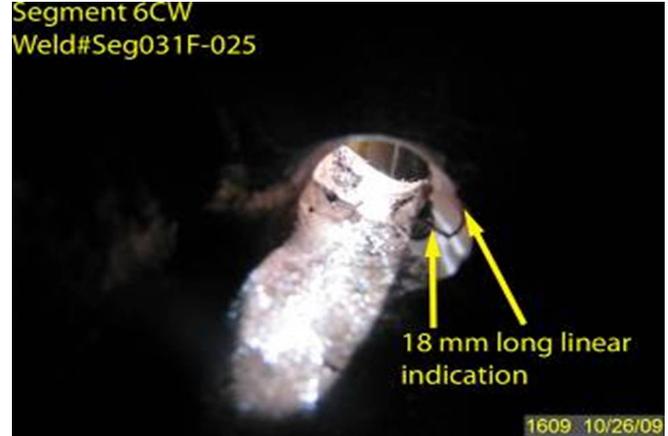
During a random Magnetic Particle (MT) verification at segment 6CW, Caltrans Quality Assurance Inspector discovered a total of five (5) Longitudinal Cracks located inside two (2) cope holes located at segment 6CW. Weld Seg031F-025 had three (3) Longitudinal Cracks with a total length of 18mm and weld Seg031F-027 had two (2) Longitudinal Cracks measuring 15mm and 12 mm in length.

Furthermore, Quality Assurance (QA) Inspector observed a Transverse Crack on the Longitudinal Diaphragm to FL3 Floor Beam weld SEG31F-028.

The Caltrans Quality Assurance Inspector also discovered three (3) Linear Cracks identified as one (1) Toe Crack, 80mm in length located at weld Seg031F-032 and two (2) Longitudinal Cracks located inside the cope hole at weld Seg031F-034.

All the welds listed above were previously tested and accepted by ZPMC QC MT.

Repair said indications and perform NDT required to verify weld quality.

Contractor submitted NDT records verifying the welds are now in conformance with Contract requirements.

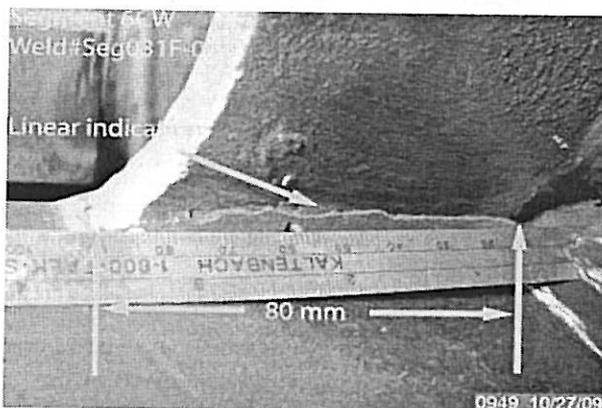
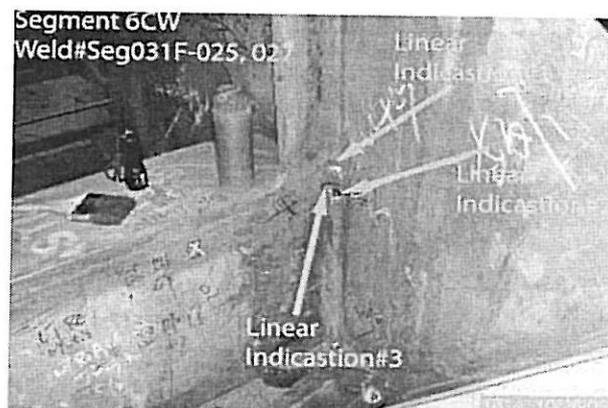
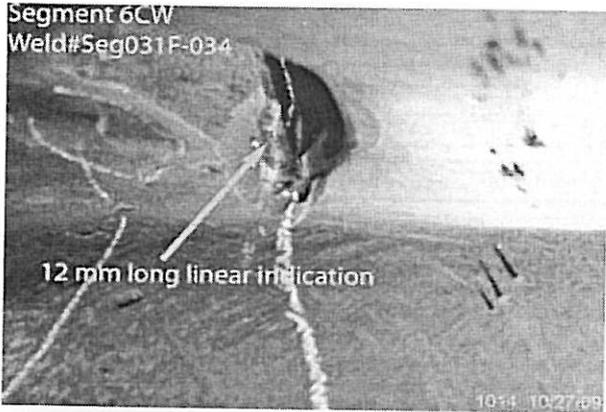
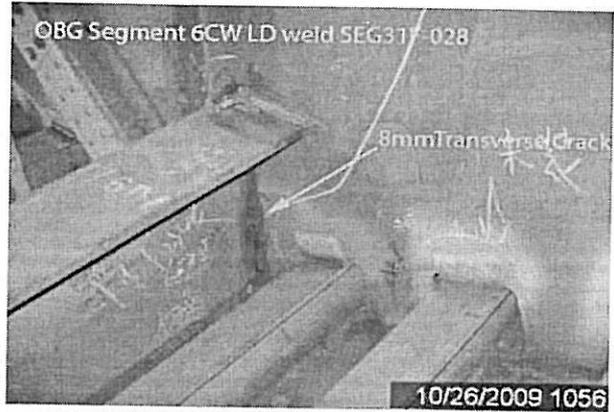
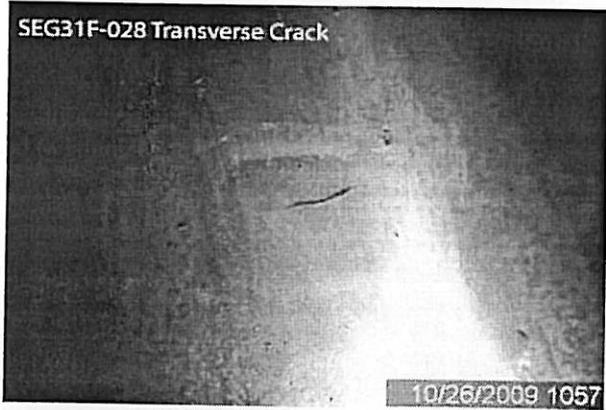
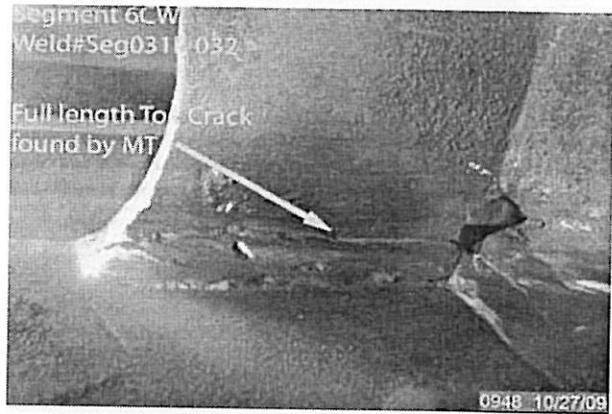
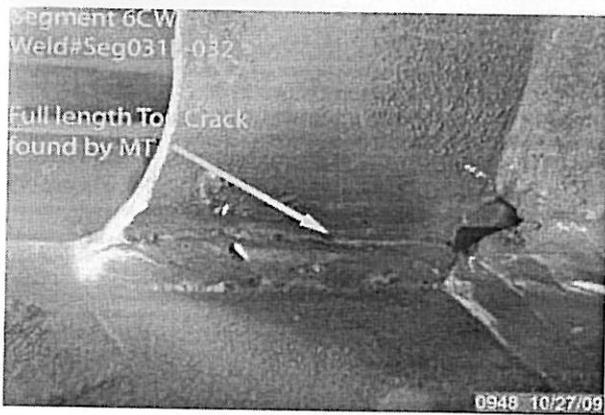
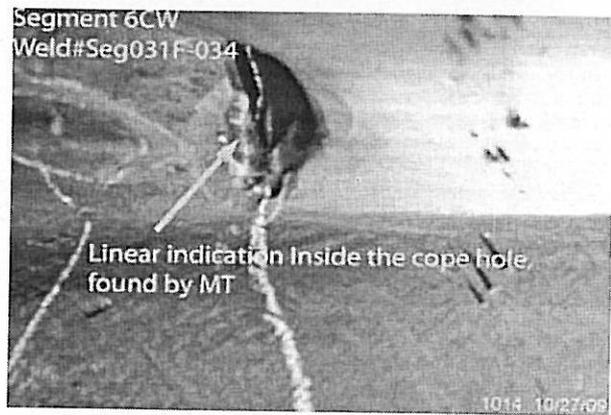
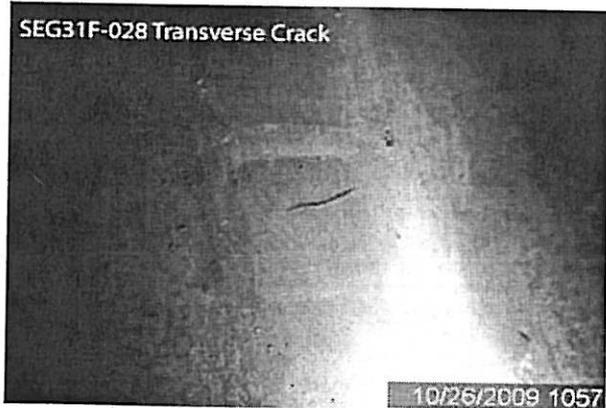
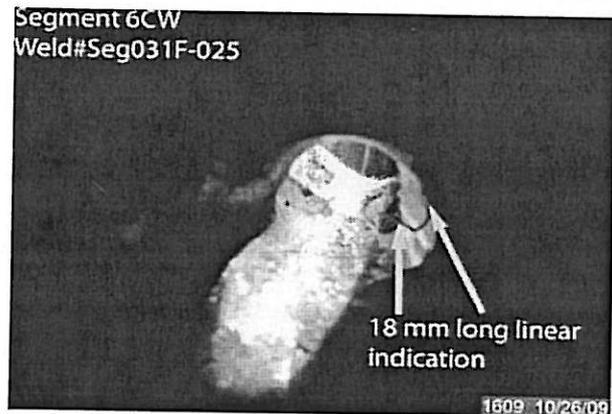
During a random Magnetic Particle (MT) verification at segment 6CW, Caltrans Quality Assurance Inspector discovered a total of five (5) Longitudinal Cracks located inside two (2) cope holes located at segment 6CW. Weld Seg031F-025 had three (3) Longitudinal Cracks with a total length of 18mm and weld Seg031F-027 had two (2) Longitudinal Cracks measuring 15mm and 12 mm in length.

Furthermore, Quality Assurance (QA) Inspector observed a Transverse Crack on the Longitudinal Diaphragm to FL3 Floor Beam weld SEG31F-028.

The Caltrans Quality Assurance Inspector also discovered three (3) Linear Cracks identified as one (1) Toe Crack, 80mm in length located at weld Seg031F-032 and two (2) Longitudinal Cracks located inside the cope hole at weld Seg031F-034.

All the welds listed above were previously tested and accepted by ZPMC QC MT.
