**DEPARTMENT OF TRANSPORTATION**

Contract #: 04-0120F4Cty: SF/ALA Rte: 80 PM: 13.2/13.9File #: 69.25B**QUALITY ASSURANCE -- NON-CONFORMANCE REPORT****Location:** Changxing Island, Shanghai, P.R. China**Report No:** NCR-000496**Prime Contractor:** American Bridge/Fluor Enterprises, a JV**Date:** 28-Oct-2009**Submitting Contractor:** Zhenhua Port Machinery Company, Ltd (ZPMC), Changxing Island**NCR #:** ZPMC-0469**Type of problem:****Welding****Concrete****Other****Welding****Curing****Procedural****Bridge No:** 34-0006**Joint fit-up****Coating****Other****Component:** Segment 6AW**Procedural****Procedural****Description:** Found MT indications after Contractor's acceptance**Reference Description:** Crater and Linear Indications discovered in 6AW with MT after the contractor's NDT acceptance**Description of Non-Conformance:**

**Reference Description:** Crater and Linear Indications discovered in 6AW with MT after the contractor's NDT acceptance

**Report No:** NCR-000496

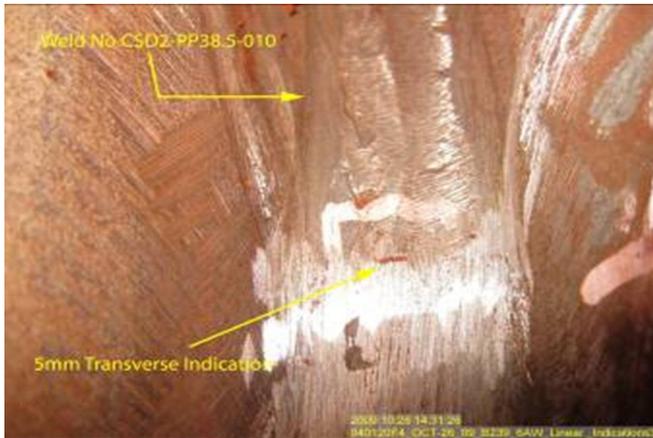
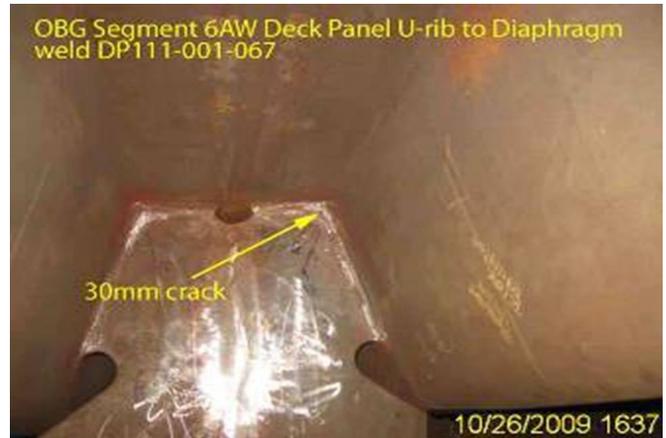
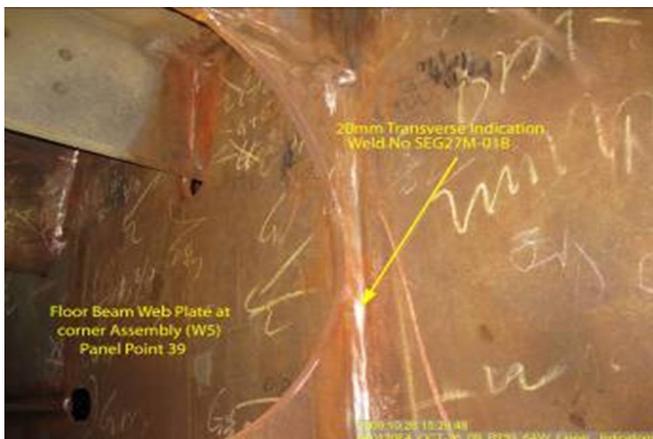
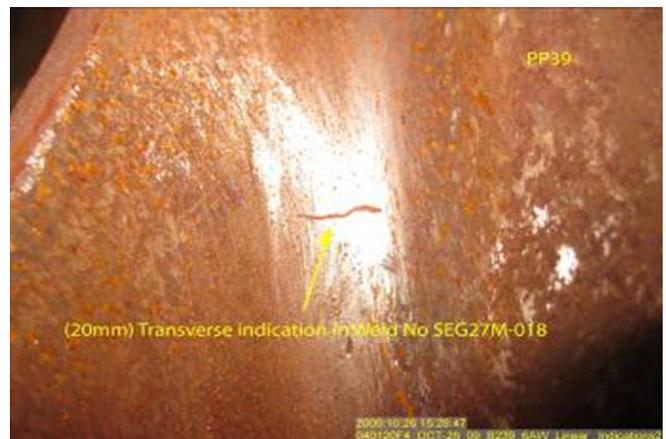
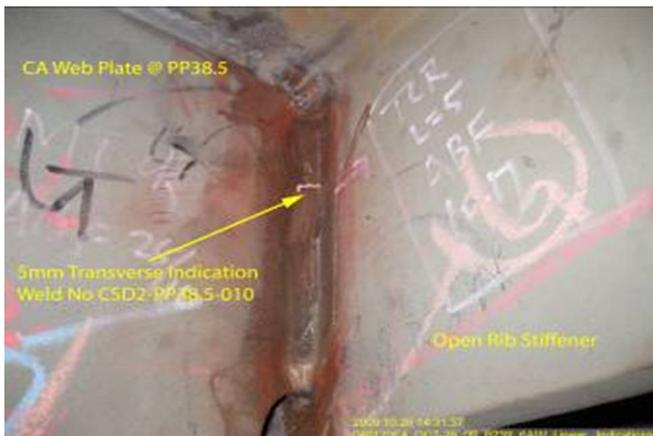
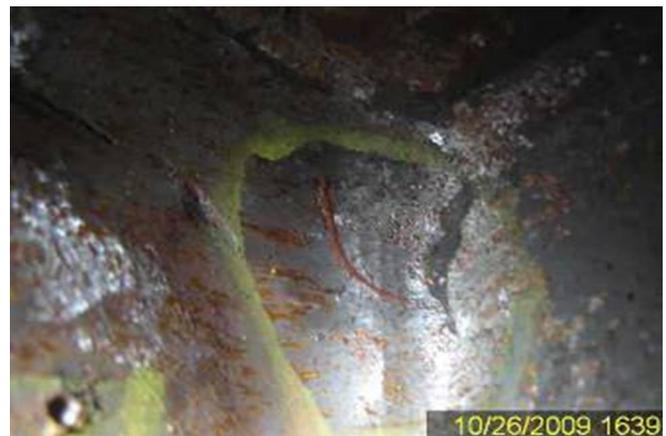
During a random Magnetic Particle (MT) verification of OBG Segment 6AW, the Caltrans Quality Assurance (QA) Inspectors observed fifteen (15) Crater Indications on the Deck Panel U rib to Diaphragm welds at panel point 38 and 39. The Crater Indications ranged from 10mm to 30mm in length and these welds were tested and accepted by ZPMC QC MT.

DP084-001-059 (10mm), DP111-001-067 (30mm), 062 (30mm), 059 (20mm), 092 (10mm) DP165-001-086 (20mm), DP273-001-056 (20mm), 051 (20mm), 048 (30mm), 038 (20mm), 084 (20mm) DP246-001-094 (30mm), 081 (15mm), 065 (10mm), 060 (10mm).

During a random verification Magnetic Particle Testing of the internal components of OBG segment 6AW, the Caltrans Quality Assurance (QA) Inspector discovered a total of two (2) Transverse Indications that measured from 5mm to 20mm in length. These welds were previously tested accepted by ZPMC (MT) technicians.

Open Rib Stiffener to corner assembly web plate weld- CSD2-PP38.5-010 (1) 5mm Transverse Indication.

Longitudinal Girder to panel point 38 Weld -SEG027M-018 (1) 20mm Transverse Indication.

- Submit a repair procedure to the engineer for approval. Missing MT indications by ZPMC MT technicians is a chronic problem.
- Provide training to ensure these occurrences are minimized.

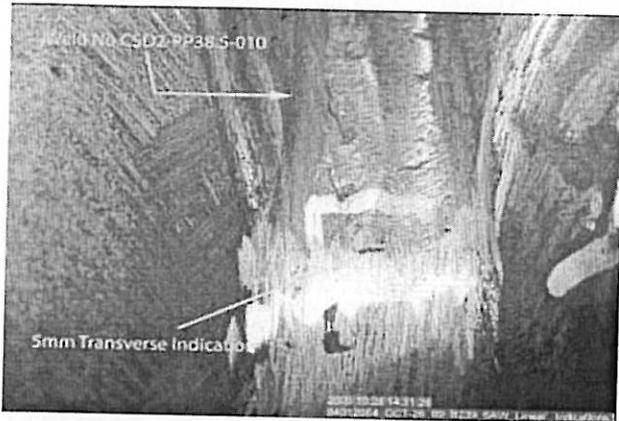
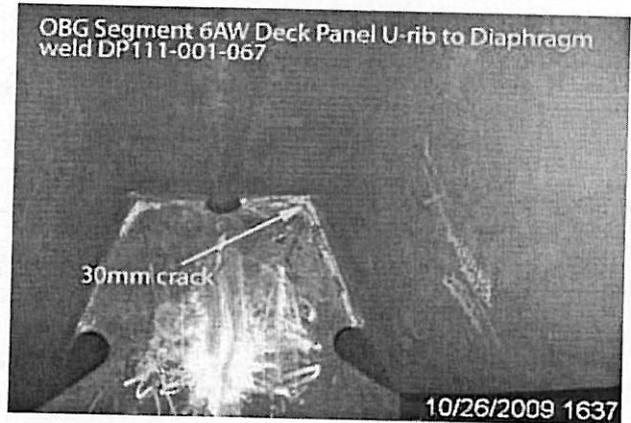
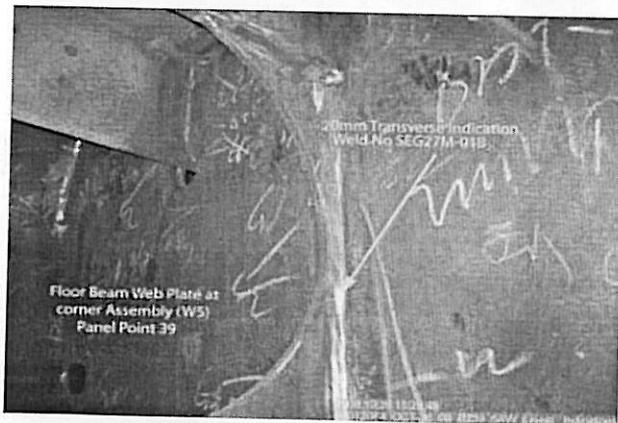
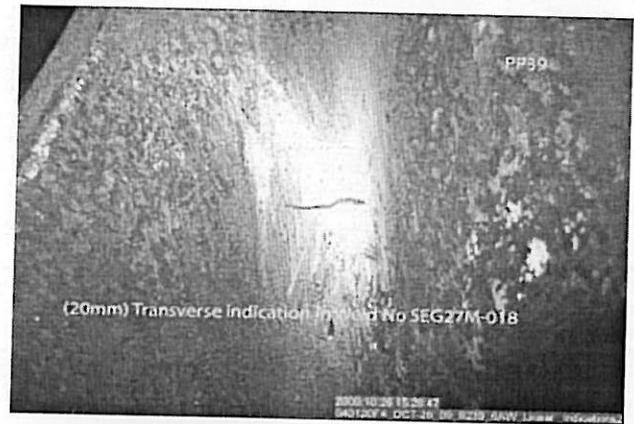
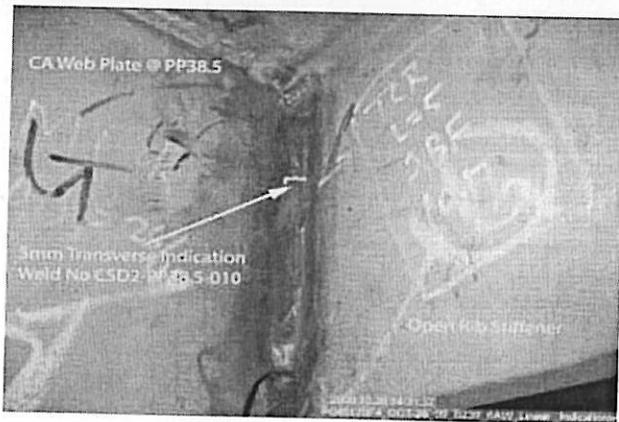
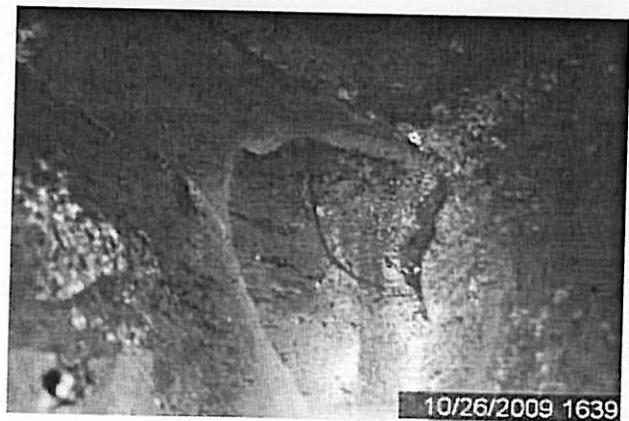
During a random Magnetic Particle (MT) verification of OBG Segment 6AW, the Caltrans Quality Assurance (QA) Inspectors observed fifteen (15) Crater Indications on the Deck Panel U rib to Diaphragm welds at panel point 38 and 39. The Crater Indications ranged from 10mm to 30mm in length and these welds were tested and accepted by ZPMC QC MT.

DP084-001-059 (10mm), DP111-001-067 (30mm), 062 (30mm), 059 (20mm), 092 (10mm) DP165-001-086 (20mm), DP273-001-056 (20mm), 051 (20mm), 048 (30mm), 038 (20mm), 084 (20mm) DP246-001-094 (30mm), 081 (15mm), 065 (10mm), 060 (10mm).

During a random verification Magnetic Particle Testing of the internal components of OBG segment 6AW, the Caltrans Quality Assurance (QA) Inspector discovered a total of two (2) Transverse Indications that measured from 5mm to 20mm in length. These welds were previously tested accepted by ZPMC (MT) technicians. The non-complying weld designations are as follows:

Open Rib Stiffener to corner assembly web plate weld- CSD2-PP38.5-010 (1) 5mm Transverse Indication.  
 Longitudinal Girder to panel point 38 Weld -SEG027M-018 (1) 20mm Transverse Indication.

Repair said indications and perform NDT required to verify weld quality

Contractor has submitted NDT records verifying the welds are now in conformance with Contract specifications. Additional training was also provided to NDT Technicians in regards to this issue.
