QUALITY ASSURANCE -- NON-CONFORMANCE REPORT

Report No: NCR-000499

Reference Description: Longitudinal indications discovered in Segment 6CW inside Cope Holes with MT after the contractor's acceptance

Job Name: SAS Superstructure

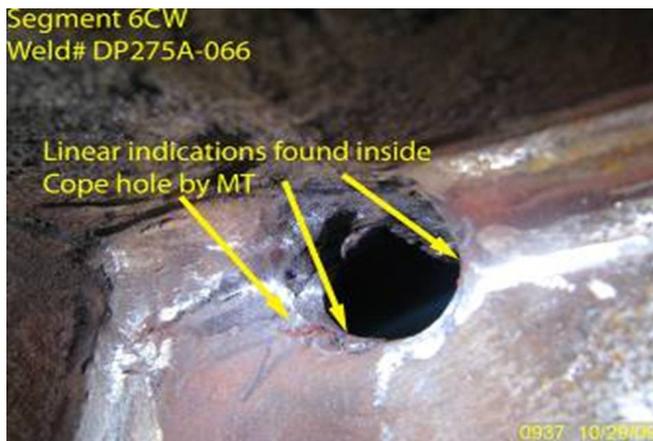
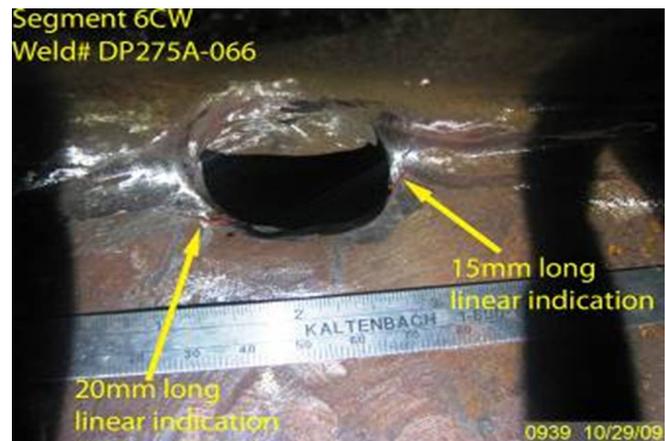
During a random Magnetic Particle (MT) verification at segment 6CW, Caltrans Quality Assurance (QA) Inspector discovered two (2) Longitudinal Indications inside the cope hole of weld # DP275A-066. The 2 indications were measured at 15mm and 20mm in length.

This weld was previously tested and accepted by ZPMC QC MT.

AWS D1.5 (02) Section 6.26.2 – “Welds that are subject to MT in addition to visual inspection shall have no cracks.”

Submit a repair procedure to the engineer for approval. Missed MT indications have become a chronic problem. Ensure that adequate training of MT technicians is performed to lessen these occurrences.
