Contract #: 04-0120F4Cty: SF/ALA Rte: 80 PM: 13.2/13.9File #: 69.25B**QUALITY ASSURANCE -- NON-CONFORMANCE REPORT****Location:** Changxing Island, Shanghai, P.R. China**Report No:** NCR-000500**Prime Contractor:** American Bridge/Fluor Enterprises, a JV**Date:** 01-Nov-2009**Submitting Contractor:** Zhenhua Port Machinery Company, Ltd (ZPMC), Changxing Island**NCR #:** ZPMC-0473**Type of problem:****Welding****Concrete****Other****Welding****Curing****Procedural****Bridge No:** 34-0006**Joint fit-up****Coating****Other****Component:** Lift 12 OBG Floor Beams**Procedural****Procedural****Description:****Reference Description:** Out of Flatness Floorbeam components for Lift 12 due to Improper Handling and Storage**Description of Non-Conformance:**

Job Name: SAS Superstructure

Subject: NCR No. ZPMC-0473

Reference Description: Out of Flatness Floorbeam components for Lift 12 due to Improper Handling and Storage

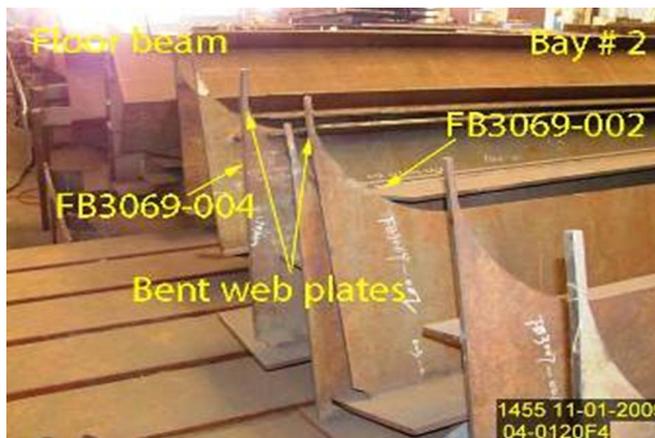
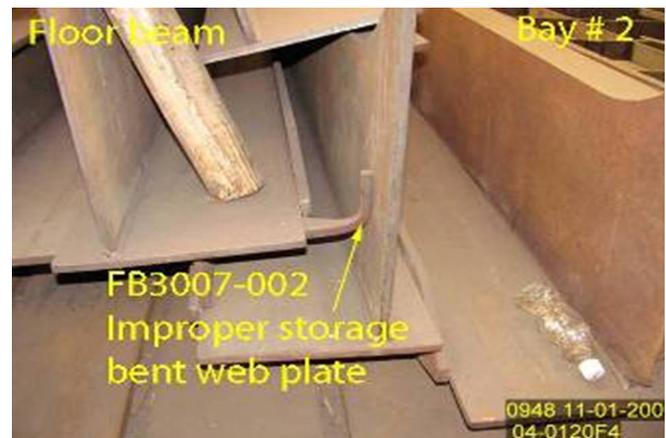
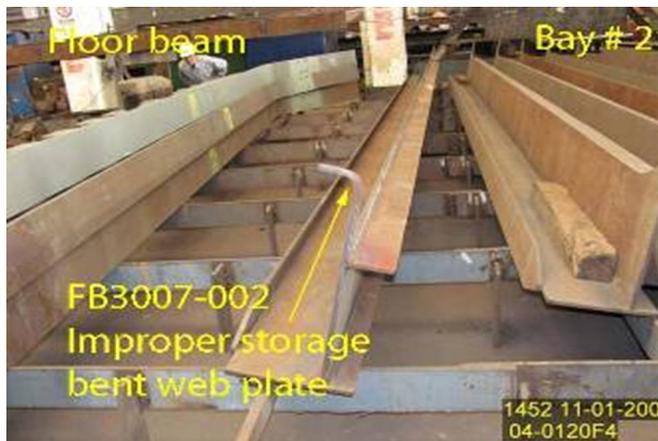
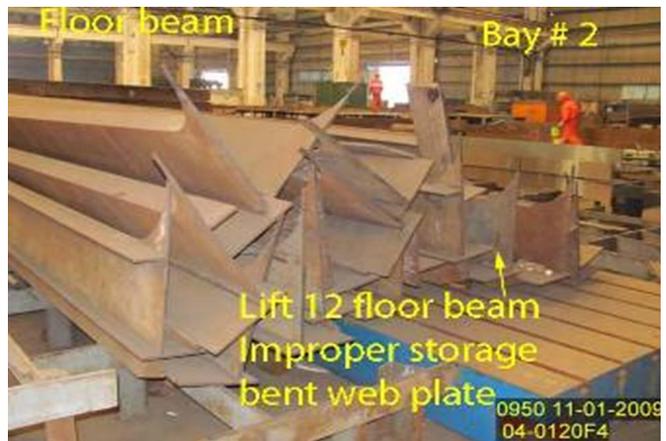
The Caltrans Quality Assurance (QA) Inspector observed lift 12 Floor Beam components located in Bay 2 that were out of flatness and have been bent due to improper handling and storage. These Floor Beam components were identified as FB3007-002, FB3069-004 and FB3069-002.

Section 55-1.04: In handling and shipping of the steel work, every care shall be taken to avoid bending, scraping or overstressing the pieces. All pieces bent or otherwise injured will be rejected.

Submit a repair plan to the engineer for approval.

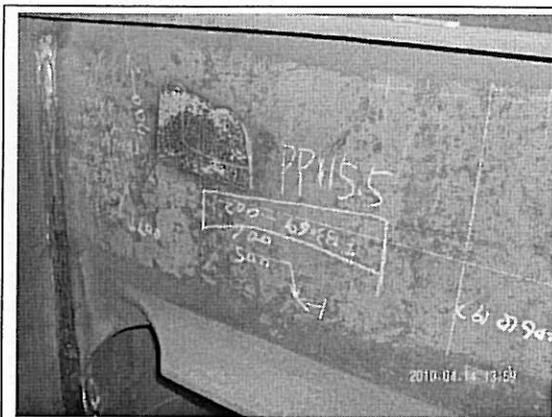
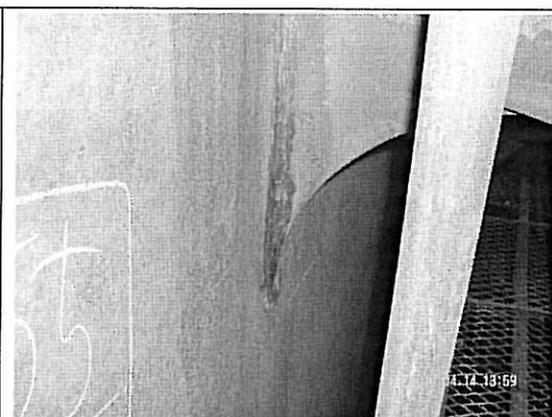
FB3069-002 @ 12CW PP115.5

ZPMC acknowledged this issue and has released an internal NCR. Heat Straightening was performed to rectify the distortion caused by the unsatisfied storage. These panels have now been assembled into segment as showed in the following pictures. ZPMC is providing the HSR1 report and the NDT record shows the soundness of metal after heat straightening and is requesting closure of this NCR.

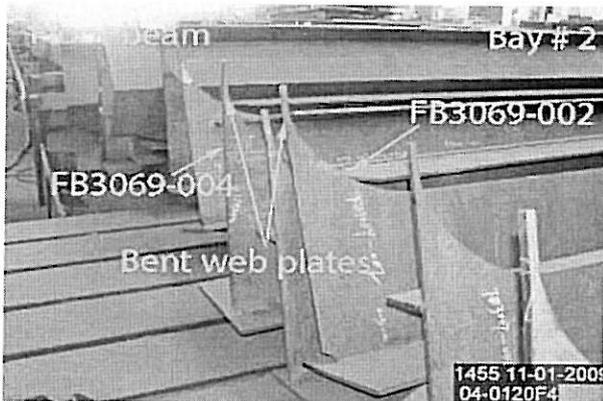
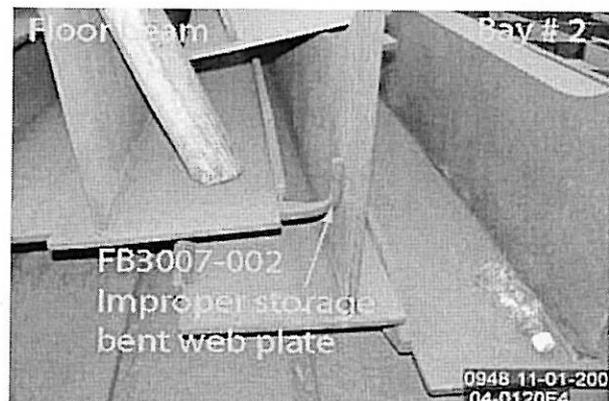
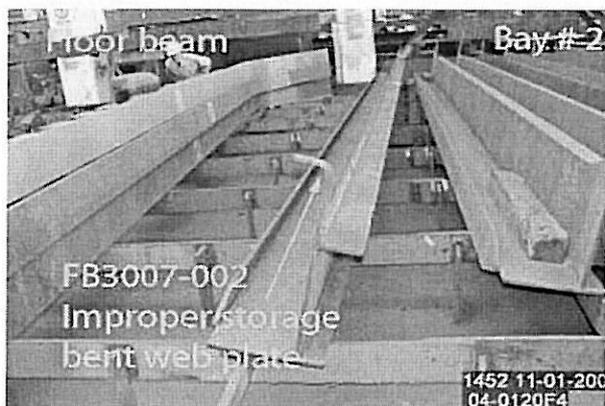
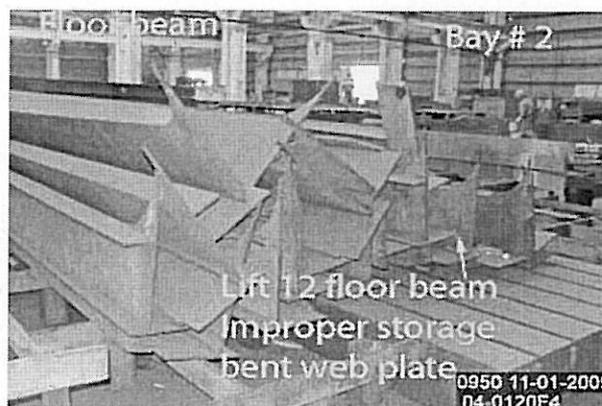
The Caltrans Quality Assurance (QA) Inspector observed lift 12 Floor Beam components located in Bay 2 that were out of flatness and have been bent due to improper handling and storage. These Floor Beam components were identified as FB3007-002, FB3069-004 and FB3069-002.

Section 55-1.04: In handling and shipping of the steel work, every care shall be taken to avoid bending, scraping or overstressing the pieces. All pieces bent or otherwise injured will be rejected.

Perform heat straightening to correct damaged components.

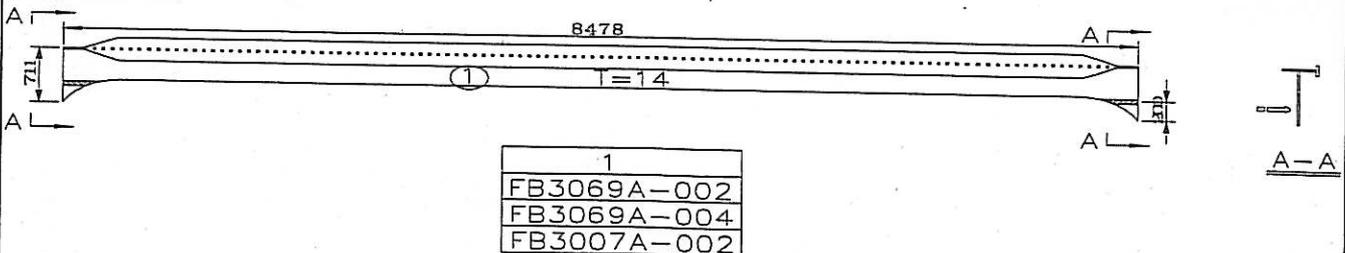
Cause 原因	Bounce distortion 撞击变形
Type of Defect 缺陷类型	Bounce distortion 撞击变形
Inspection Method 检查方法	Visual 目检

缺陷去除方法(Defect Removal Method):	natural gas 天然气
后续NDE(Post-Removal NDE):	After finishing heat straightening, the weld of the heat area shall perform NDT according to the approved shop drawing 校火后, 根据图纸要求对热影响区域进行NDT检测.
纠正措施(Corrective Action(s)):	Control current, voltage and weld speed according to relevant WPS. If necessary anti-deformation or hold down device can be added. 依据相应的WPS的要求控制电流, 电压和焊接速度. 如有必要, 可使用反变形设施进行校正.
实施次数(Number of application):	1~3
最高温度(Maximum temperature):	<650°C
