QUALITY ASSURANCE -- NON-CONFORMANCE REPORT

Location: Changxing Island, Shanghai, P.R. China**Report No:** NCR-000501**Prime Contractor:** American Bridge/Fluor Enterprises, a JV**Date:** 04-Nov-2009**Submitting Contractor:** Zhenhua Port Machinery Company, Ltd (ZPMC), Changxing Island**NCR #:** ZPMC-0474**Type of problem:**

Reference Description: Fracture Critical Tack Welds did not comply with the minimum length requirement in CB13 and 6AE

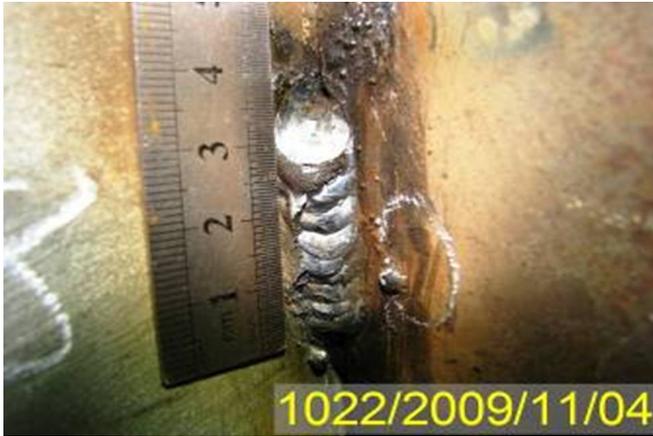
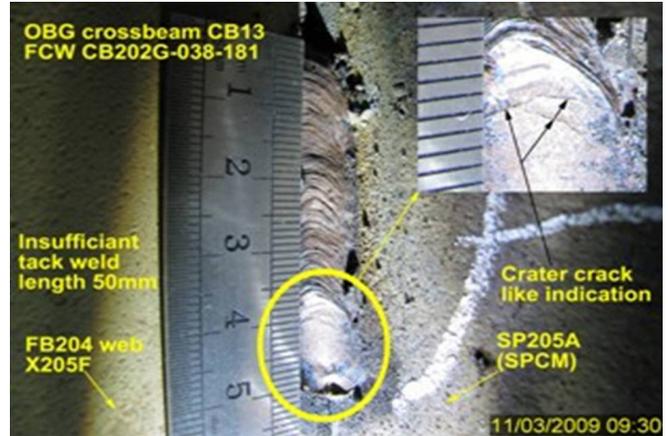
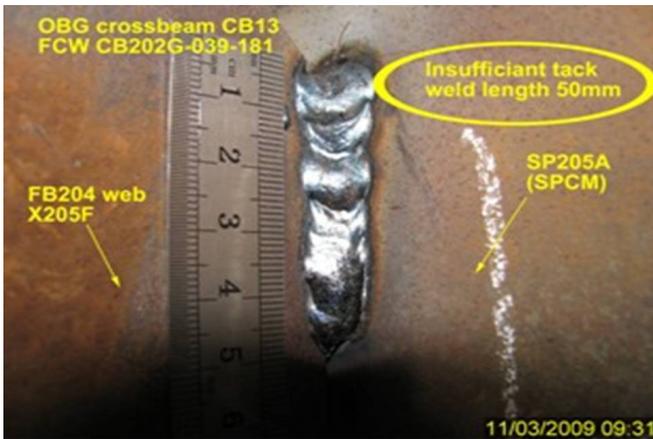
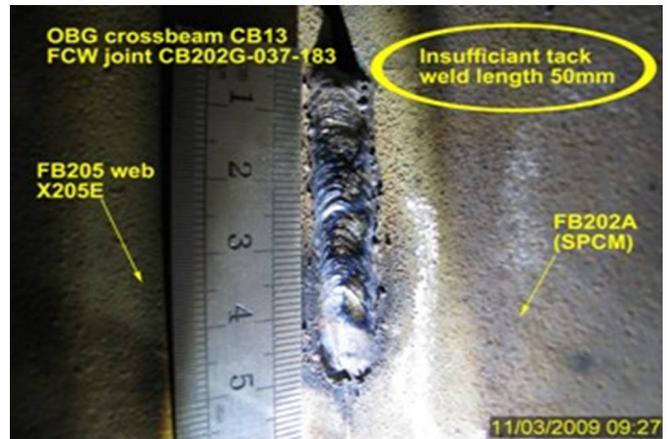
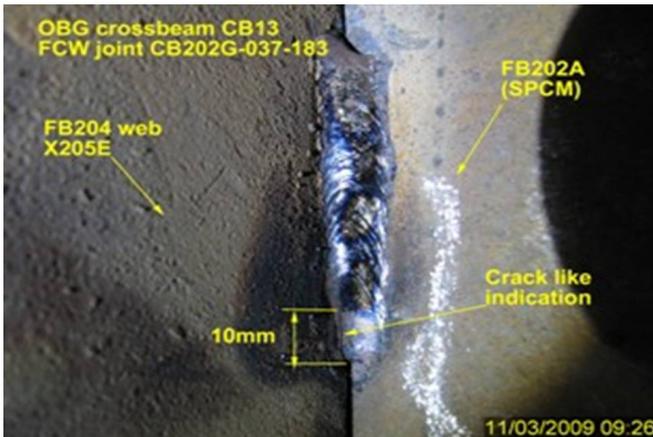
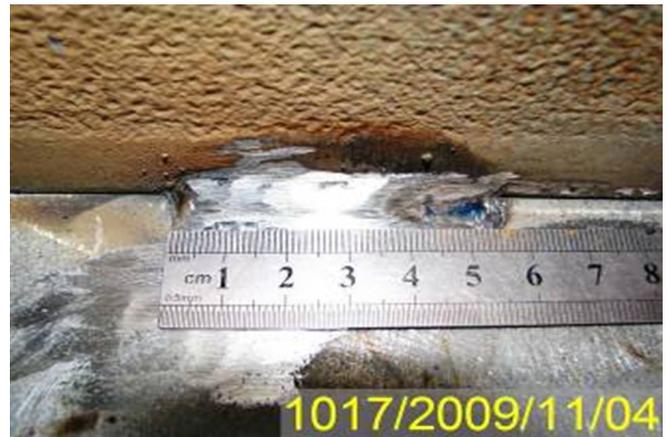
During random in process visual inspection of above mentioned crossbeam, this Quality Assurance Inspector (QA) observed numerous Fracture Critical Weld (FCW) tack welds that do not appear to comply with the contract documents. The tack welds in question are joining the floor beam diaphragms to the SPCM area of the intermediate panel and the east and west side panels. The length of the tack welds measure approximately 50mm. The insufficient tack weld length exists at all four floor beam locations. The members affected are identified as floor beams FB204, FB205, FB202A (SPCM) and side panels SP202A (SPCM) and SP205A (SPCM) in CB13. Weld joints are identified as CB202G-037/038/039/040-181, CB202G-037/038/039/040-183 and CB202G-037/038/039/040-185. The following FCW tack welds appeared to exhibit crack like indications in the crater areas: CB202G-037-183 and CB202G-038-181.

During a random in process visual inspection, this Quality Assurance (QA) Inspector observed several Fracture Critical Weld (FCW) tack welds that do not appear to comply with the contract documents. The tack welds in question are joining one (1) of the FB Diaphragms to the SPCM area of the Side Panel and FB Diaphragm to Bottom Plate. The members are identified as FB20A to X27B weld joint and X104E to Bottom Plate between PP38 and PP39 in 6AE. The length of these tack welds measure 35mm to 55mm in length and there were six (6) tack welds in each weld joint listed above. The minimum length of FCW tack welds per AWS D1.5 section 12 shall be 75mm or as specified by table 12.2.

AWS D1.5 2002 section 12, table 12.2 requires FCW tack welds not covered by Submerged Arc Welding (SAW) to be a minimum of 75mm in length.

AWS D1.5 2002 section 3.3.7.1 "Tack welds shall be subject to the same quality requirements as the final welds..."

AWS D1.5 2002 section 6.26.1.1 "The weld shall have no cracks."

Submit a repair procedure to the engineer for approval that includes the correct size tack welds.

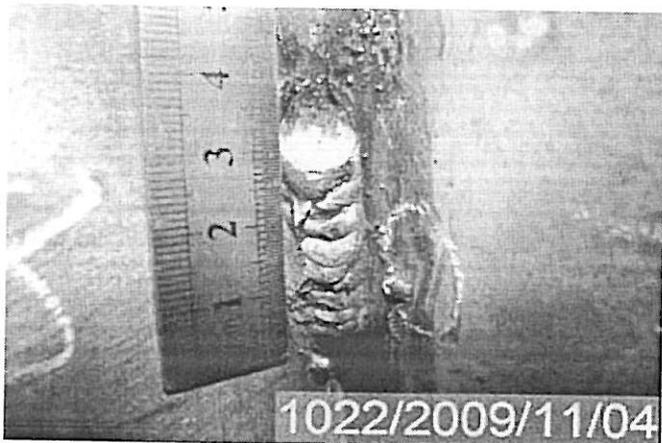
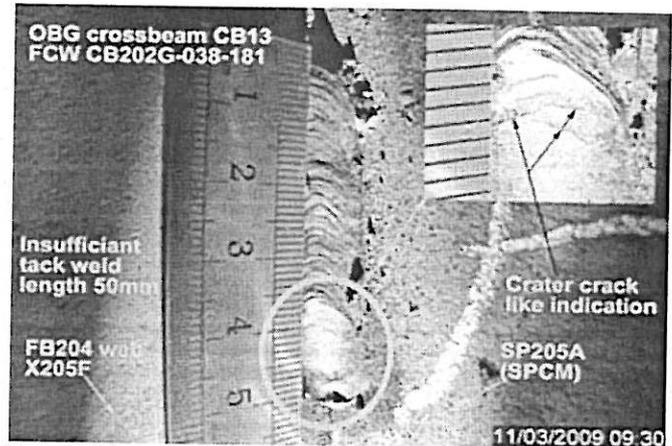
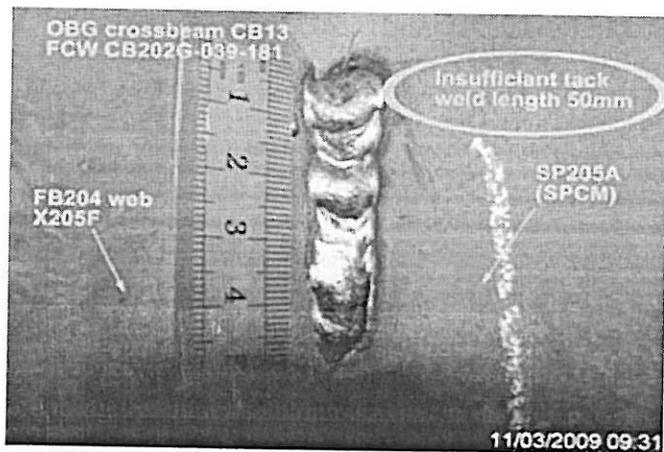
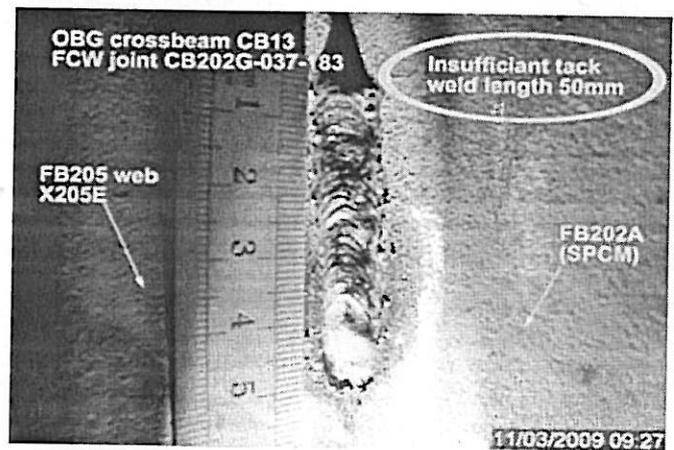
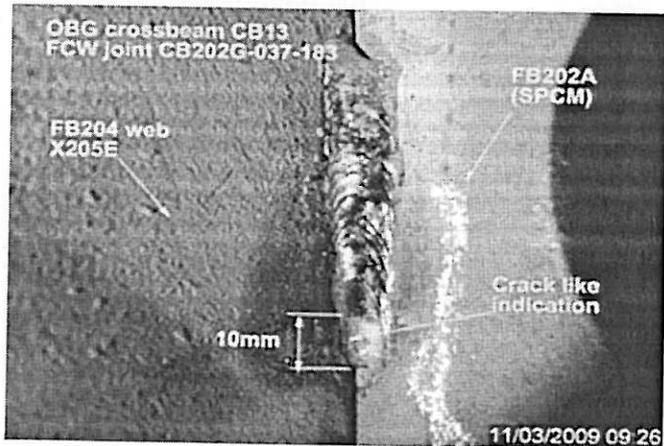
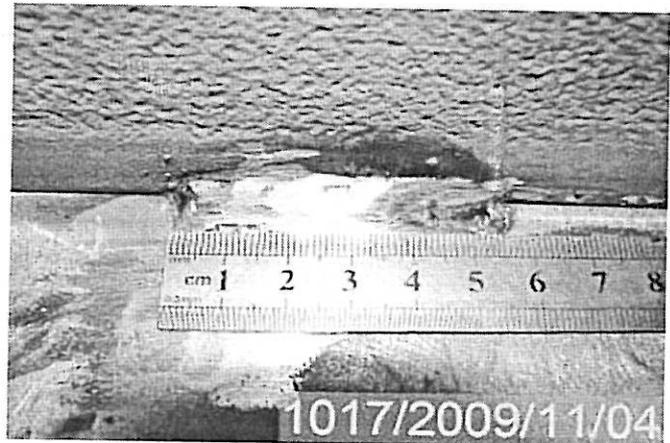
During random in process visual inspection of above mentioned crossbeam, this Quality Assurance Inspector (QA) observed numerous Fracture Critical Weld (FCW) tack welds that do not appear to comply with the contract documents. The tack welds in question are joining the floor beam diaphragms to the SPCM area of the intermediate panel and the east and west side panels. The length of the tack welds measure approximately 50mm. The insufficient tack weld length exists at all four floor beam locations. The members affected are identified as floor beams FB204, FB205, FB202A (SPCM) and side panels SP202A (SPCM) and SP205A (SPCM) in CB13. Weld joints are identified as CB202G-037/038/039/040-181, CB202G-037/038/039/040-183 and CB202G-037/038/039/040-185. The following FCW tack welds appeared to exhibit crack like indications in the crater areas: CB202G-037-183 and CB202G-038-181.

During a random in process visual inspection, this Quality Assurance (QA) Inspector observed several Fracture Critical Weld (FCW) tack welds that do not appear to comply with the contract documents. The tack welds in question are joining one (1) of the FB Diaphragms to the SPCM area of the Side Panel and FB Diaphragm to Bottom Plate. The members are identified as FB20A to X27B weld joint and X104E to Bottom Plate between PP38 and PP39 in 6AE. The length of these tack welds measure 35mm to 55mm in length and there were six (6) tack welds in each weld joint listed above. The minimum length of FCW tack welds per AWS D1.5 section 12 shall be 75mm or as specified by table 12.2.

AWS D1.5 2002 section 12, table 12.2 requires FCW tack welds not covered by Submerged Arc Welding (SAW) to be a minimum of 75mm in length.

AWS D1.5 2002 section 3.3.7.1 "Tack welds shall be subject to the same quality requirements as the final welds..."

AWS D1.5 2002 section 6.26.1.1 "The weld shall have no cracks."

Submit a repair procedure to the engineer for approval that includes the correct size tack welds.
