Contract #: 04-0120F4Cty: SF/ALA Rte: 80 PM: 13.2/13.9File #: 69.25B**QUALITY ASSURANCE -- NON-CONFORMANCE REPORT****Location:** Changxing Island, Shanghai, P.R. China**Report No:** NCR-000502**Prime Contractor:** American Bridge/Fluor Enterprises, a JV**Date:** 27-Oct-2009**Submitting Contractor:** Zhenhua Port Machinery Company, Ltd (ZPMC), Changxing Island**NCR #:** ZPMC-0475**Type of problem:**

Reference Description: ZPMC moved segment 6AW to the Blast Shop prior to completion and obtaining the "QA Approval Form" per CCO77

Job Name: SAS Superstructure

Subject: NCR No. ZPMC-0475

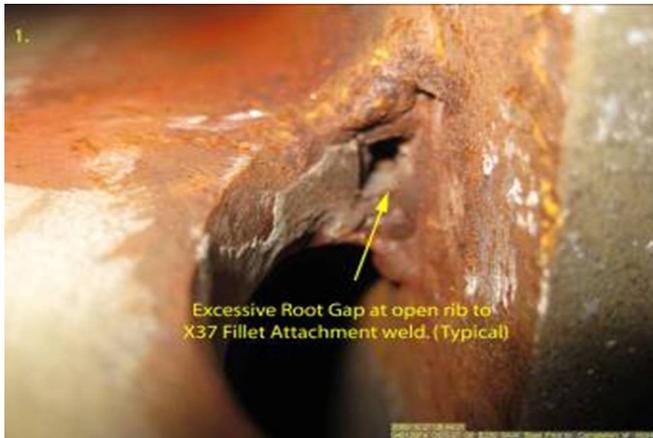
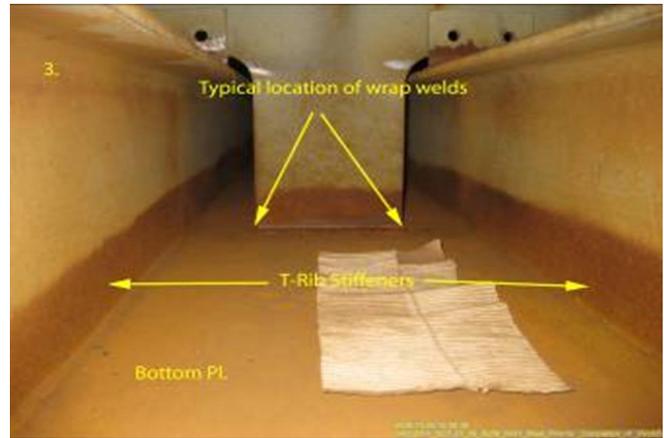
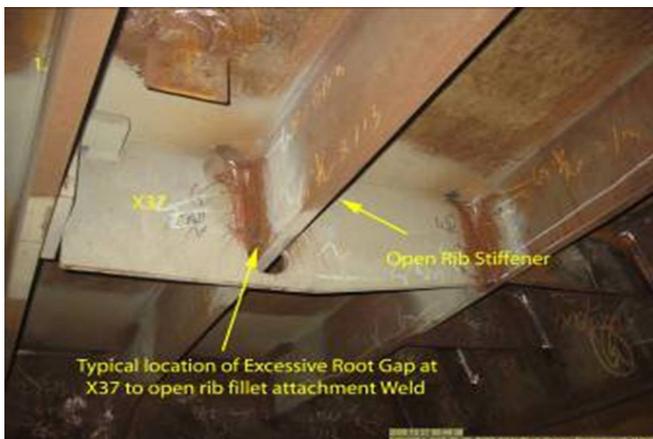
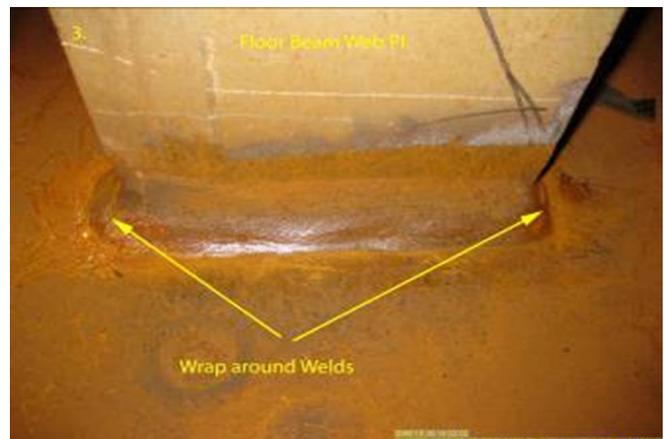
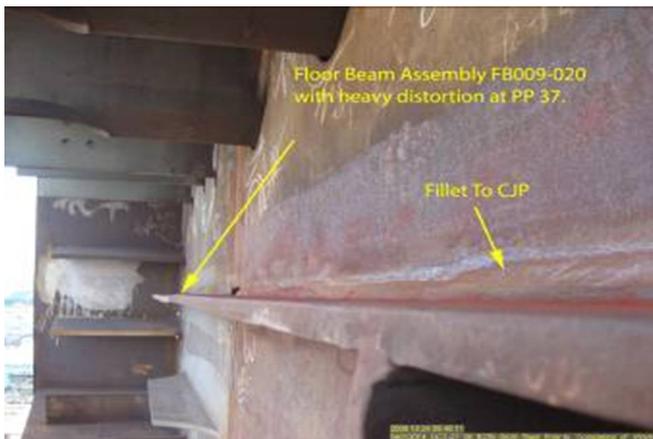
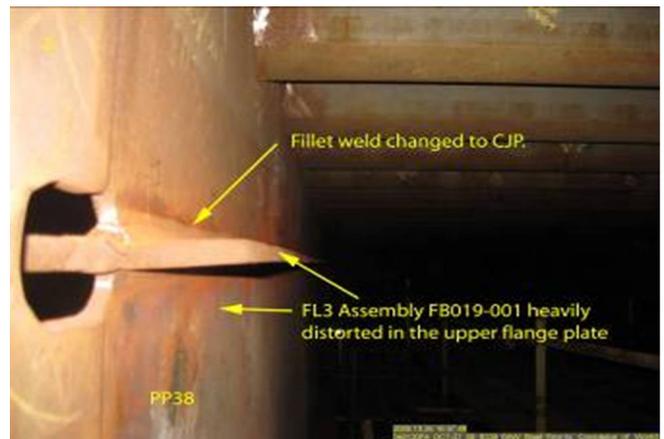
1. The transverse X37 Deck Brackets in this segment require a fillet weld per approved drawings with the maximum root opening not to exceed 5mm as allowed by AWS D1.5-2002 Section 3.3.1. The termination of these fillet welds at the following locations show a root gap greater than that allowed by the code:
X37 Brackets at Location W2 at panel points 37.25, 37.75, 38.25, 38.75, 39.25, 39.75, 40.25, and 40.75.
X37 Brackets at Location W5 at panel points 37.25, 37.75, 38.25, and 38.75.

2. The FL2-1, FL1 and FL3 Floor Beam sub-assemblies were found distorted on the upper Flange Plate after the adjacent Deck Panel Diaphragm weld connecting to this upper Flange Plate was changed from a fillet weld to a complete joint penetration (CJP) due to fit up issues. The maximum distortion (tilt) of the flange from its original flat position is 23mm.

3. Welds connecting the Floor Beam Web Plate to the Bottom and Side Plates have fillet welds wrapped on both ends of the cut out for T-Rib stiffeners. The weld detail on drawing shows the fillet weld is to be welded both sides and not welded all around (wrapped). Furthermore, RFI 1786 clarified that contractor shall "terminate welds in accordance with the contract plans and the approved shop drawings."

1. Make sure to submit the "QA Approval Form" per CCO77.
2. Submit repair request to use CJP weld in lieu of fillet weld.
3. Submit a repair plan to the engineer for approval.

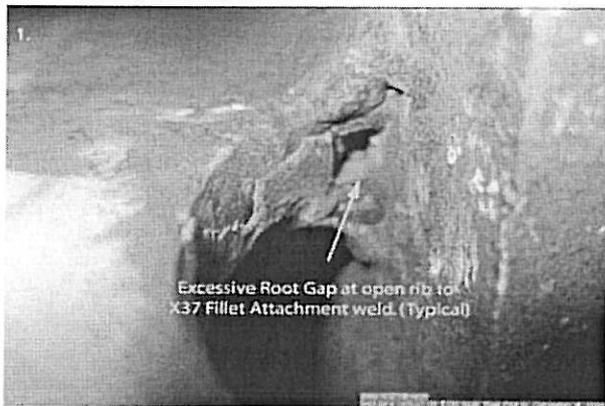
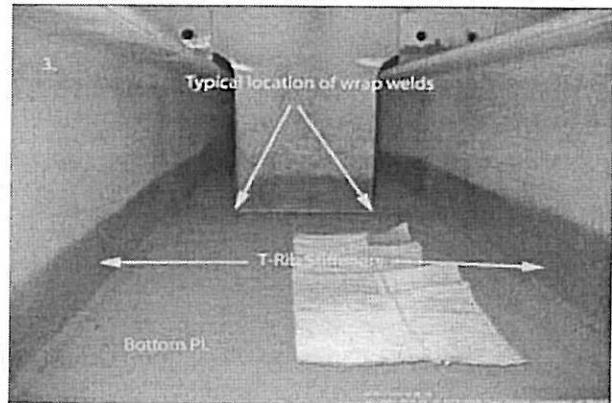
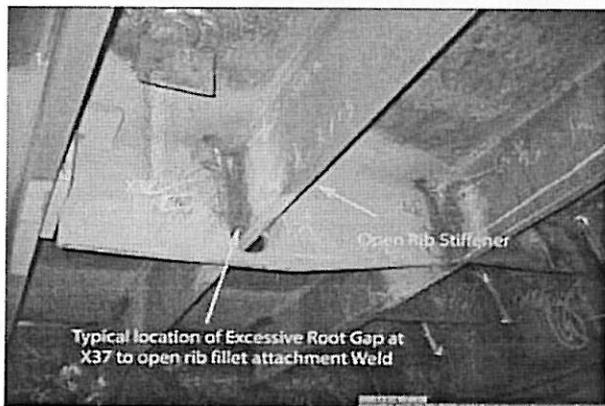
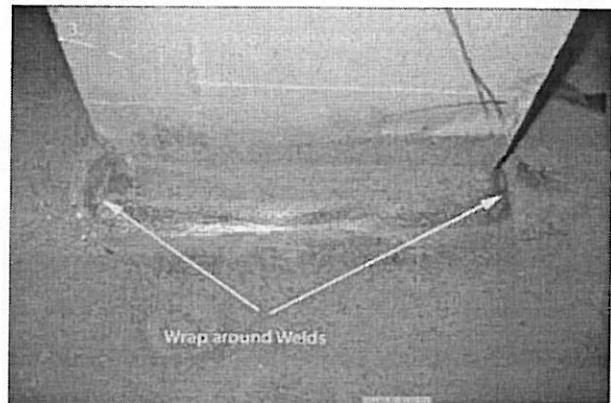
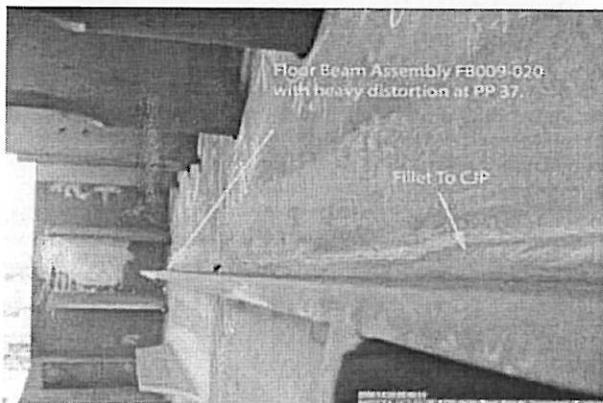
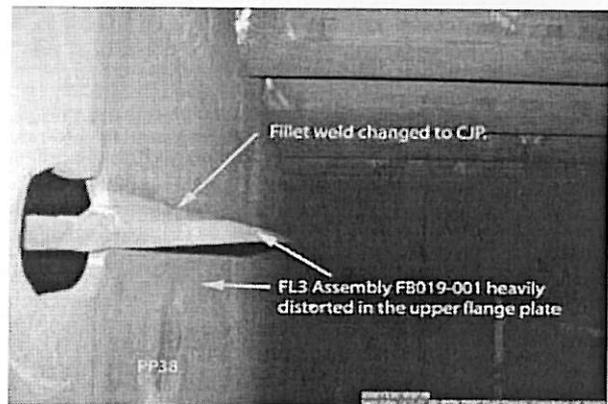
1. The transverse X37 Deck Brackets in this segment require a fillet weld per approved drawings with the maximum root opening not to exceed 5mm as allowed by AWS D1.5-2002 Section 3.3.1. The termination of these fillet welds at the following locations show a root gap greater than that allowed by the code:

X37 Brackets at Location W2 at panel points 37.25, 37.75, 38.25, 38.75, 39.25, 39.75, 40.25, and 40.75.

X37 Brackets at Location W5 at panel points 37.25, 37.75, 38.25, and 38.75.

2. The FL2-1, FL1 and FL3 Floor Beam sub-assemblies were found distorted on the upper Flange Plate after the adjacent Deck Panel Diaphragm weld connecting to this upper Flange Plate was changed from a fillet weld to a complete joint penetration (CJP) due to fit up issues. The maximum distortion (tilt) of the flange from its original flat position is 23mm.

3. Welds connecting the Floor Beam Web Plate to the Bottom and Side Plates have fillet welds wrapped on both ends of the cut out for T-Rib stiffeners. The weld detail on drawing shows the fillet weld is to be welded both sides and not welded all around (wrapped). Furthermore, RFI 1786 clarified that contractor shall "terminate welds in accordance with the contract plans and the approved shop drawings."

1. Make sure to submit the "QA Approval Form" per CCO77.
2. Submit repair request to use CJP weld in lieu of fillet weld.
3. Submit a repair plan to the engineer for approval.

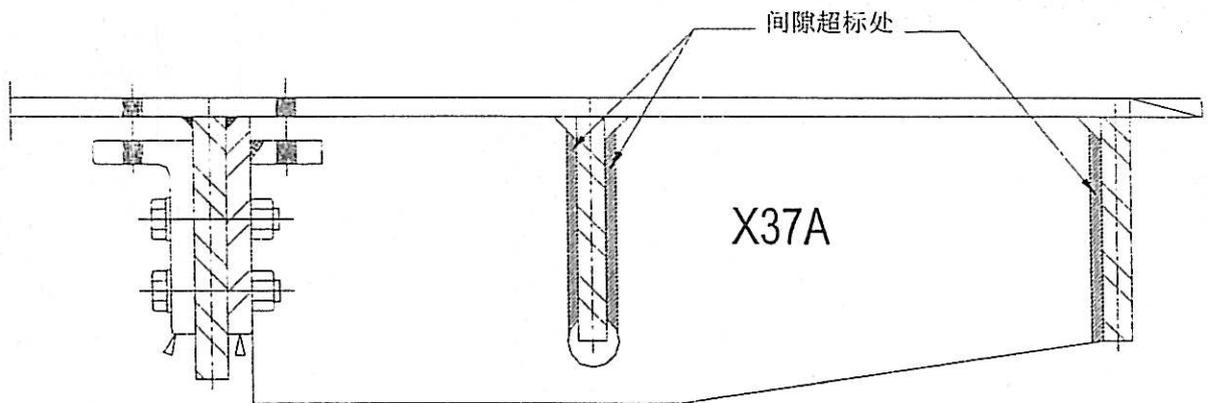
焊接变形和制作误差。

1. Perform surfacing to item X37A per work drawing;
2. Grind the edge of the repair area cleanly;
3. Prepare an right joint according to the approved WPS;
4. Perform 100%VT and 100%MT, and add steel backing according to the attached drawing 1 and AWS D1.5.3.13;
5. Preheat and weld according to the relevant WPS;
6. Gouge off the steel backing and grind the weld flush with base metal after welding;
7. Perform NDT inspection(VT、MT and UT) of the weld according to the working drawings.

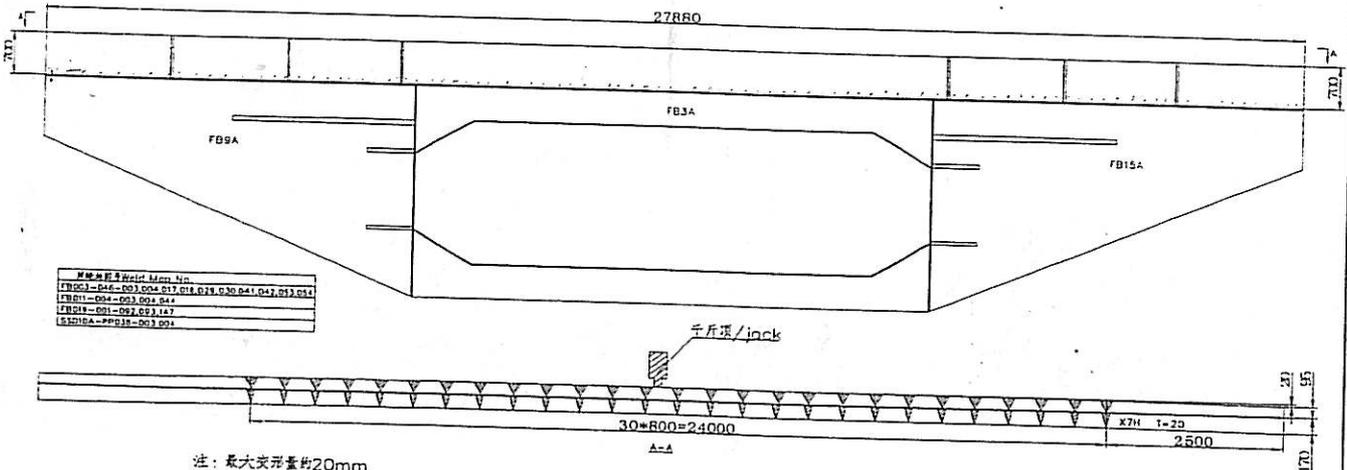
Cause原因 Welding distortion 焊接变形
 Type of Defect缺陷类型 Welding distortion 焊接变形
 Inspection Method检查方法 Visual 目检

注: 最大变形量约20mm
 NOTE: the max deformation is about 20mm

缺陷去除方法(Defect Removal Method): natural gas 天然气

最高温度(Maximum temperature): <650°C
