## QUALITY ASSURANCE -- NON-CONFORMANCE REPORT

**Report No:** NCR-000507

**NCR #:** ZPMC-0480

**Reference Description:** Linear Indication found by MT inside a Cope in 7AW after contractor's acceptance

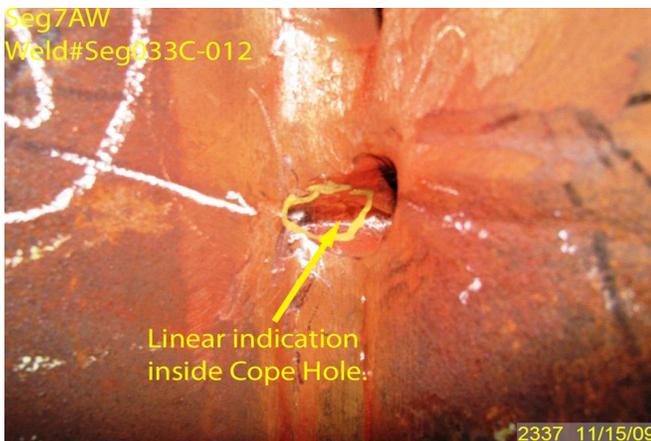
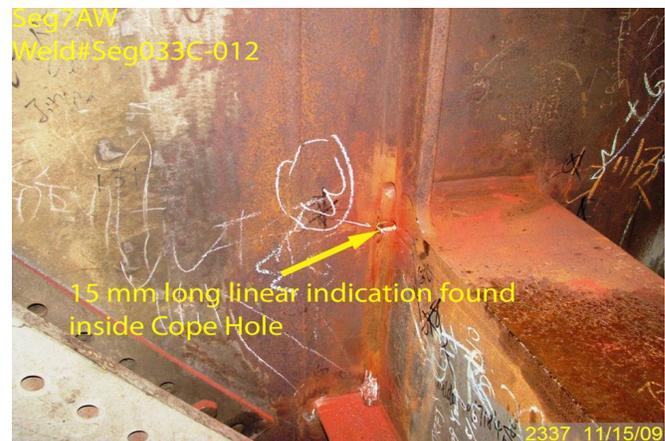
During random Magnetic Particle Testing (MT) verification at segment 7AW, Caltrans Quality Assurance (QA) Inspector discovered a linear indication inside the cope hole of weld # SEG033C-012. The indication was measured at 15mm in length. This weld was previously tested and accepted by ZPMC QC MT.

-AWS D1.5 (02) Section 6.26.2 – “Welds that are subject to MT in addition to visual inspection shall have no cracks.

Submit a repair procedure to the engineer for approval. Missed MT indications have become a chronic problem. Provide the appropriate MT technician training so these occurrences can be minimized.

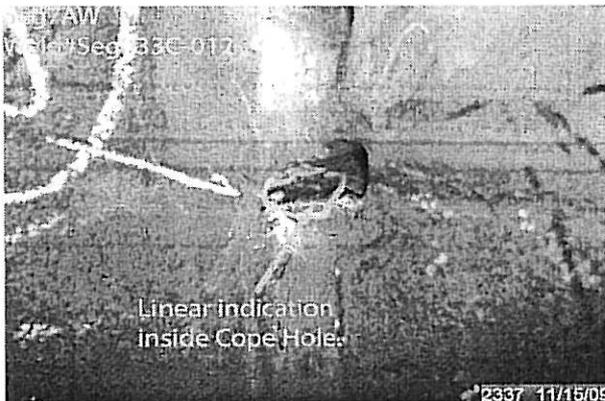
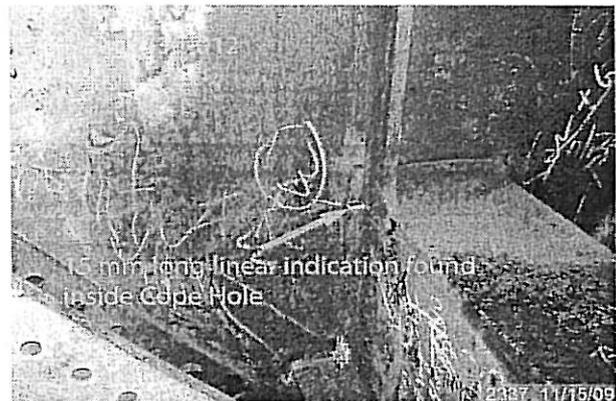
During random Magnetic Particle Testing (MT) verification at segment 7AW, Caltrans Quality Assurance (QA) Inspector discovered a linear indication inside the cope hole of weld # SEG033C-012. The indication was measured at 15mm in length. This weld was previously tested and accepted by ZPMC QC MT.

-AWS D1.5 (02) Section 6.26.2 – “Welds that are subject to MT in addition to visual inspection shall have no cracks.

Repair said indication and perform NDT required to verify weld quality.

Contractor submitted NDT records verifying the weld is in conformance with Contract weld quality requirements. An internal NCR was issued by the Contractor in regards to this issue in addition to providing supplemental training to NDT technicians.
