Contract #: 04-0120F4
 Cty: SF/ALA Rte: 80 PM: 13.2/13.9
 File #: 69.25B

QUALITY ASSURANCE -- NON-CONFORMANCE REPORT

Report No: NCR-000514

Reference Description: Heat Straightening not according to the Heat Straightening Procedure on Crossbeam
 8

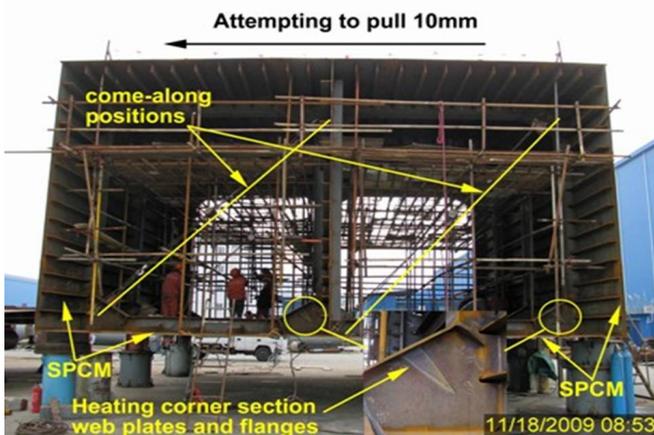
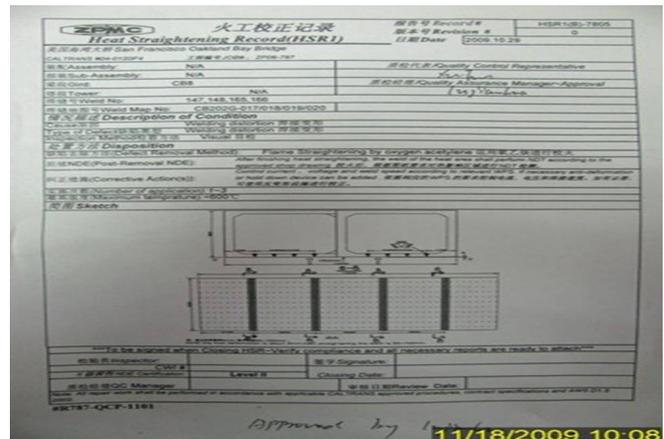
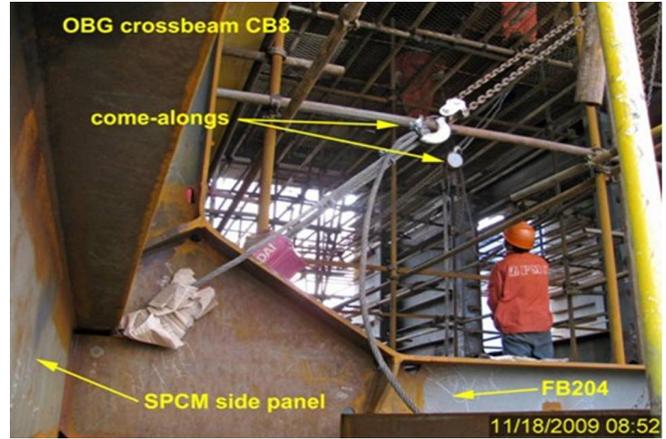
This Quality Assurance (QA) inspector observed ZPMC personnel attempting to correct an “out of square” condition on OBG crossbeam CB8. According to ZPMC Quality Control (QC) inspector identified as Mr. Liu Cheun Gang, this crossbeam was fabricated 10mm out of square. This QA noted that all welding has been completed on this crossbeam. This QA observed ZPMC personnel rigging hand operated winches (come-alongs) diagonally, top to bottom, inside of the crossbeam at two floor beam diaphragm locations on each side of the intermediate diaphragm panel. This QA also observed that ZPMC appears to have heated the web and flange plates on the floor beam diaphragm corner sections. These procedures and the description of the distortion were not documented in the two Heat Straightening Records HSR1(B)-7466 and 7805 dated 8/25/2009. The work performed is not in compliance in the ZPMC internal approved HSR documents.

Submit HSR to the engineer for approval.

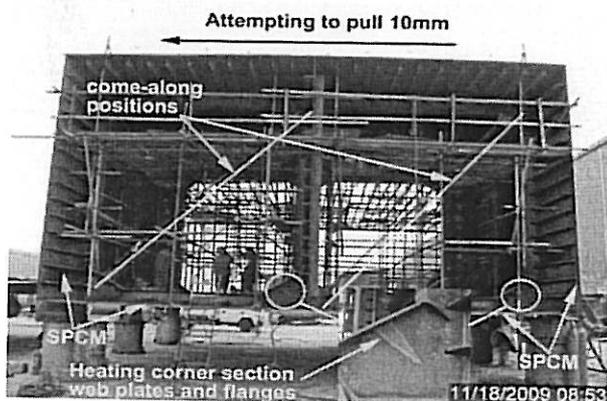
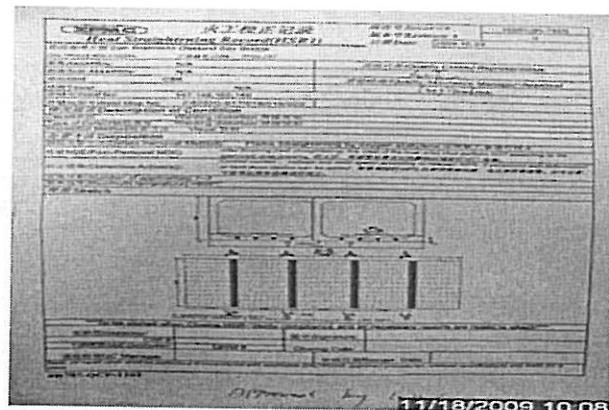
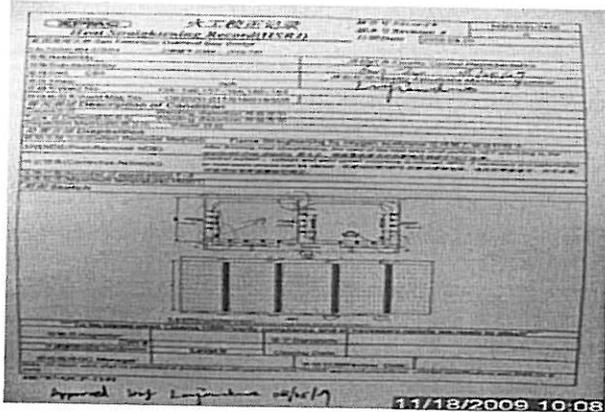
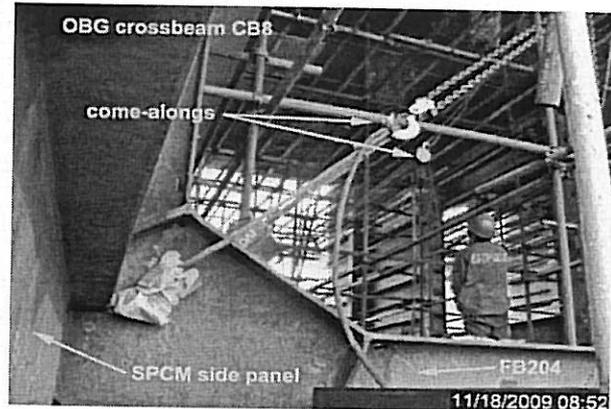
This Quality Assurance (QA) inspector observed ZPMC personnel attempting to correct an "out of square" condition on OBG crossbeam CB8. According to ZPMC Quality Control (QC) inspector identified as Mr. Liu Cheun Gang, this crossbeam was fabricated 10mm out of square. This QA noted that all welding has been completed on this crossbeam. This QA observed ZPMC personnel rigging hand operated winches (come-alongs) diagonally, top to bottom, inside of the crossbeam at two floor beam diaphragm locations on each side of the intermediate diaphragm panel. This QA also observed that ZPMC appears to have heated the web and flange plates on the floor beam diaphragm corner sections. These procedures and the description of the distortion were not documented in the two Heat Straightening Records HSR1(B)-7466 and 7805 dated 8/25/2009. The work performed is not in compliance in the ZPMC internal approved HSR documents.

Submit HSR to the engineer for approval.

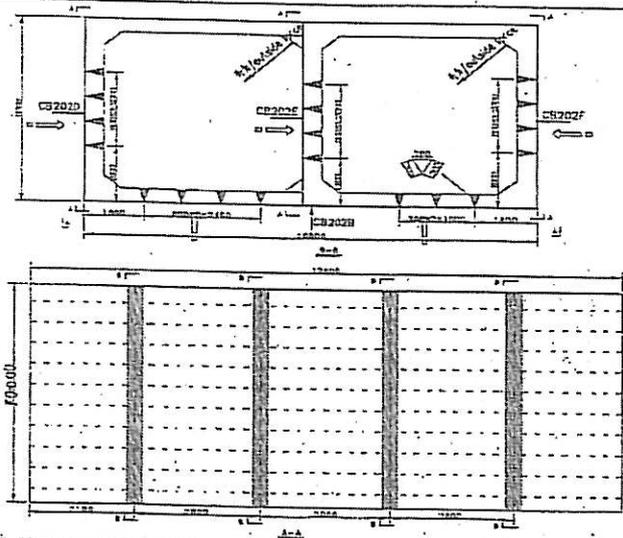
HSR1(B)-7466

Cause原因: Welding distortion 焊接变形

Type of Defect缺陷类型: Welding distortion 焊接变形

注: 校火时25mm, 最大50-100mm.
NOTE: the max deformation is about 5mm, heat straightening the width is 50-100mm.

缺陷去除方法(Defect Removal Method): Flame Straightening by oxygen acetylene 运用氧乙炔进行校火

后续NDE(Post-Removal NDE): After finishing heat straightening, the weld of the heat area shall perform NDT according to the approved shop drawing 校火后, 根据图纸要求对热影响区域进行 NDT 检测.

纠正措施(Corrective Action(s)): Control current, voltage and weld speed according to relevant WPS. If necessary anti-deformation or hold down device can be added. 依据相应的WPS的要求控制电流, 电压和焊接速度. 如有必要, 可使用反变形设施进行校正.

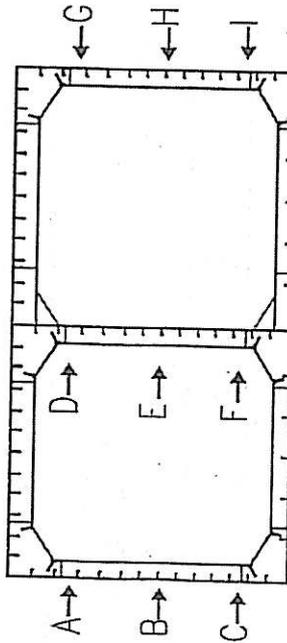
HSR1(B) 7466

测量点 Measure position:	A	B	C	D	E	F	G	H	I	J	M
测量值 Measure result:	4	4	5	3	4	4	4	5	3	3	4

测量点 Measure position:	A	B	C	D	E	F	G	H	I	J	M
测量值 Measure result:	1	1	1	0.5	0.5	1	0.5	0.5	0.5	0.5	0.5

整体平整度/钢板垂直度是否合格
Heat straightening result:

合格

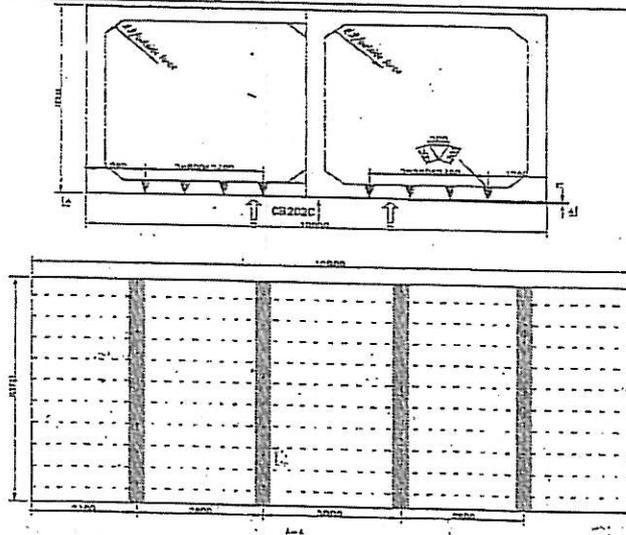
HSR1(B)-7805

Welding distortion 焊接变形

注: 火焰校正片5mm, 校正区50-100mm
 NOTE: the max deformation is about 5mm, heat straightening the width is 50-100mm.

Flame Straightening by oxygen acetylene 运用氧乙炔进行校火

After finishing heat straightening, the weld of the heat area shall perform NDT according to the approved shop drawing 校火后, 根据图纸要求对热影响区域进行 NDT 检测.

Control current, voltage and weld speed according to relevant WPS. If necessary anti-deformation or hold down device can be added. 依据相应的WPS的要求控制电流, 电压和焊接速度. 如有必要, 可使用反变形设施进行校正.

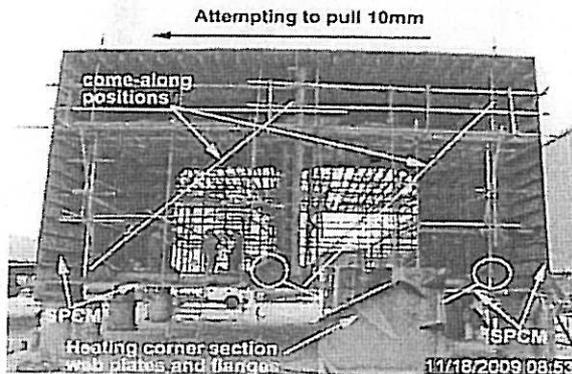
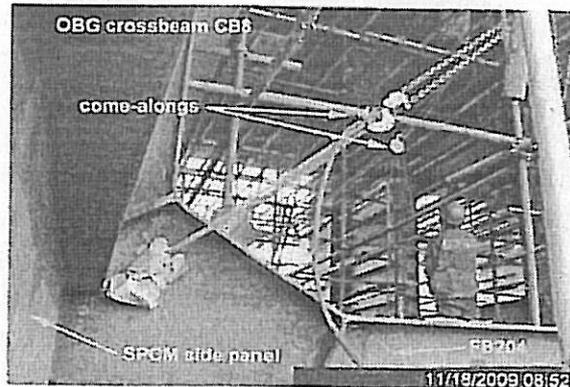
This Quality Assurance (QA) inspector observed ZPMC personnel attempting to correct an "out of square" condition on OBG crossbeam CB8. According to ZPMC Quality Control (QC) inspector identified as Mr. Liu Cheun Gang, this crossbeam was fabricated 10mm out of square. This QA noted that all welding has been completed on this crossbeam. This QA observed ZPMC personnel rigging hand operated winches (come-alongs) diagonally, top to bottom, inside of the crossbeam at two floor beam diaphragm locations on each side of the intermediate diaphragm panel. This QA also observed that ZPMC appears to have heated the web and flange plates on the floor beam diaphragm corner sections. These procedures and the description of the distortion were not documented in the two Heat Straightening Records HSR1(B)-7466 and 7805 dated 8/25/2009. The work performed is not in compliance in the ZPMC internal approved HSR documents.

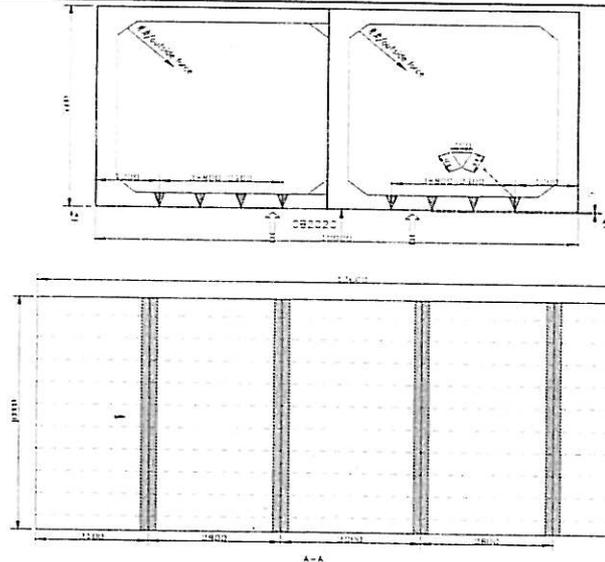
Cause 原因	Welding distortion 焊接变形
Type of Defect 缺陷类型	Welding distortion 焊接变形
Inspection Method 检查方法	Visual 目检

注: 最大变形量85mm, 热影响区50-100mm.
NOTE: the max deformation is about 85mm, heat straightening the width is 50-100mm.

缺陷去除方法(Defect Removal Method): Flame Straightening by oxygen acetylene 运用氧乙炔进行校火

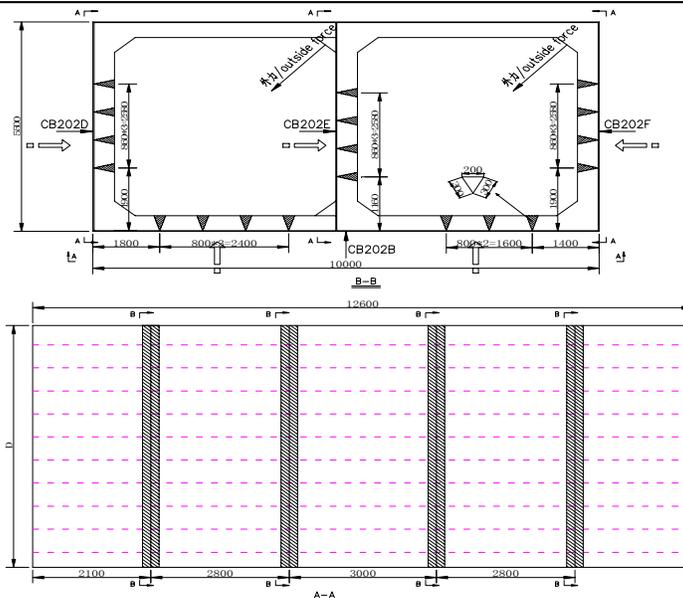
Cause 原因 Welding distortion 焊接变形

Type of Defect 缺陷类型 Welding distortion 焊接变形

注: 最大变形量5mm, 校火宽度50~100mm.
NOTE: the max deformation is about 5mm, heat straightening the width is 50~100mm.

缺陷去除方法 (Defect Removal Method): Flame Straightening by oxygen acetylene 运用氧乙炔进行校火

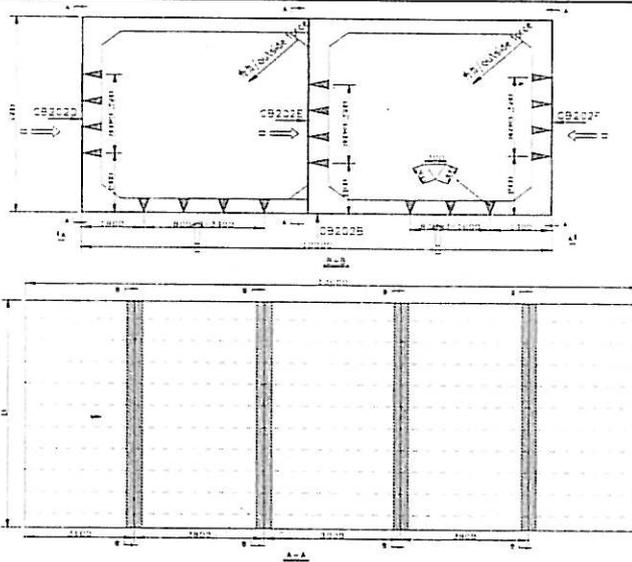
Cause 原因	Welding distortion 焊接变形
Type of Defect 缺陷类型	Welding distortion 焊接变形
Inspection Method 检查方法	Visual 目检

注: 最大变形量约5mm, 校火宽度50~100mm.
NOTE: the max deformation is about 5mm, heat straightening the width is 50~100mm.

缺陷去除方法(Defect Removal Method):	Flame Straightening by oxygen acetylene 运用氧乙炔进行校火
后续NDE(Post-Removal NDE):	After finishing heat straightening, the weld of the heat area shall perform NDT according to the approved shop drawing 校火后, 根据图纸要求对热影响区域进行NDT检测。
纠正措施(Corrective Action(s)):	Control current, voltage and weld speed according to relevant WPS. If necessary anti-deformation or hold down device can be added. 依据相应的WPS的要求控制电流、电压和焊接速度。如有必要, 可使用反变形设施进行校正。

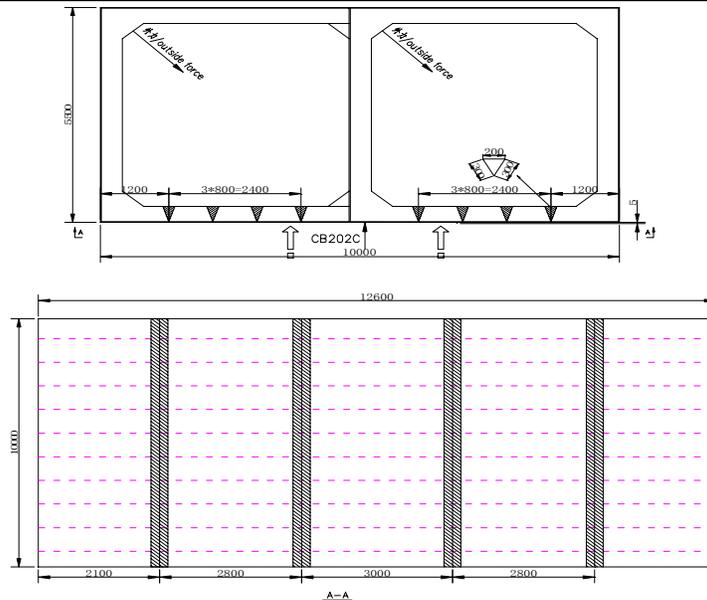
Cause原因 Welding distortion 焊接变形

Type of Defect缺陷类型 Welding distortion 焊接变形

注: 最大变形量5mm, 校火宽度50~100mm.
NOTE: the max deformation is about 5mm, heat straightening the width is 50~100mm.

缺陷去除方法(Defect Removal Method): Flame Straightening by oxygen acetylene 运用氧乙炔进行校火

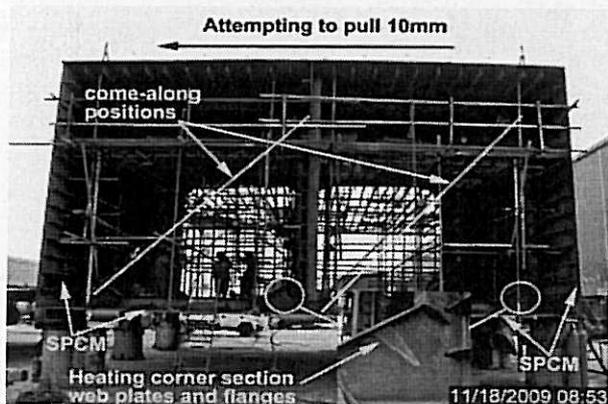
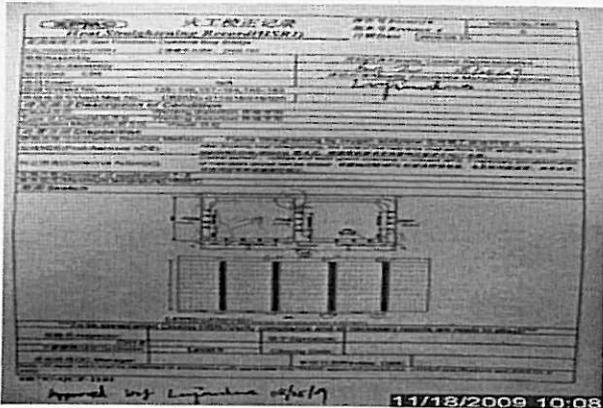
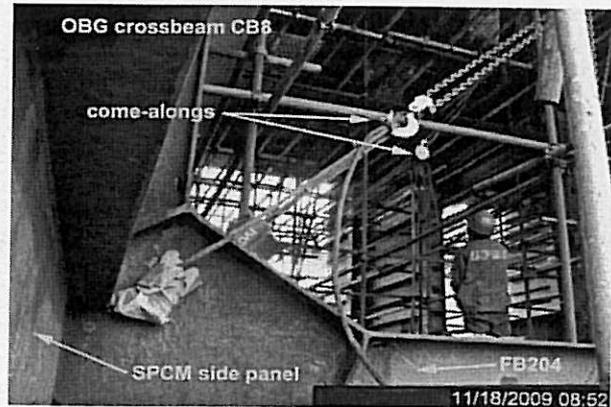
This Quality Assurance (QA) inspector observed ZPMC personnel attempting to correct an "out of square" condition on OBG crossbeam CB8. According to ZPMC Quality Control (QC) inspector identified as Mr. Liu Cheun Gang, this crossbeam was fabricated 10mm out of square. This QA noted that all welding has been completed on this crossbeam. This QA observed ZPMC personnel rigging hand operated winches (come-alongs) diagonally, top to bottom, inside of the crossbeam at two floor beam diaphragm locations on each side of the intermediate diaphragm panel. This QA also observed that ZPMC appears to have heated the web and flange plates on the floor beam diaphragm corner sections. These procedures and the description of the distortion were not documented in the two Heat Straightening Records HSR1(B)-7466 and 7805 dated 8/25/2009. The work performed is not in compliance in the ZPMC internal approved HSR documents.
